SERVICE BULLETIN

APPLICABILITY: 2020MY Legacy and Outback

NUMBER: 12-280-20

SUBJECT: A-Pillar Trim- Gap Visible at Head Liner

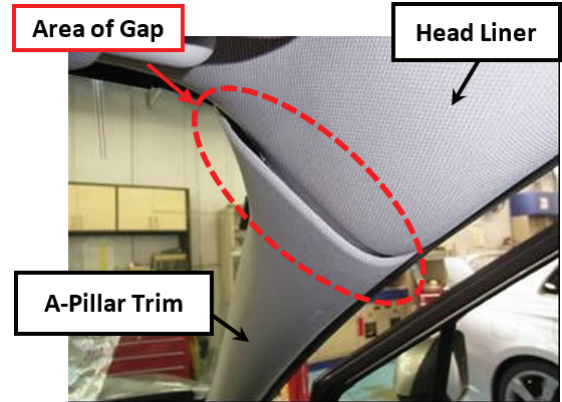
This bulletin provides a procedure to address a limited number of customer concerns regarding a visible gap between the A-Pillar trim panel and the head liner as shown in the photo here.

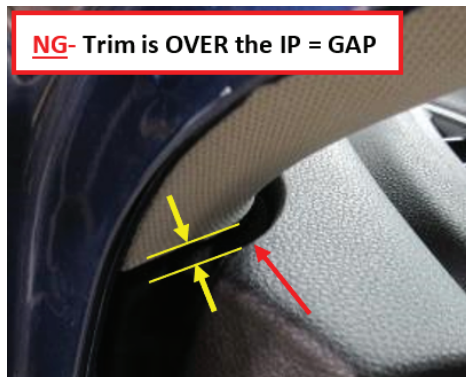
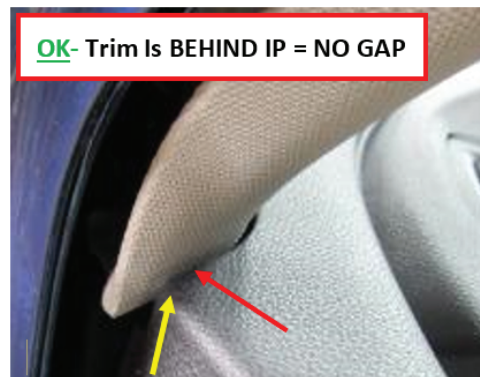
- Condition “A”

These comparison photos show the A-Pillar trim not fitting into the instrument panel (IP) properly. The trim is contacting a structural rib of the IP and is keeping it from fitting in behind the IP as it should.

- If Condition A, B or D is confirmed, the affected A-Pillar trim must be replaced as the holding force of the clips is reduced. Follow the procedure in the applicable Service Manual.
- If Condition C is confirmed, trim replacement is NOT needed as the clips were never properly seated at assembly.

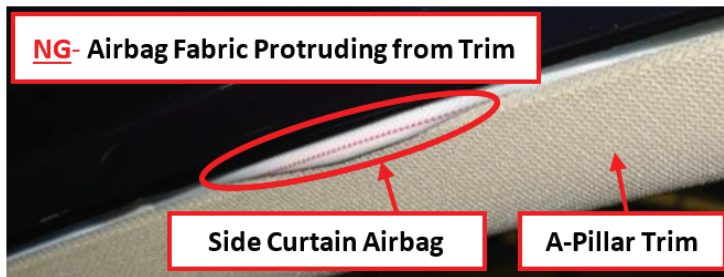
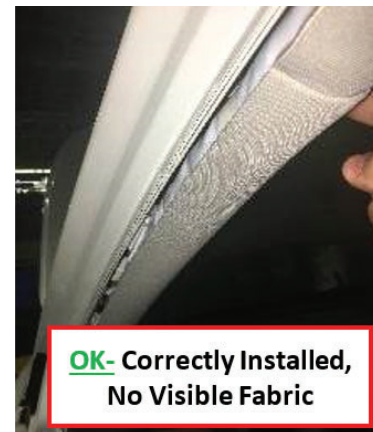
- Condition “B”

The NG photo below shows a portion of the side airbag module fabric protruding from between the A-Pillar trim and the A-Pillar of the vehicle body.

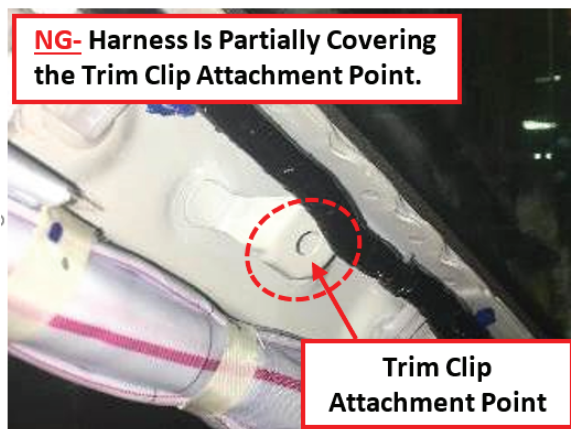
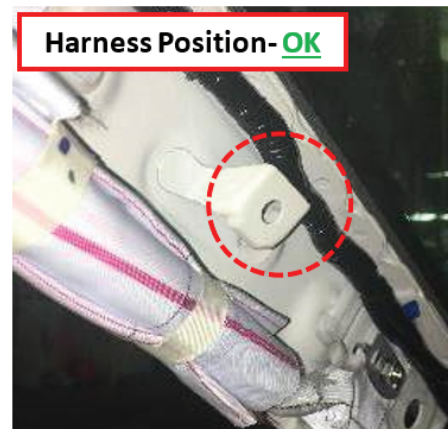
- Condition “C”

Here, the roof harness is partially covering the surface of the trim clip attachment point. The OK photo shows the harness properly tucked in away from the attachment point.

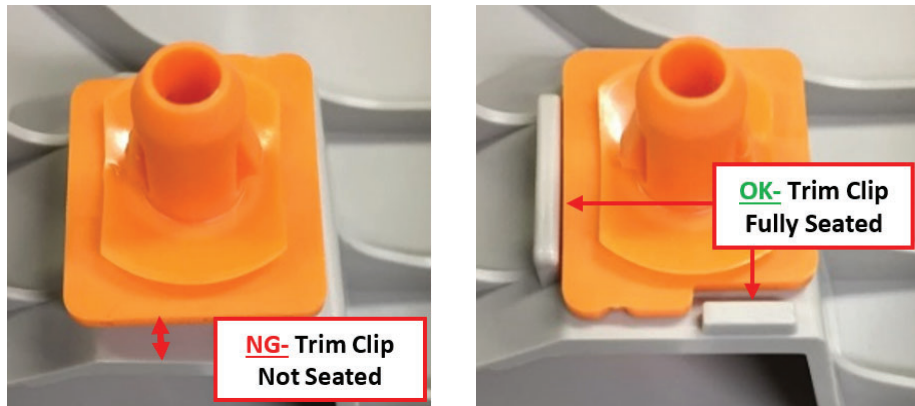
- Condition “D”

The trim clip securing the trim panel to the A-Pillar must be fully seated against the locating bosses as shown here.

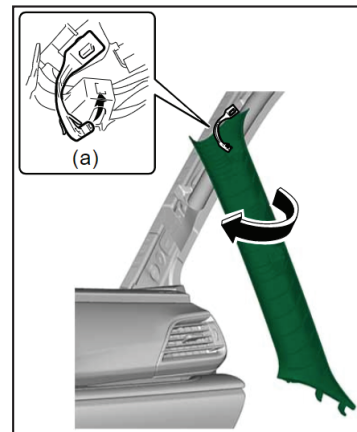
VERY IMPORTANT REMINDER: Whenever removing or installing the A-Pillar trim panels, use CAUTION when disengaging the tether clip (a). If the tether clip is damaged in any way, it MUST be replaced.

- Release the trim toward the center of the IP using a plastic trim tool to access the tether clip.
- Using a needle-nose plier or the special Tether Clip removal tool, CAREFULLY rotate the clip to disengage it from the trim (b).
- Rotate the trim toward the center of the IP to remove it.
