Mercedes-Benz

Campaign No. 2019120002, December 2019

SUBJECT: **Model 907 (Sprinter), Model Year 2019  
Abutting Wedge**

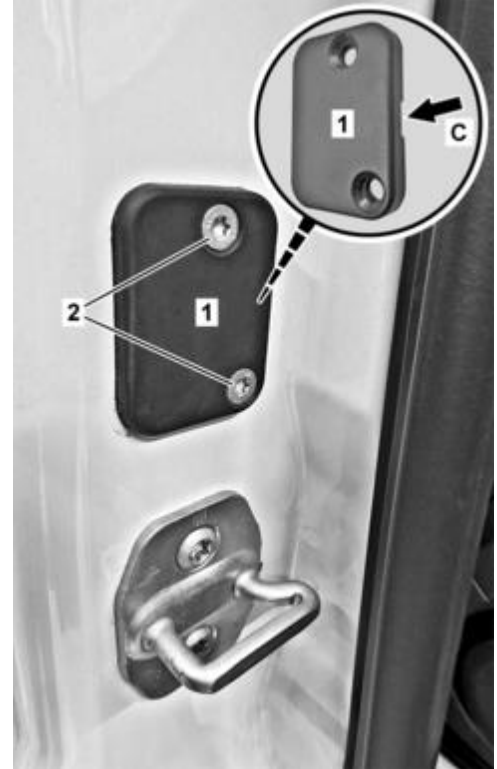
Figure 1: D72.10-A004-03

- 1 Closing wedge
- 2 Bolts

1	Check installation position of wedge-type stop (1) on left and right B-pillar.	<p><b>i</b></p> <p>Cutout must face toward vehicle interior (see arrow C). If the cutout (see arrow C) of the wedge-type stop (1) does not face toward the vehicle interior,</p> <p>↓</p> <p>rotate wedge-type stop (1) through 180°; to do so, continue with operation step 3. If the cutout (see arrow C) of the wedge-type stop (1) faces toward the vehicle interior,</p> <p>↓</p> <p>proceed with operation step 2.</p>	
2	Check torque of screws (2).	<p><b>i</b></p> <p>To do so, tighten screws (2) to specified torque.</p> <p><b>Nm</b> Bolt, wedge-type stop to B-pillar</p> <p>If the screw (2) or rivet nut (3) turns and the torque is not reached,</p> <p>↓</p> <p>replace rivet nuts (3); to do so, continue with operation step 3. If torque is reached,</p> <p>↓</p> <p>end the measure.</p>	BA72.10-N-1011-01TS
<b>Remove</b>

3	Remove wedge-type stop (1).	<p>If the installation position of the wedge-type stop (1) is incorrect or the rivet nuts (3) are replaced.</p> <p><b>i</b></p> <p>To do this, remove screws (2). Replace screw/bolts (2). If screws (2) can be removed, ↓ continue with step 11. If screws (2) cannot be unscrewed or if rivet nuts (3) turn, ↓ continue with operation step 4.</p>	
4	Remove respective seat belt from B-pillar.	If rivet nuts (3) are replaced.	AR91.40-D-1015TS
5	Remove screws (2).	<p>If rivet nuts (3) are replaced.</p> <p><b>i</b></p> <p>Replace screw/bolts (2).</p> <p><b>i</b></p> <p>To do so, counterhold rivet nuts (3) using pliers through opening in respective B-pillar and remove screws (2).</p>	
6	Remove rivet nuts (3).	<p>If rivet nuts (3) are replaced.</p> <p>

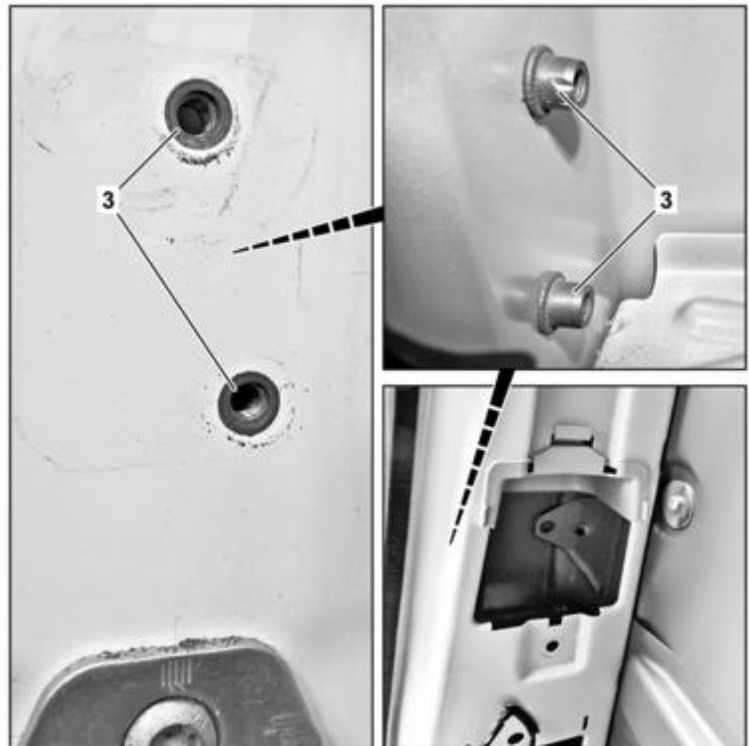
Figure 2: D72.10-A005-12

- 3 Rivet nuts

</p> <p>Cover up paint surface in working area. This prevents any paint damage.</p> <p><b>i</b></p> <p>Drill out using a suitable drill bit <math>\varnothing</math> 8.5 mm.</p>

7	Remove drill chips and residue of rivet nuts (3).	<p>If rivet nuts (3) are replaced.</p> <p><b>i</b> The drill chips and residue of rivet nuts (3) can be reached through an opening in respective B-pillar.</p> <p><b>i</b> <b>Commercially available devices/tools</b> Wet and dry vacuum cleaner</p>	
8	Apply zinc dust paint around bores.	<p>If rivet nuts (3) are replaced.</p> <p>1K-zinc dust paint</p>	BR00.45-Z-1056-07A
<b>Install</b>			
9	Process wedge-type stop (1).	<p>If rivet nuts (3) were replaced.</p> <p><b>i</b> The head of the rivet nut (3) must be flush with the outer edge of the wedge-type stop (1) (see arrow B). Process contact surfaces (A) of wedge-type stop (1) using a suitable tool until the wedge-type stop (1) lies flush with the B-pillar.</p>	
10	Install new rivet nuts (3).	<p>If rivet nuts (3) were replaced.</p> <p><b>i</b> <b>Commercially available devices/tools</b> Rivet nut pliers</p>
