Subject: J-Coach ESP/ABS Pressure Sensor Rework			
Field Change Program: Field Campaign	FCP Number: 472	Revision: A	Date: 01/21/2020
Coach Section: 07- Electrical	P/N: N/A		Type: Product Integrity

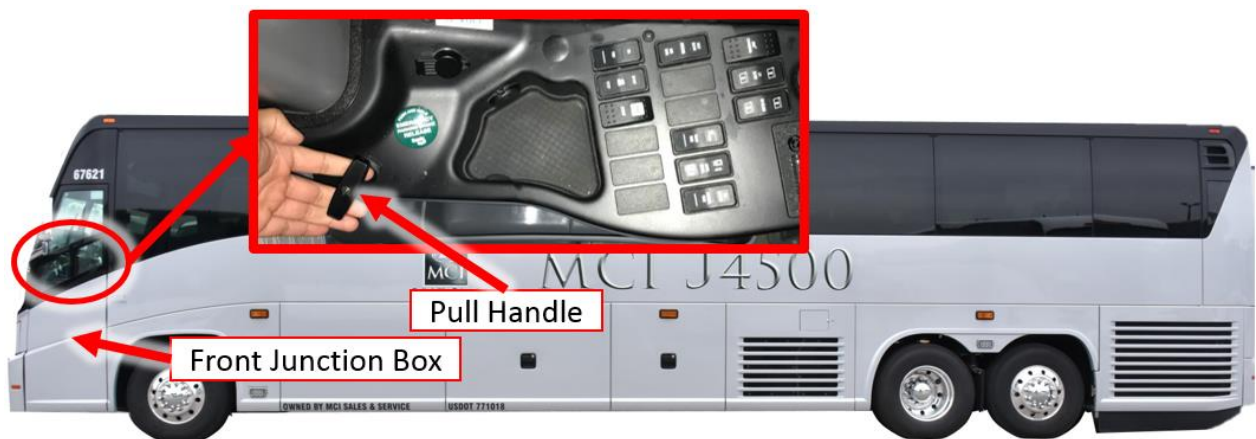
Locate the front junction box (FJB) on the front left side of the coach. Open the front junction box by pulling the handle by the driver left hand console.

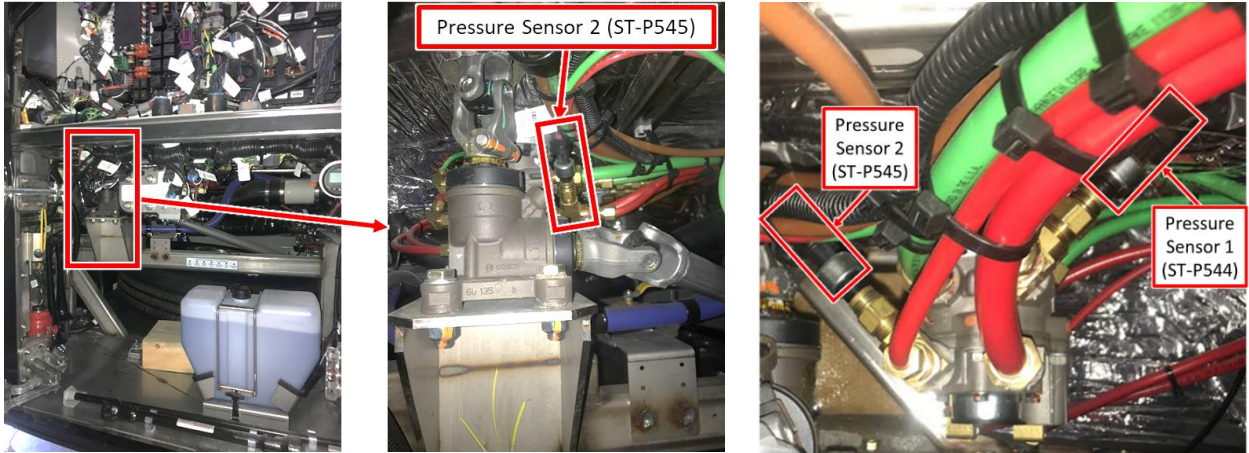
The Bendix ESP/ABS pressure sensor electrical connectors (ST-P544/ST-P545) were reversed during installation.

Under the driver's floor in the FJB, locate the two pressure sensors on the pedal assembly fittings. Ensure the electrical connector labeled ST-P544 is connected to pressure sensor 1 and the electrical connector labeled ST-P545 is connected to pressure sensor 2 on the ESP/ABS Bendix harness. Pressure sensor 1 is connected to the green air delivery hose and pressure sensor 2 is connected to the red air delivery hose.

If either of the sensors' electrical connections are incorrect, continue to **section 5.0**. Otherwise the work is complete.

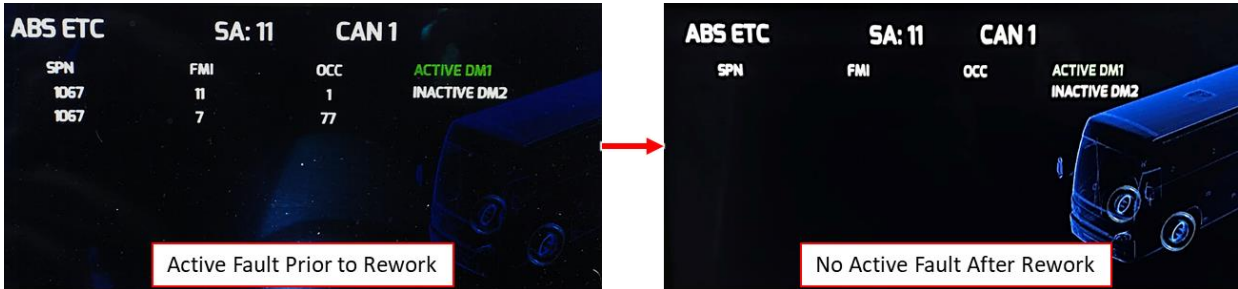
Once both pressure sensors' electrical connections are corrected, cycle the power on the Main Battery Disconnect switch. Using the steering wheel controls, enter the diagnostic menu in the IP and select ABS ETC. The plausibility error (SPN 1067) should no longer be active. This completes the procedure.
