Preliminary Information

PIP5531A Stalling Shudder And/or Hard shifting Into 1st Gear Or Reverse Vibration On launch (With Excessive Crankshaft End Play) And/Or Engine Noise Inspect Crankshaft Bearings

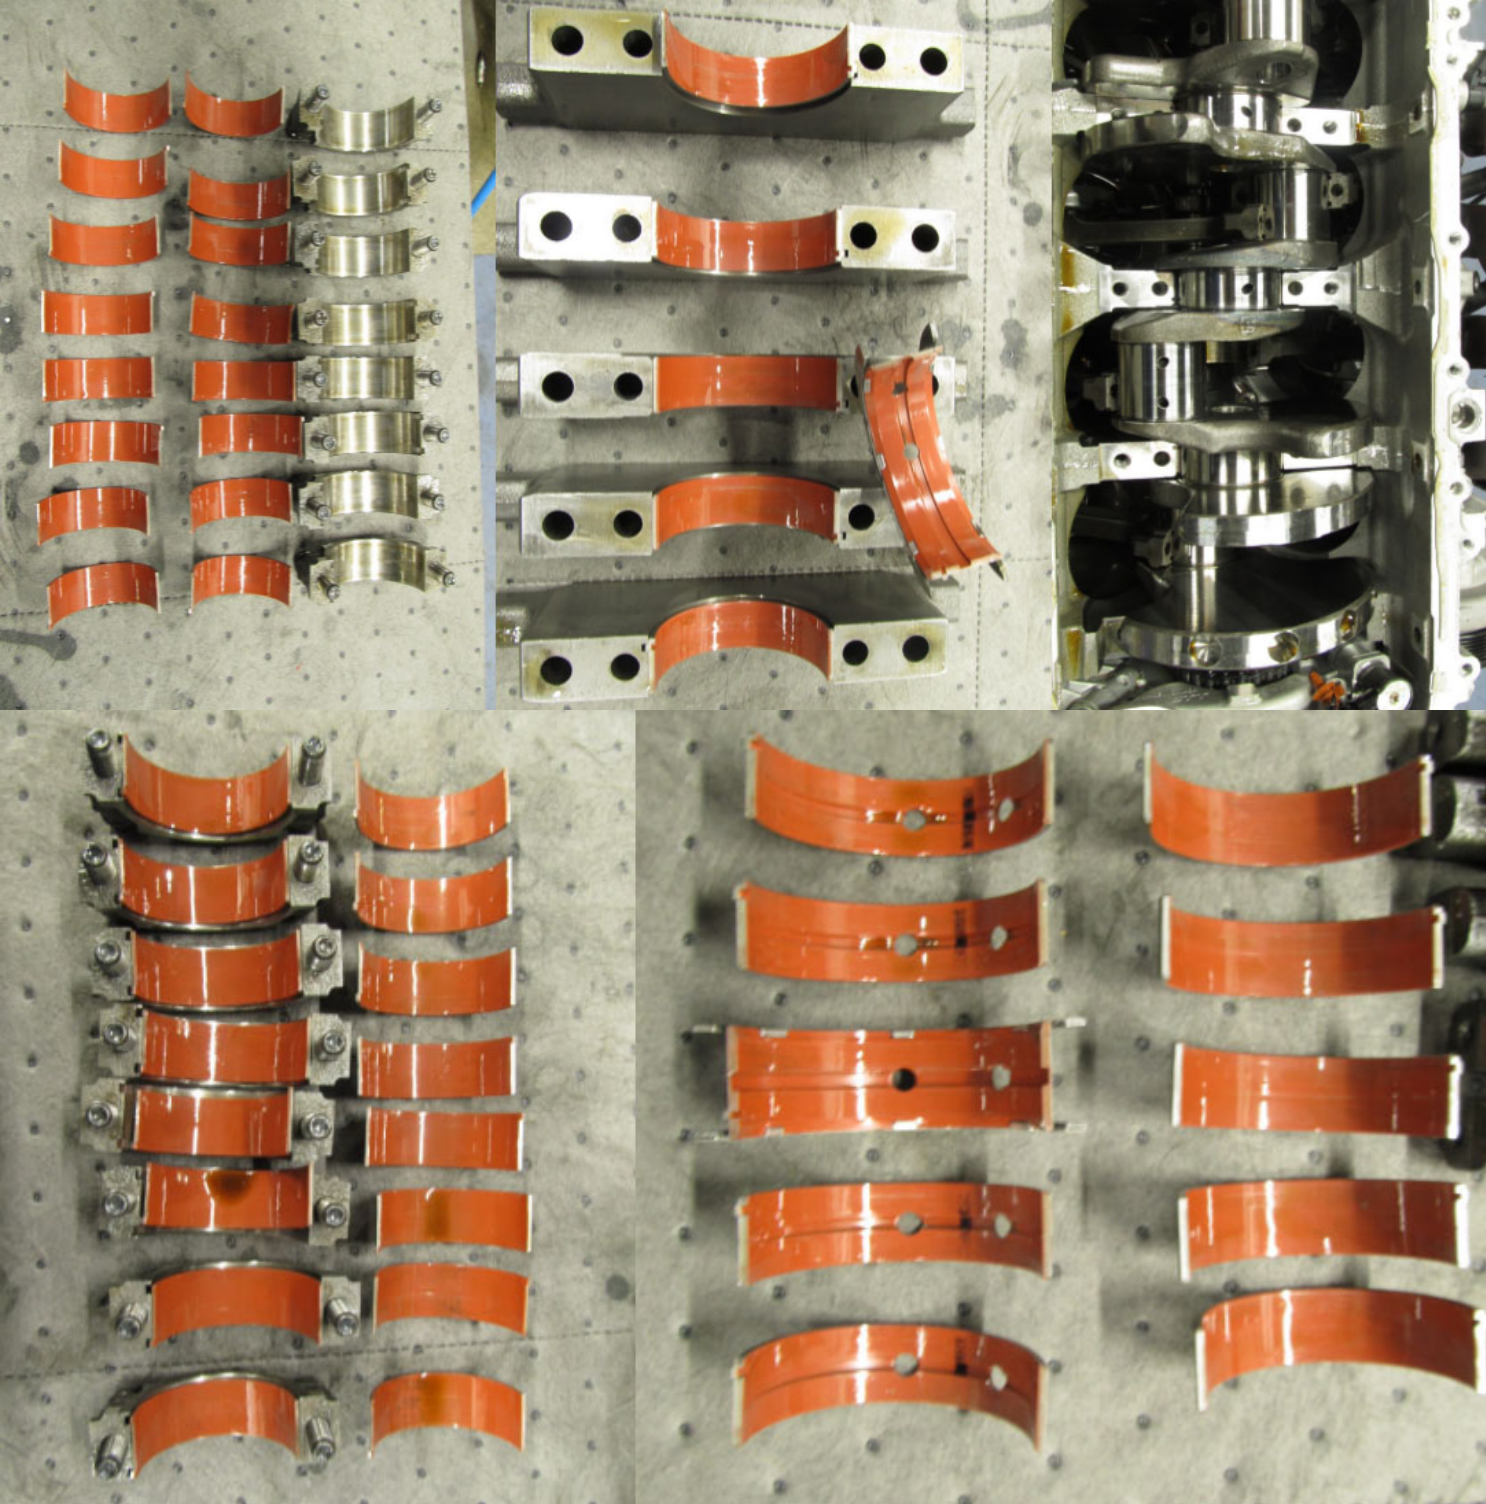
This concern could be caused by excessive crankshaft end play.

Note: If bearings and crankshaft look like components in attached picture, damage has not occurred.

Inspect thrust bearing for wear on one side and crankshaft on that “mating” surface.

If wear is evident (3 vertical channels worn off) replace connecting rod bearings, main bearings, thrust bearing and crankshaft.
