PIC6396 Towing Recovery Eyelet Found In Rear Compartment During PDI

Brand:	Model:	Model Years:	VIN:		Engine:	Transmissions:
			from	to		
Buick	Encore GX	2020	All	All	All	All

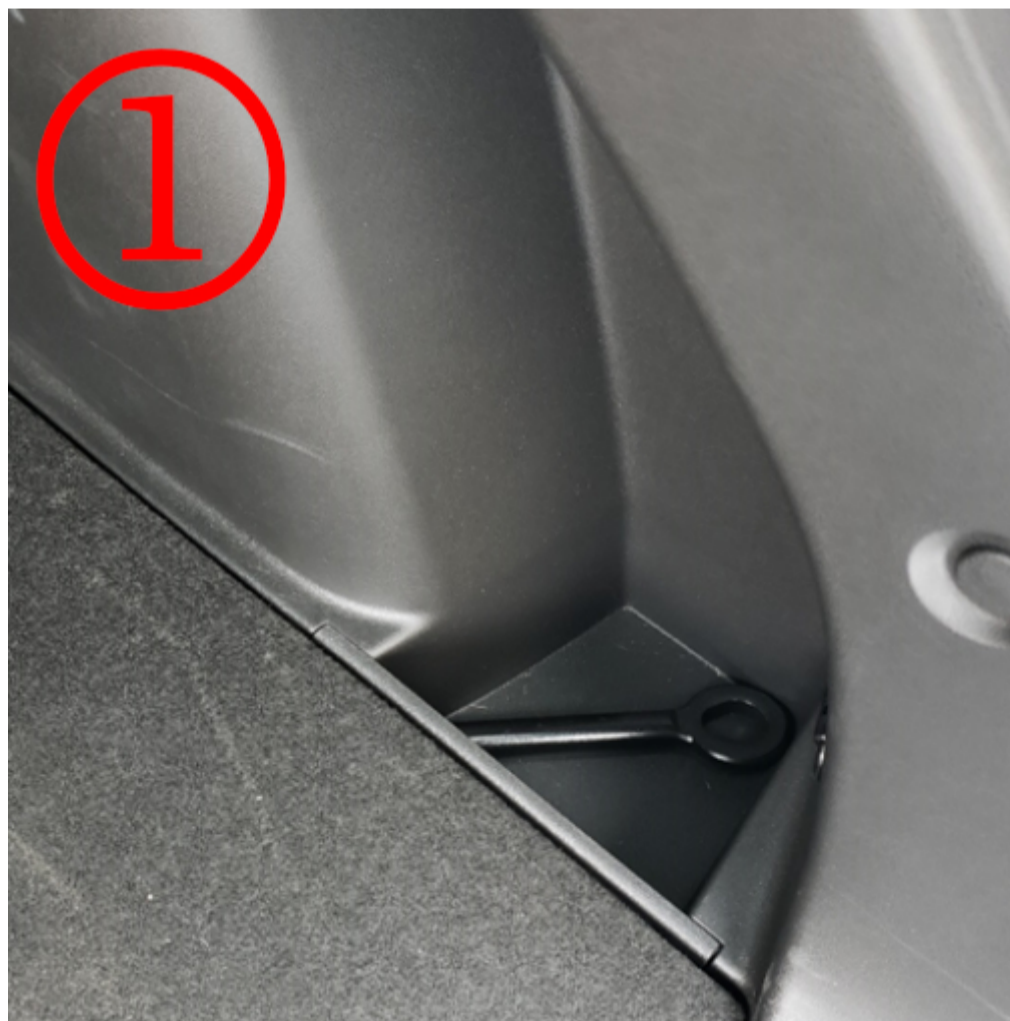
Involved Region or Country	North America
Condition	Dealers might find a towing recovery eyelet in the right side rear compartment bin during PDI
Cause	Towing recovery eyelet is placed in this location (1) after it arrives at the port

Remove the eyelet from the right side rear bin and place it into the foam holder with the jack tools under the cargo floor, refer to pictures below.

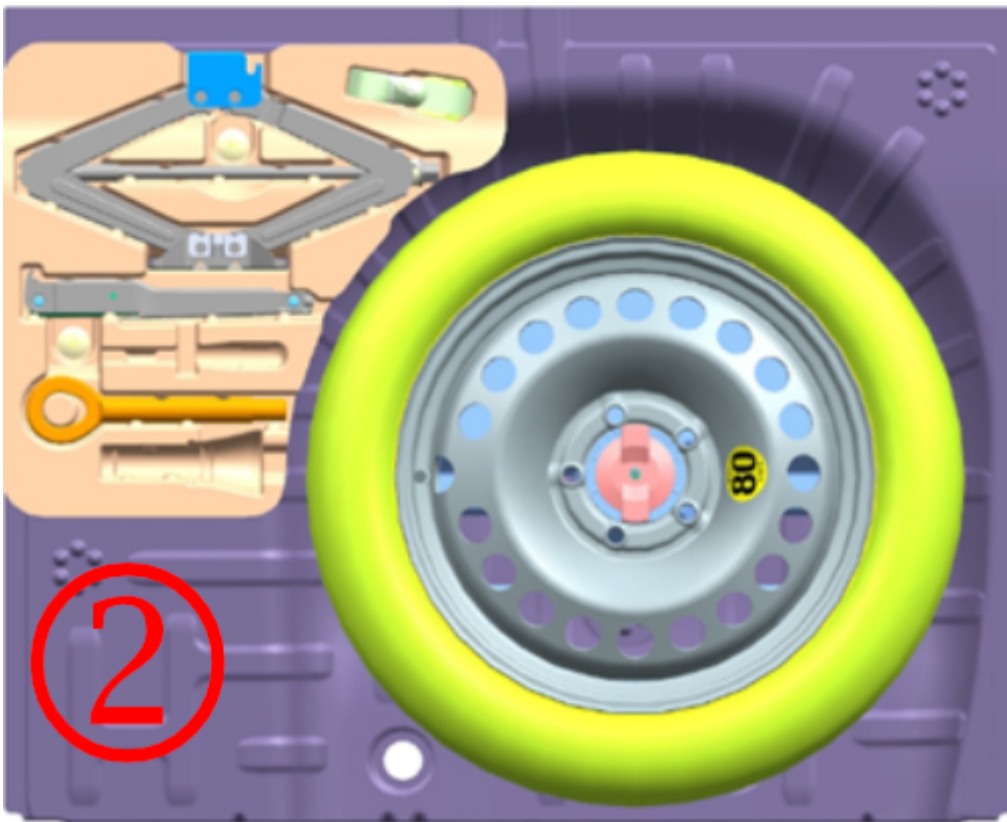
Bose Audio stow beside spare tire

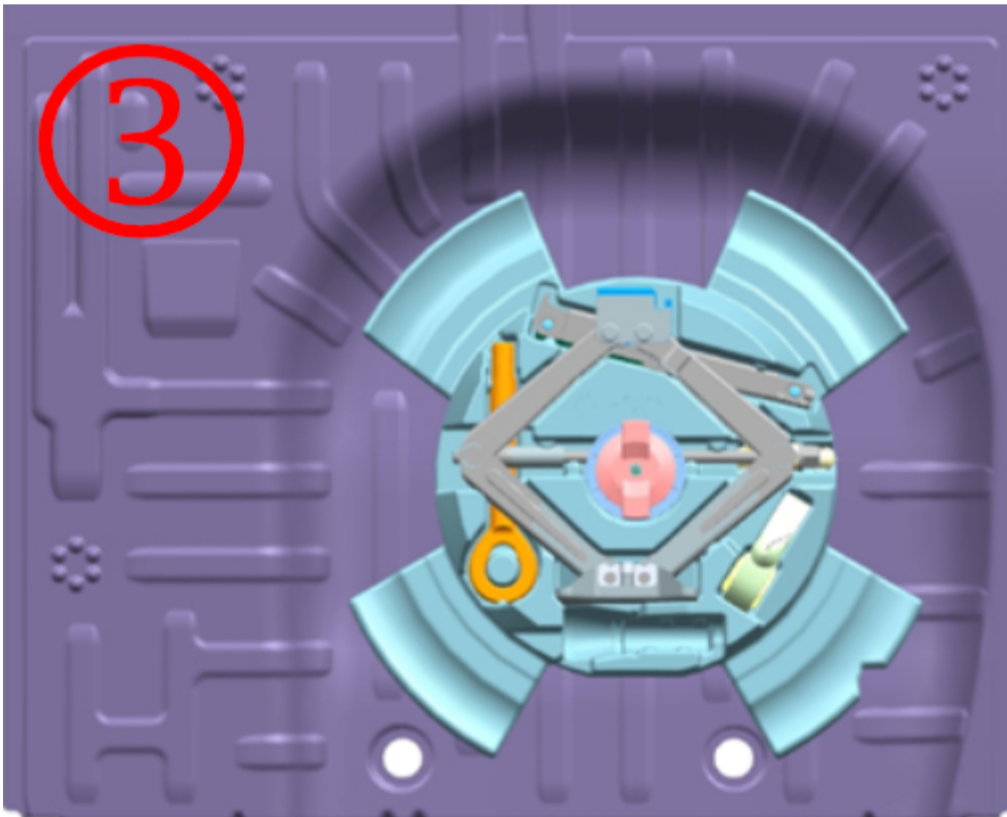
Non-Bose Audio stow under spare tire
