Preliminary Information

PIP5705 DFM/AFM Vibration Or Drone

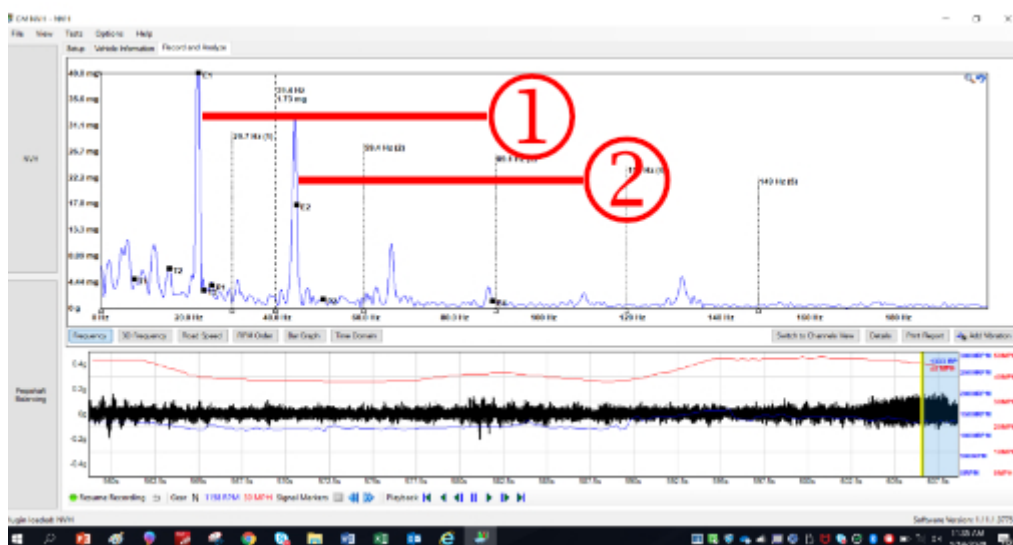
When vibration was first occurring there may be a large spike that aligned with E1 and E2.

After the tone shift the vibration no longer directly aligned with E1 and E2. (As seen below)

1, Show the E1 spike

2, Is the E2 spike

If this type of vibration is found remove and inspect the transmission mount for debris.

If debris is found, clean the mount, reinstall and evaluate for the concern.

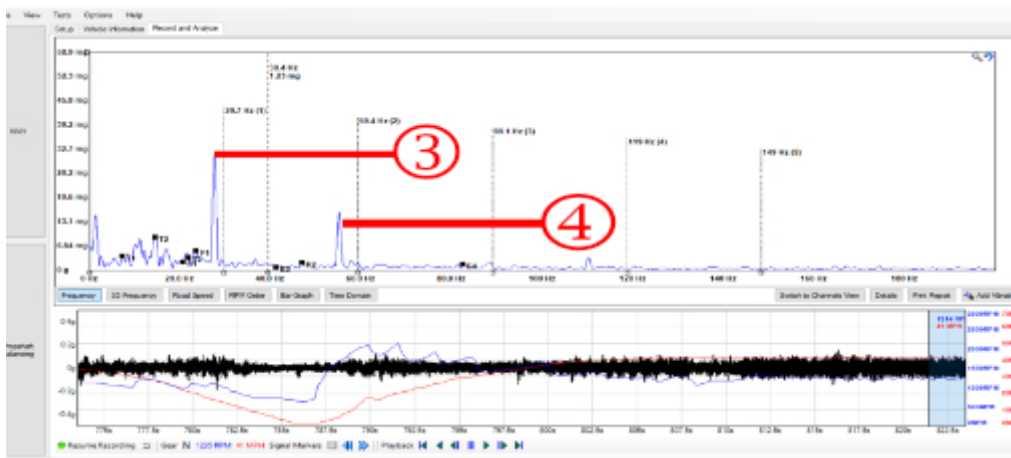
The above shows the change in the vibration.
