Preliminary Information

PIT5665A Poor Remote Keyless Entry (RKE) Fob or Passive Unlocking Range

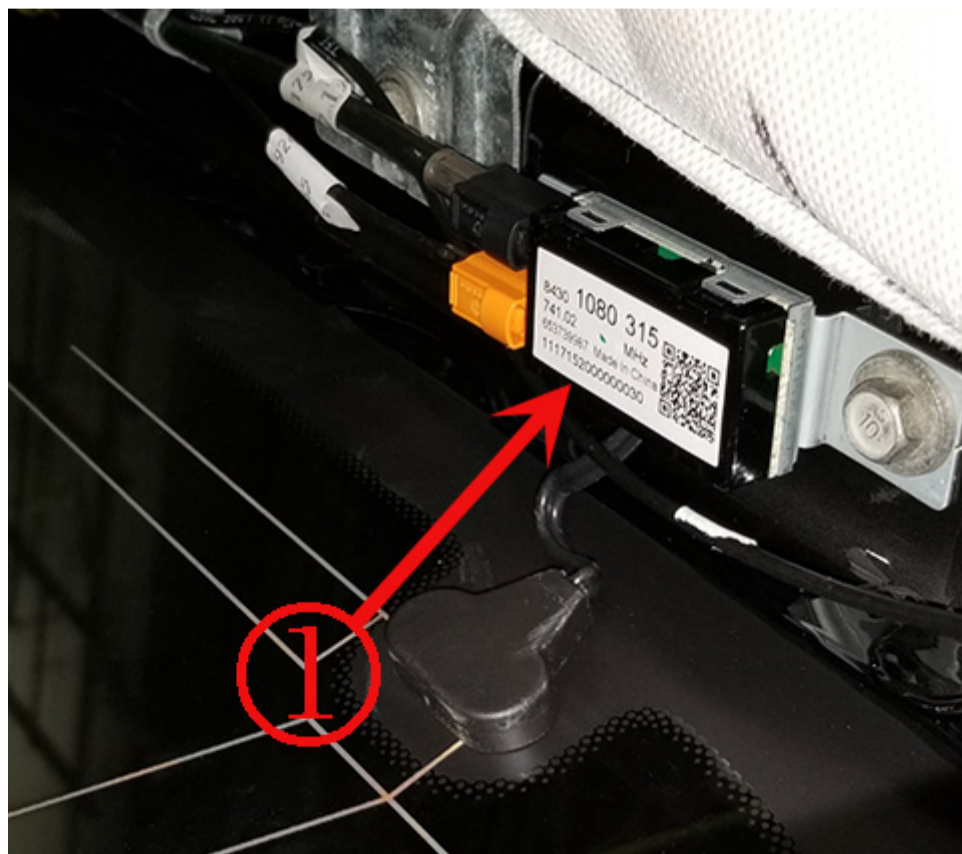
Involved Region or Country	North America
Condition	Some customers may comment on poor remote keyless entry (RKE) range (less than 20 feet.) Some customers may comment that the RKE fob must be held next to the driver's door handle before the doors will unlock when passively attempting to unlock the door.
Cause	Engineering is currently investigating this concern.

Replacing the Radio Antenna Amplifier (1) may correct the range concern.
