Bulletin No.: PIC6399 Published date: 01/28/2020

## PIC6399 Diagnostic Tip - Service Keyless Start message with B1446 SYM13 Interior Keyless Entry Antenna 3 High Signal

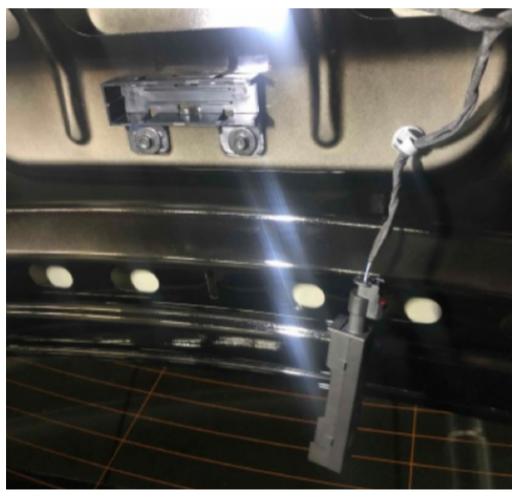
Brand:	Model:	Model Years:	VIN:		Engine:	Transmissions:	
Dranu.			from	to	Engine.		
Cadillac	CT5	2020	ALL	ALL	ALL	ALL	
Involved Region or Country		North America					
Condition		A technician may find a Service Keyless Start message displayed . DTC B1446 SYM13 may be found relating to the Keyless Entry Antenna Rear Compartment					
Cause		The T10E Keyless Entry Antenna - Rear Compartment may not be mounted in its bracket.

Inspect the T10E Keyless Entry Antenna - Rear Compartment for being loose or having fallen out of the bracket.
