Preliminary Information

PIP5706 Rough Running, Reduce Engine Power, Service Engine Soon (SES) light on, P0123 and P0222

Brand:	Model:	Model Years:	VIN:		Engine:	Transmissions:
			from	to		
Chevrolet	Silverado 2500/3500	2020	All	All	6.6L L8T	All
GMC	Sierra 2500/3500	2020	All	All	6.6L L8T	All

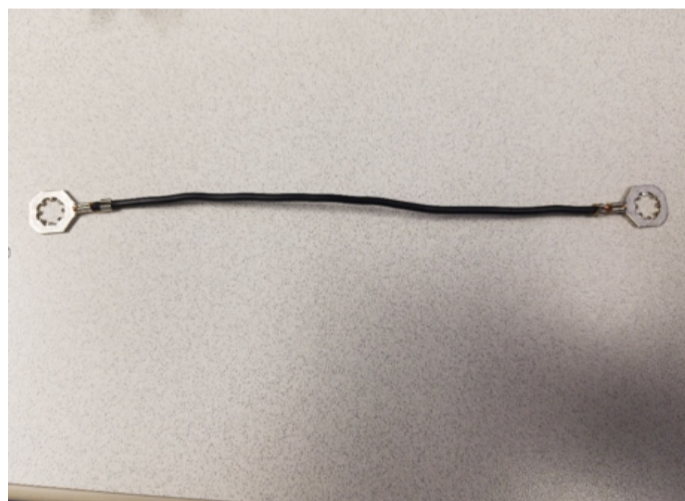
Involved Region or Country	North America
Condition	A vehicle may come into the dealer with a rough idle and /or reduced engine power . Upon inspection the technician may find the SES lamp is illuminated and DTC 's P0123 and P0222 may be active or stored history . This condition may be more noticeable in very cold climates. Note: This PI only applicable to failures that have resulted from vehicles being exposed to extreme cold (-10F / -23C or colder)
Cause	This condition may be caused by an internal circuit board fault within the throttle body .

1. Replace throttle body following the service procedure as outlined in service information.
2. Using two 8mm ring terminals and one 8-inch piece of wire 14-gauge wire to make a ground wire as shown below:
