Technical Service Bulletin

37 Transmission malfunction, DTC P17F600, P17F500, P17F400, P18C400, U008000, and/or U010100 in the TCM or ECM

37 20 92 2058450/1 February 10, 2020.

Model(s)	Year	VIN Range	Vehicle-Specific Equipment
A6, A7	2019 - 2020	All	Not Applicable

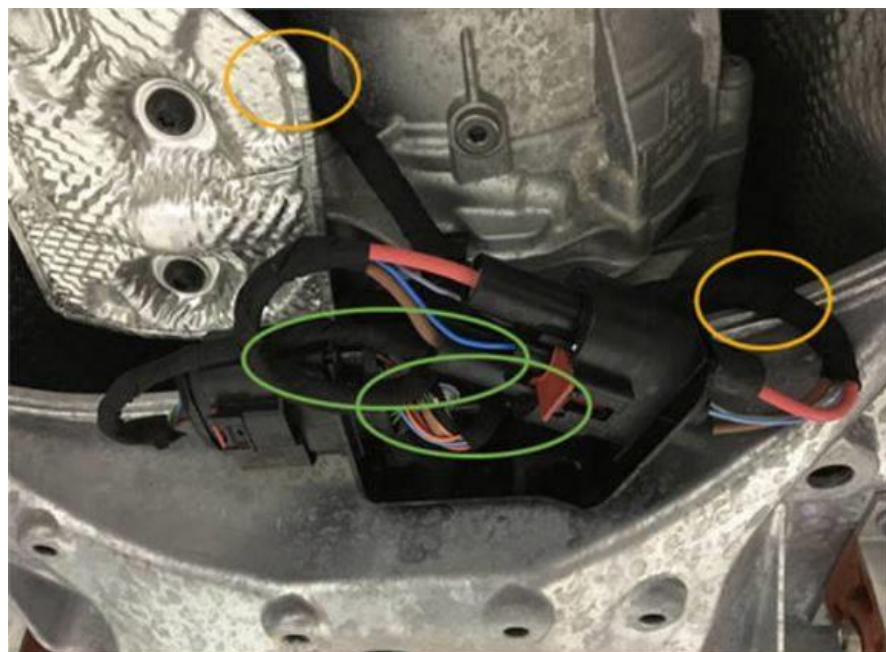
Due to routing deviations during production, the transmission harness may come in contact with the transmission crossmember and chafe over time.

Note: Harness damage can be very subtle. Even a light chafing of the harness wrap can cause DTCs.

Figure 1. Common areas for harness damage. Also depicted is the original routing concept.

1. Thoroughly inspect the transmission and body side wiring harness and routing near the areas depicted in Figures 1 and 2.

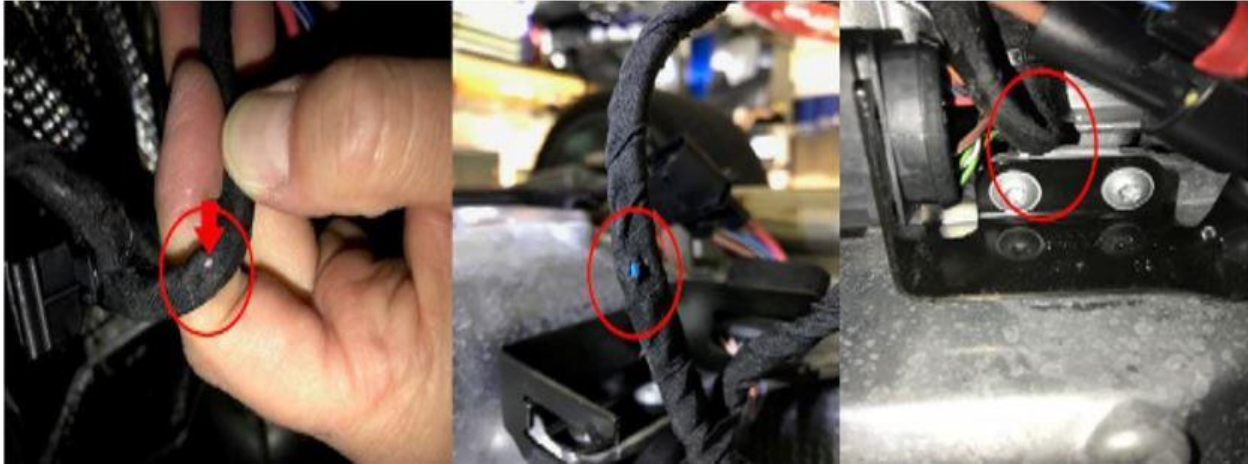
Figure 2. Body harness inspection near the area of transmission connector.

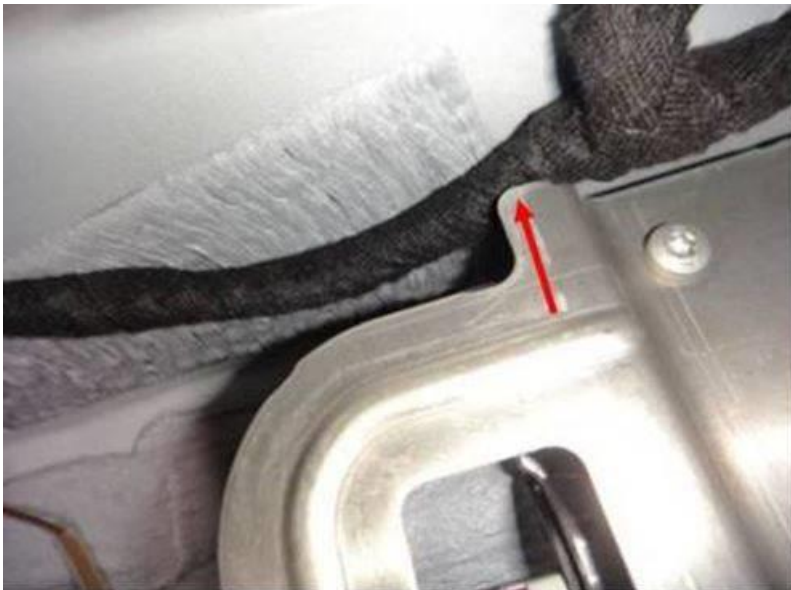
The body harness containing the FlexRay circuit to the transmission may rub against the mounting bracket of the driver assist systems control module, J1121 (address word 00A5).

If there is no damage found and DTC U11B000 (FlexRay data bus branch 2 faulty) is stored, inspect for chafing near the J1121 mounting bracket shown in Figure 3.

Figure 3. The area where the body harness may rub.

Note: If damage is found as shown in Figure 3, please create a TAC case, include photos, and a clear description of your findings.

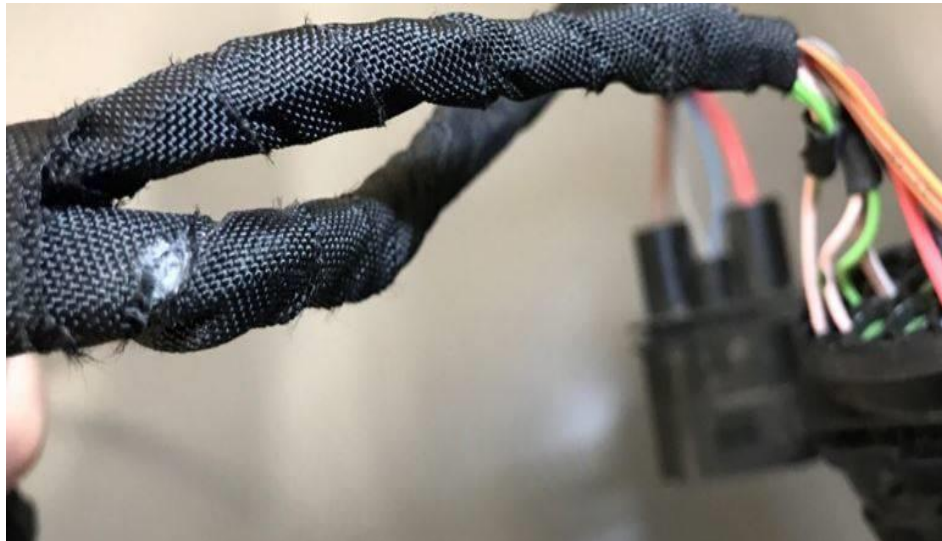
Figure 4. Close-up of transmission harness rub through against the transmission brace.

1. Repair the damaged sections of the transmission or body harness as needed per the repair manual (Figure 4).

Note: Ensure the repairs are staggered as needed to avoid large bunches in the harness or that repairs are not made at critical flex points.
