Technical Service Bulletin

40 Noises from the front axle and swivel joint (ball joint)

40 20 99 2058421/1 February 4, 2020.

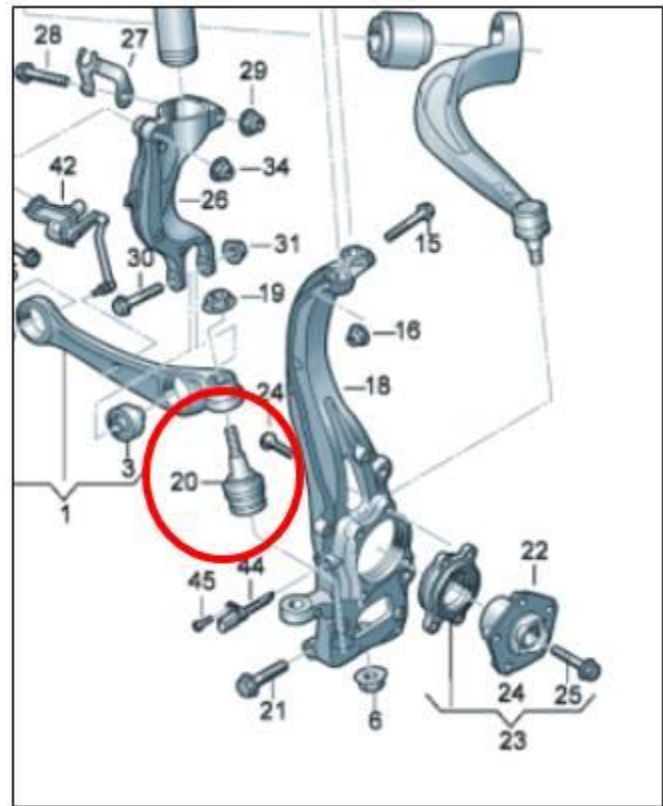
Figure 1. Swivel (ball joint).

- The customer statement can be reproduced.
- The noises can be assigned to the swivel joint (ball joint) of the left or right front axle (Figure 1, pos. 20).

Identify and replace the affected swivel joint (ball joint) of the left/right front axle according to the instructions in Elsa at Repair Manual, *Chassis >> Suspension, Wheels, Steering >> 40 Front Suspension >> Lower Control Arm and Ball Joint >> Ball Joint, Removing and Installing.*

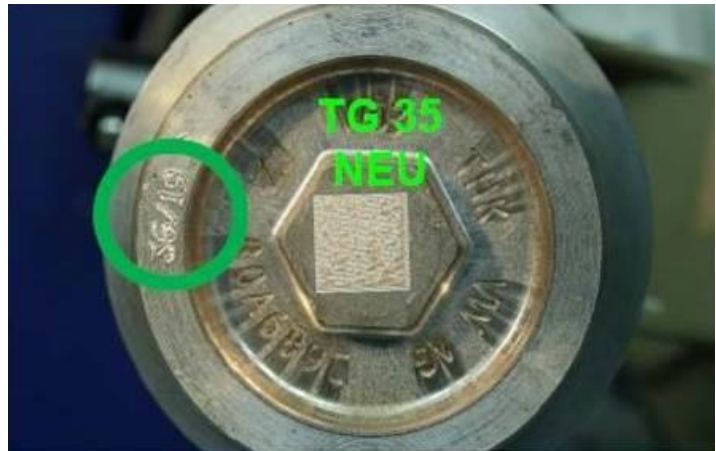
Figure 2. Example of initial production date of week 36/19.

Make sure that the new parts you are installing have production date week 36/19 or later (Figure 1 and 2, green circles).

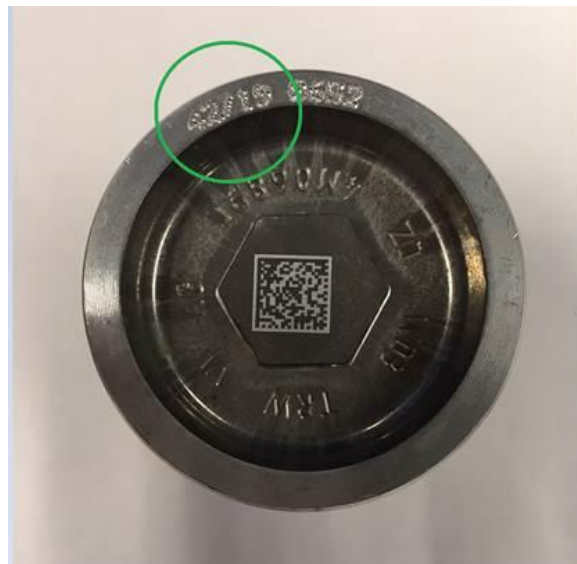
Figure 3. Example of production date after week 36/19.
