## 57 Power closing door latch is intermittently inoperative, door adjustment is required

57 20 64 2058159/2 February 6, 2020. Supersedes Technical Service Bulletin Group 57 number 20-63 dated January 8, 2020 for reasons listed below.

Model(s)	Year	VIN Range	Vehicle-Specific Equipment
Q7	2017 - 2019	All	With Power Closing

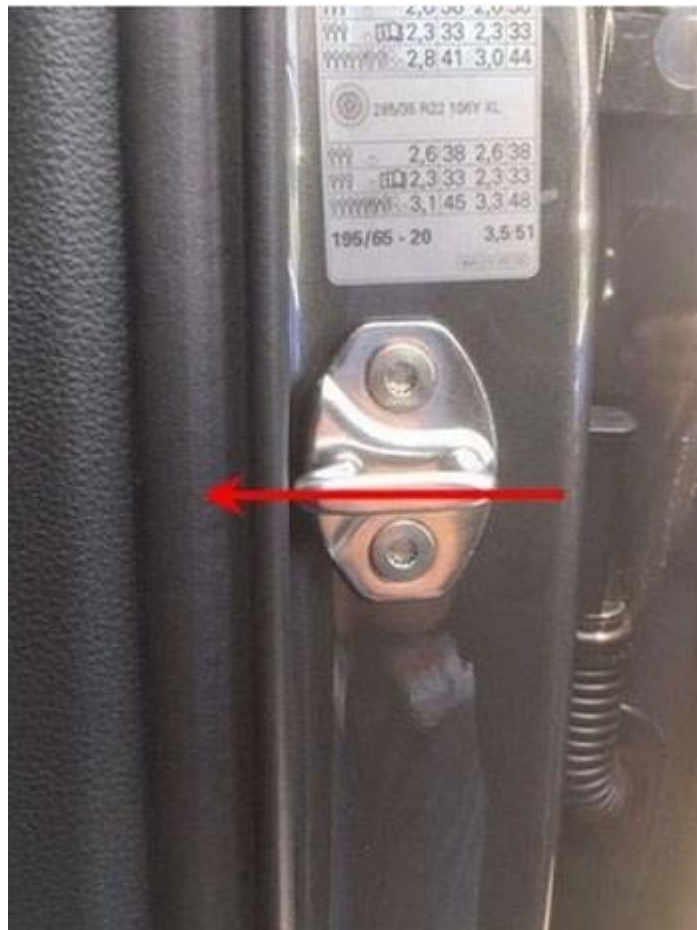
The door latch requires counter-pressure from the door/door seal, in order to generate a reliable signal for the door control module that the customer wants to close the door. If the door striker is adjusted in such a way that does not provide enough counter-pressure for the latch, the door control module does not recognize the door latch signal long enough or at all. Hence the door will not be closed.

**Figure 1.** Adjust door striker inward by at least 0.5 mm.

1. Check the door striker to latch alignment and perform any adjustments necessary to center the striker to the latch.
2. At the same time, adjust the door striker inward as far as possible (at least 0.5 mm) (Figure 1). The front door can be flush or slightly underflush to the rear door without causing a wind noise concern (Figure 2).

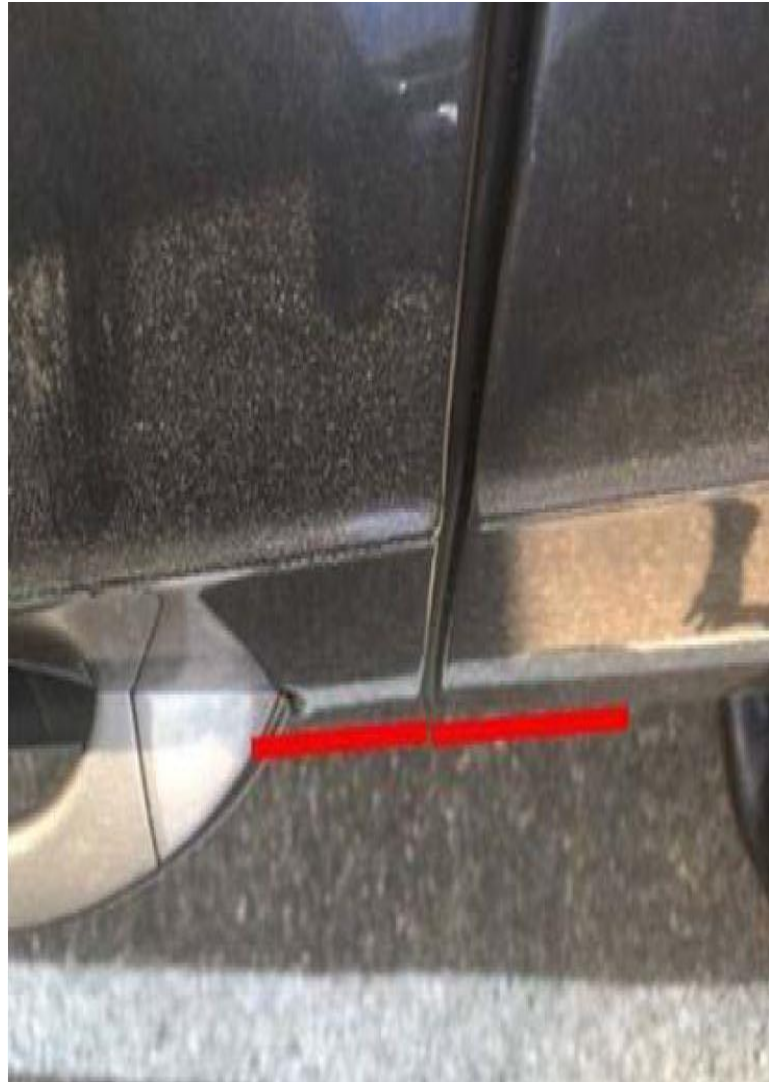
**Figure 2.** The front door can be flush or slightly underflush to the rear door.

3. Recheck the functionality of the power closing door latch system. If after the striker adjustment the door closes properly, do not proceed with any additional repairs.

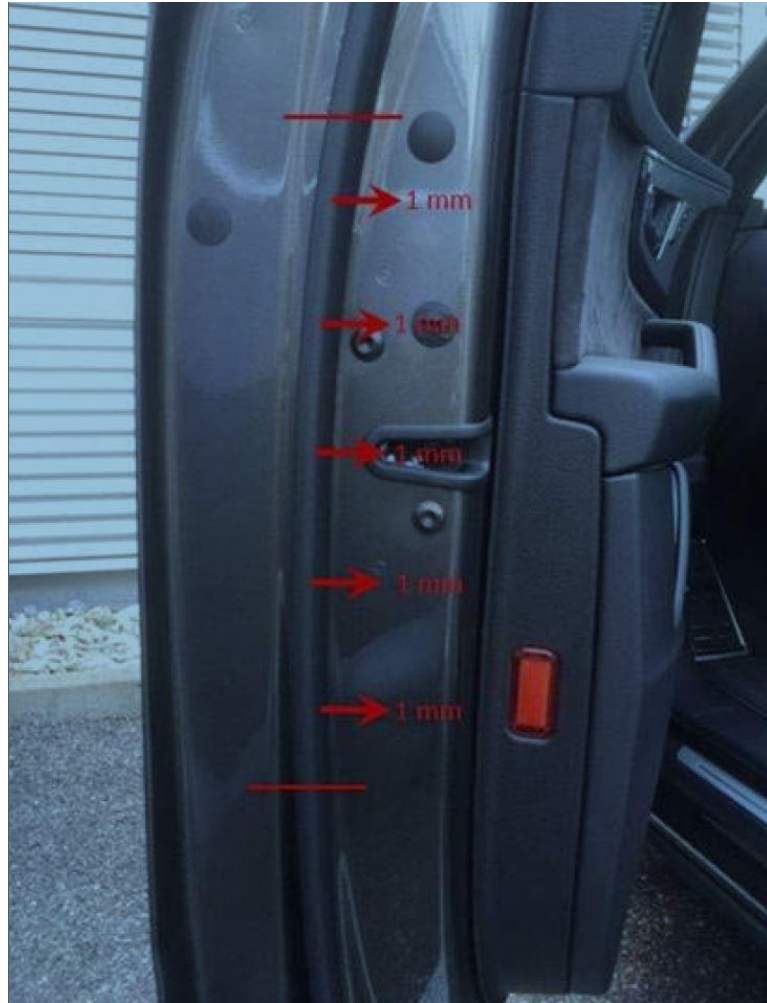
**Figure 3.** Install the new outer door seal with an inward offset by 1.0 mm.

4. If the customer concern still persists, install a new outer door seal with an inward offset of 1.0 mm when compared to the original door seal location (Figure 3).

**Tip:** Mark the position of the original outer door seal prior to replacing it.
