Technical Service Bulletin

60 Water entry into cabin from the sunroof area

60 20 39 2056944/2 February 5, 2020. Supersedes Technical Service Bulletin Group 60 number 19-36 dated October 25, 2019 for reasons listed below.

Model(s)	Year	VIN Range	Vehicle-Specific Equipment
Q3, Q8, and Audi e-tron quattro	2019 - 2021	All	Not Applicable

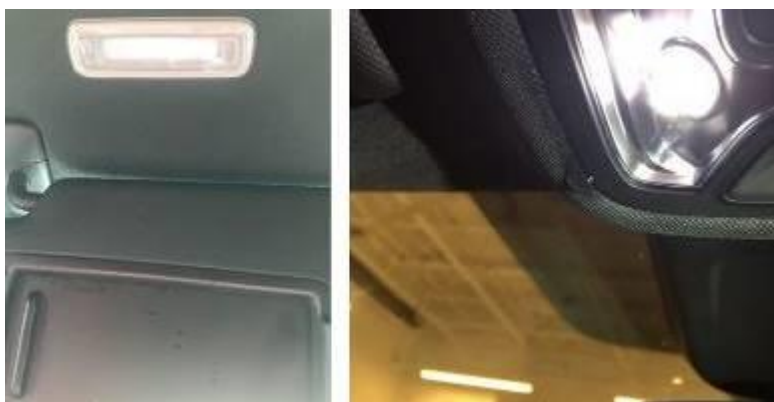
- They see water drip from the headliner area (Figure 1).

Figure 1. Water intrusion near the headliner.

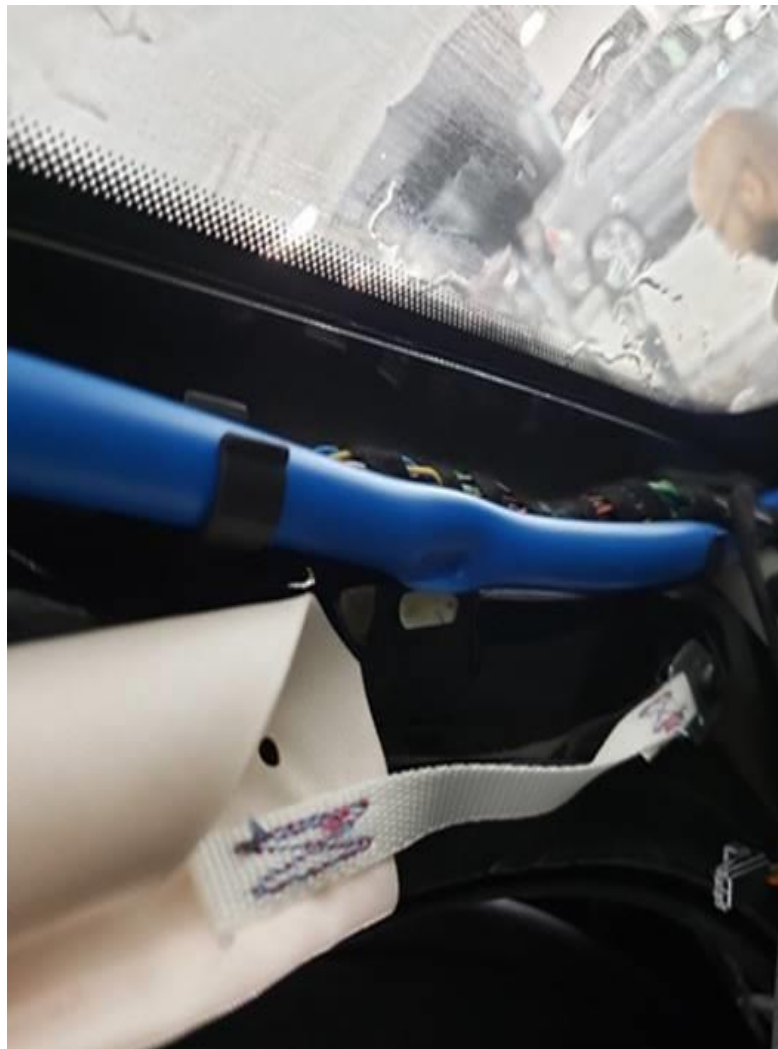
Visually inspect all 4 sunroof drain hoses and valves for any damage or obstruction (Figure 2).

Figure 2. Sunroof drain hose pinched by pillar trim.

Ensure that any water in the sunroof frame drainage areas flows freely. Replace any pinched or otherwise obstructed drain hose(s) or valve(s).

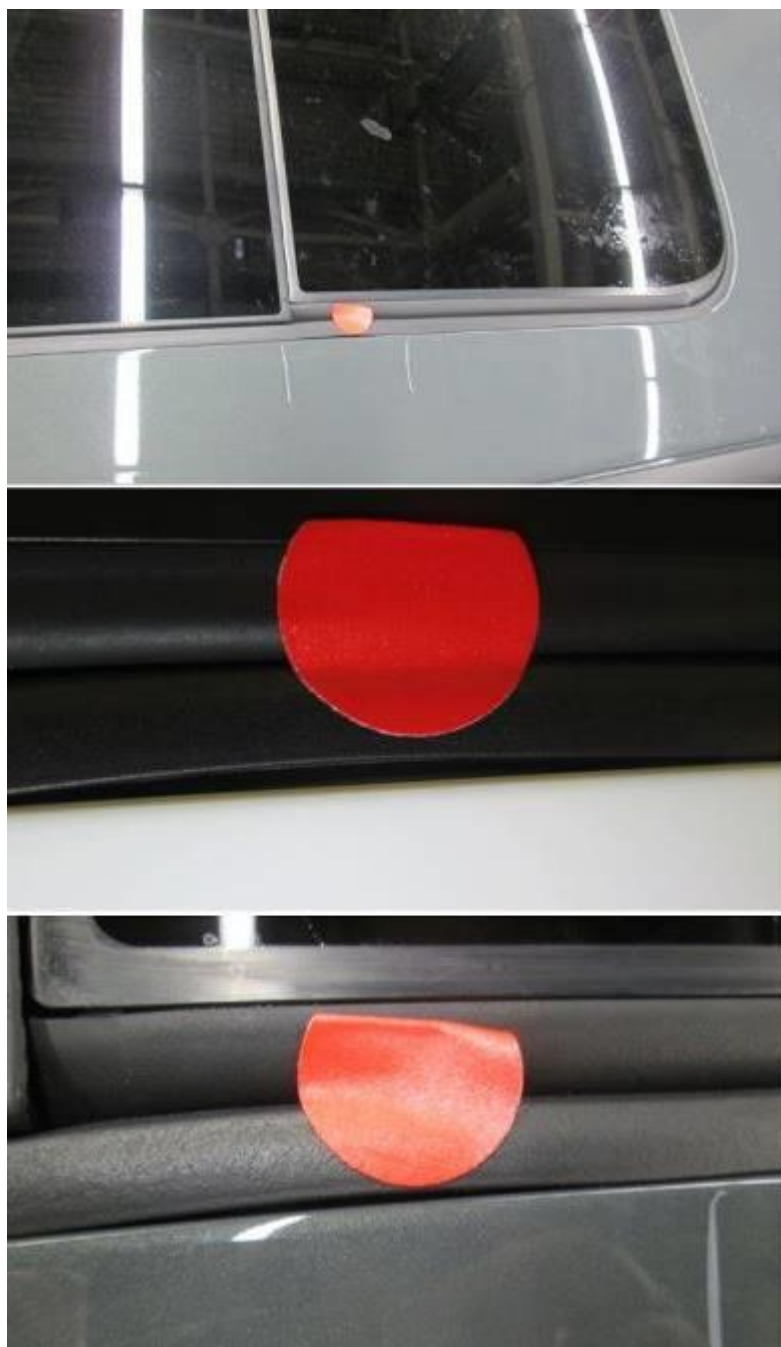
Inspect the entire perimeter of the roof opening seal for any detachment or malformation (Figure 3).

Figure 3. Detached and malformed roof opening seal.

If after inspecting the roof opening seal any detachment, malformation or damage is discovered, replace the sunroof opening seal.

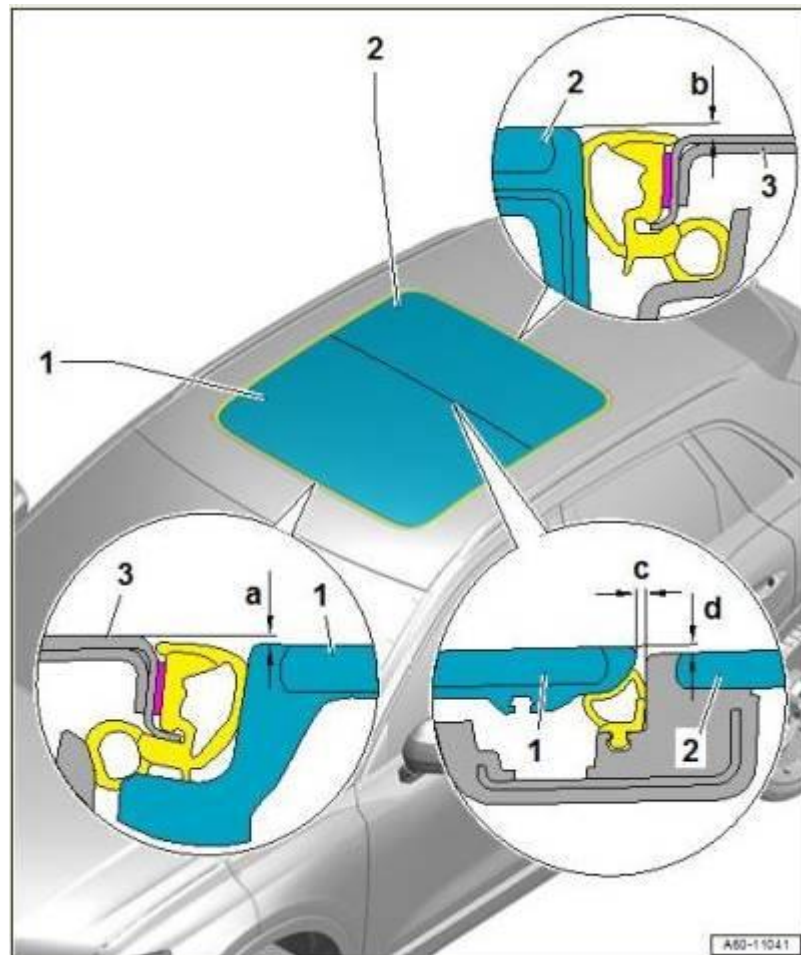
Check all adjustment axes of the sunroof glass panels for poor adjustment (Figure 4).

Figure 4. Front and rear glass panel adjustment.

If after all dimensional measurements are made on the sunroof glass panels a problem is found make the necessary adjustments to the sunroof glass panels.

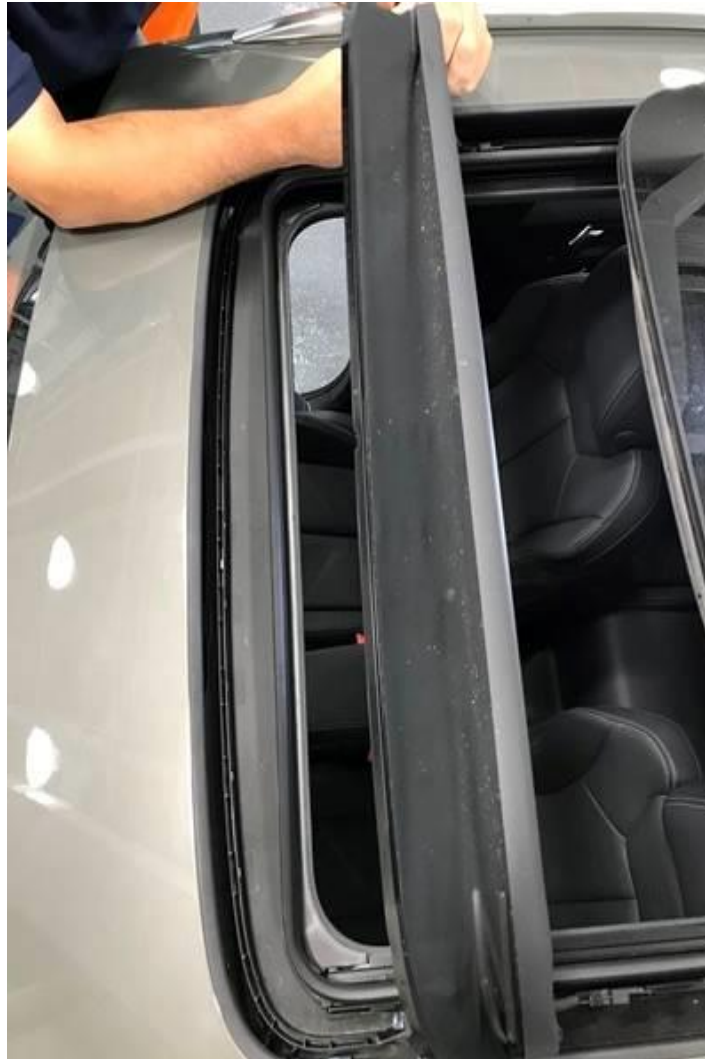
When the vehicle is exposed to water (rain, car wash, or standing water on the roof panel) either with the vehicle stationary or driving it is possible for water to enter the sunroof frame mechanism that is not designed for exposure to water, breach the normal water drainage channeling, and leak into the cabin area. This risk is heightened if the sunroof is opened or vented when the vehicle is wet. This water intrusion may not manifest itself immediately but may appear after a driving period when the water travels to the underside of the headliner area during the normal course of driving (Figure 5-7). This occurs due to a slow migration of water along the wind deflector hinge arms and water entry into the stowage area for the wind deflector. This stowage area does not provide water drainage away from the vehicle.

Figure 5. Front sunroof opening with drainage exposed.

Replace no parts for this condition. Replacing parts at this time will not mitigate this symptom.

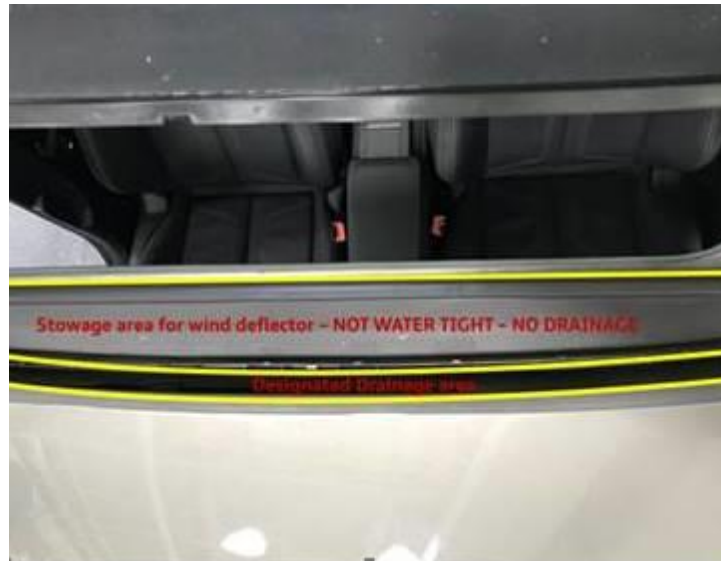
Figure 6. Areas of sunroof opening water elimination capabilities.

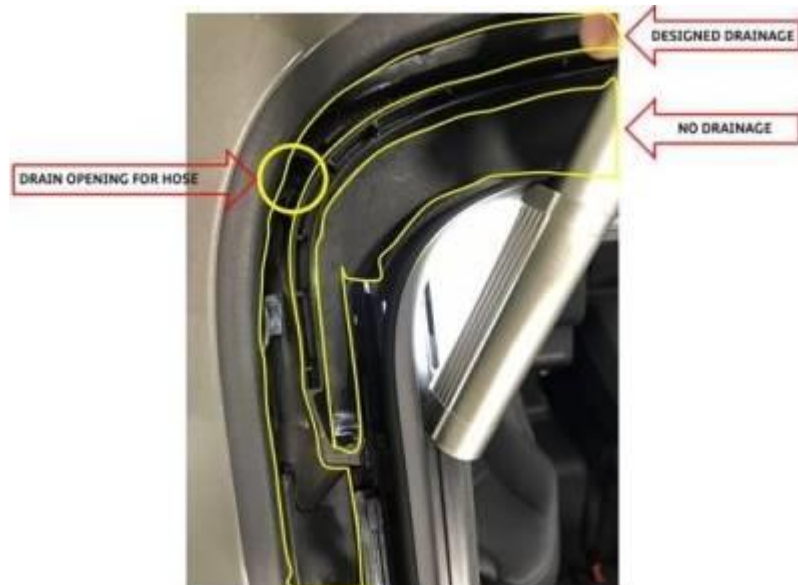
Figure 7. Sunroof water channeling diagram.

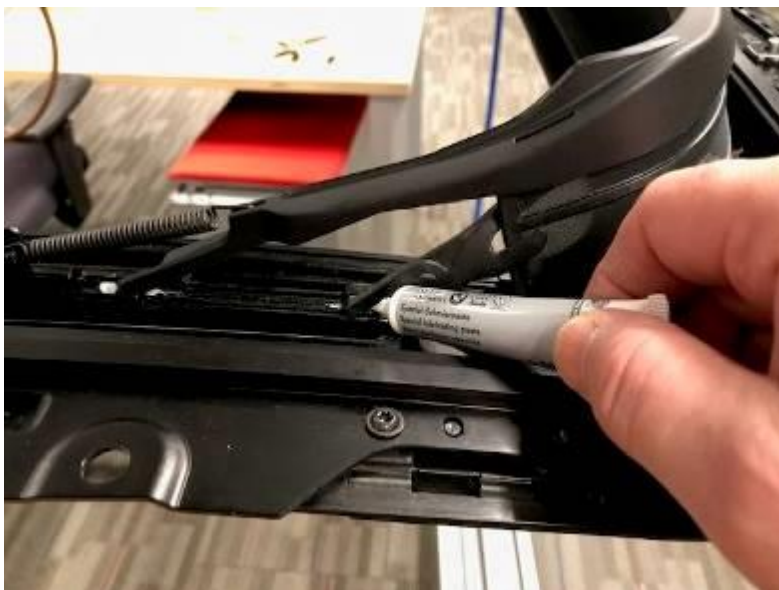
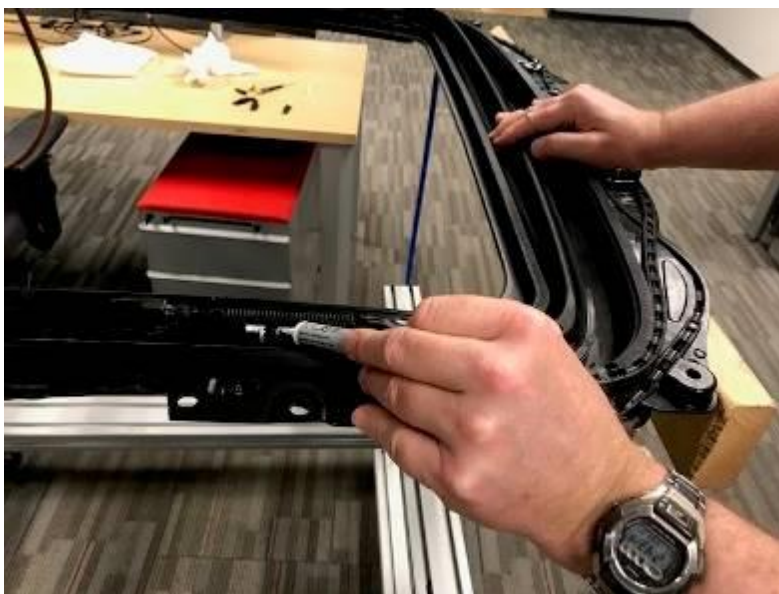
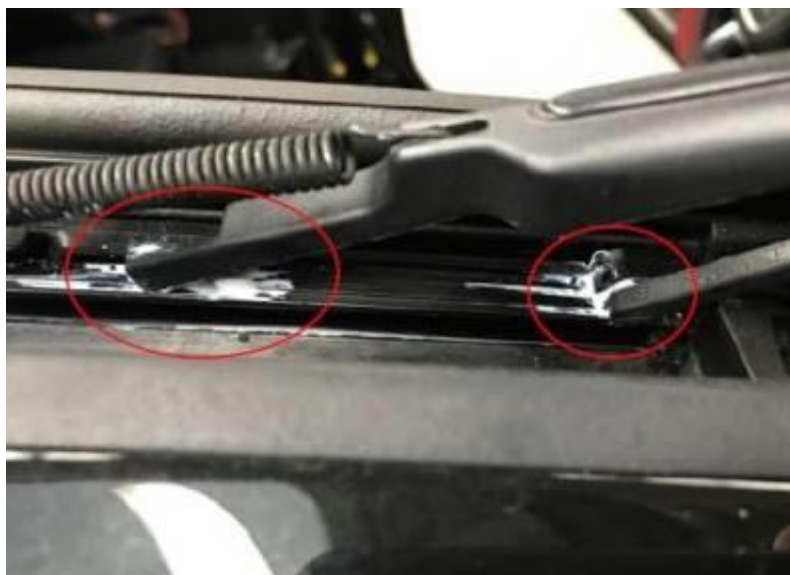
Figure 9. Lubrication points.

Figure 10. Lubrication points, wind deflector compressed.

Figure 11. Lubricant applied.

6. Fill the entire cavity of the sliding channels for the wind deflector with special lubricant G 052 141 A2. This has been shown to mitigate the migration of water along the wind deflector arms and into the undrained portions of the sunroof frame (Figure 9-11).

Only apply this lubricant to the areas directed. This sunroof frame is lubricated with the Carbafluo lubricant and the special lubricant G 052 141 A2 will contaminate the slide and tilt mechanism lubrication and accelerate the wear.
