Technical Service Bulletin

91 Multiple vehicle features (ACC, Nav, DriveSelect, etc.) are not available, DTC P164700 stored in the ECM

91 20 34 2042506/9 February 6, 2020. Supersedes Technical Service Bulletin Group 91 number 19-16 dated December 6, 2019 for reasons listed below.

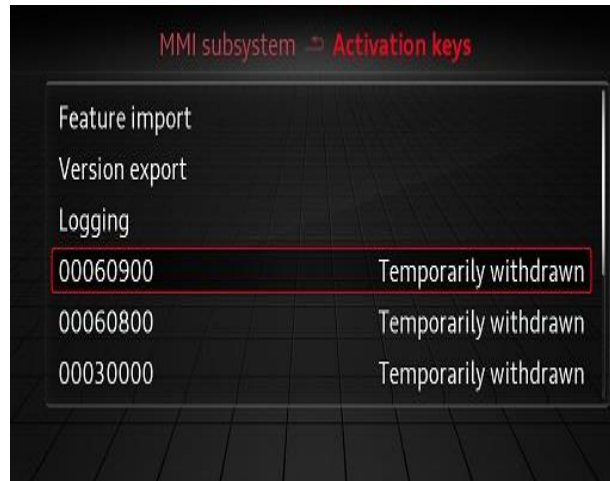
Temporarily withdrawn or Temp illegal = This indicates that the SVM activation test plan was not completed (Figure 4). This status is normal for all parts that have been swapped from a different vehicle. Perform the SVM Activations test plan as indicated below, under *Repair Procedure*.

Figure 4. Activation keys showing “Temporarily withdrawn”.
