Release Date	02/11/2020	<b>Technical Service Bulletin</b>	
<b>39E8 UPDATE</b>

<b>Audi</b>
<b>Checking Flange Shaft – (NVLW)</b>

Applicable Vehicles			
Model(s)	Year	VIN Range	Vehicle-Specific Equipment
Q5, A7, A6	2019	See Campaign/Action screen in ELSA	See Campaign/Action screen in ELSA

## 39E8 UPDATE

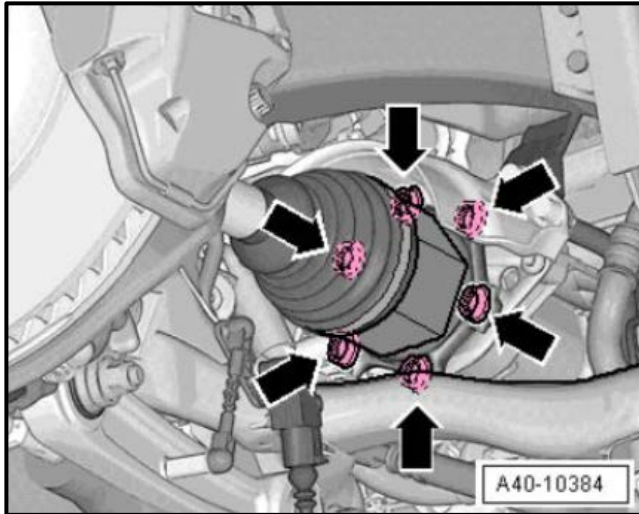
## Inspect threads on left side axle flange:

- Remove noise insulation.
- Remove bolts <arrows> on front left axle shaft (gearbox side) and pull axle shaft away so that holes on the flange shaft are visible.
