February 2020
SF593AB

Subject: FCCC Motorhome Chassis Fan Cages

Models Affected: Specific Freightliner Custom Chassis XCM and XCP chassis manufactured December 12, 2013, through April 16, 2019.

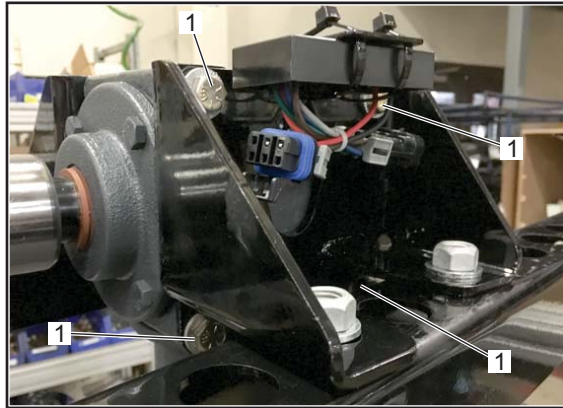
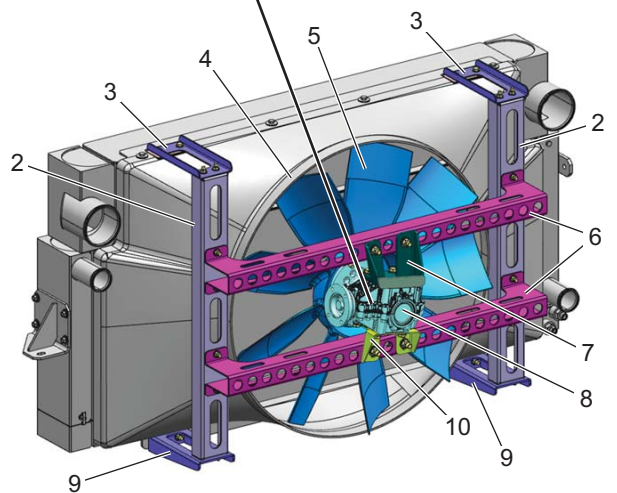
Fig. 1, Bolt-Together Fan Cage with Four Fan Gear Box Mounting Bolts (per bracket)

4. Inspect the fan gear box mounting brackets. If the bottom bracket (with flanges on the left and right side) has four mounting bolts that attach the fan gear box, shown in [Fig. 1](#), no further work is needed. Clean a spot on the base label (Form WAR259) and attach a campaign completion sticker for SF593 (Form WAR261) indicating this work has been completed.

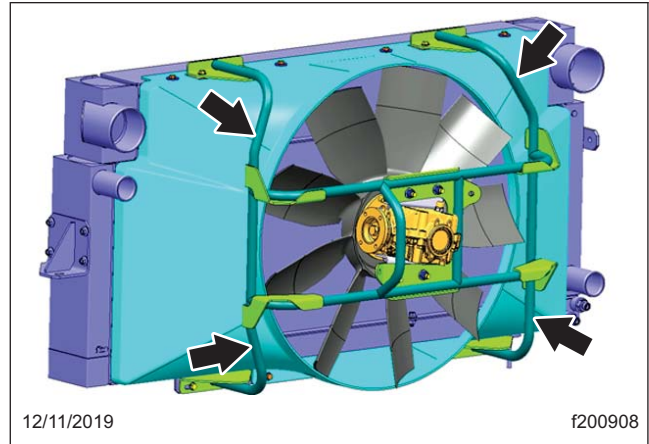
Fig. 2, Welded Fan Cage Assembly

If the fan cage is a welded assembly, shown in [Fig. 2](#), it must be replaced. Go to *Replacing a Welded Fan Cage Assembly* for instructions.

If the fan cage is a welded assembly, as shown in [Fig. 2](#), it must be replaced with vertical and horizontal fan cage brackets, and fan gear box mounting brackets as shown in [Fig. 1](#).

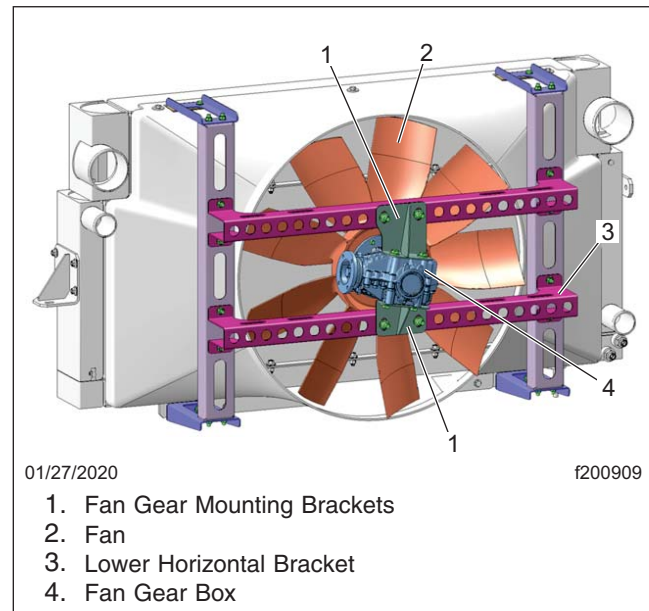
Fig. 3, Bolt-Together Fan Cage with Two Fan Gear Box Mounting Bolts (per bracket)

If the bottom fan gear box mounting bracket (with a flange in the center) only has two bolts that attach the fan gear box, shown in [Fig. 3](#), go to *Replacing Two-Bolt Mounted Fan Gear Box Brackets* to replace the top and bottom fan gear box mounting brackets.

If the bottom fan gear box mounting bracket only has two mounting bolts, the mounting brackets must be replaced with the fan gear mounting brackets shown in [Fig. 1](#).

5. Remove the top and bottom two-bolt gear box mounting brackets, then install the new four-bolt mounting brackets. Tighten the mounting bolts 59 lbf-ft (80 N·m).
6. Install the gear box on the top horizontal bracket. Tighten the mounting hardware 64 lbf-ft (87 N·m).
7. Using 3/8 bolts, install the lower horizontal bracket on the vertical brackets. Tighten the bolts 26 lbf-ft (35 N·m).
8. With the bottom horizontal fan cage bracket installed, tighten the bottom mounting hardware of the gear box 64 lbf-ft (87 N·m).
9. Mount the fan to the gear box and then center the fan. Using the six bolts removed earlier, install the fan. Tighten the bolts 35 lbf-ft (47 N·m).
10. Install the driveshaft. Tighten the bolts 70 lbf-ft (95 N·m).
11. Clean a spot on the base label (Form WAR259) and attach a campaign completion sticker for SF593 (Form WAR261) indicating this work has been completed.
