SIL 34-1K2K-19, Rev. A
January 06, 2020
Page 1 of 4

SUBJECT: P2789 Clutch Adaptive Learning at Limit

MODELS AFFECTED: 1000/2000 Series™ Transmissions

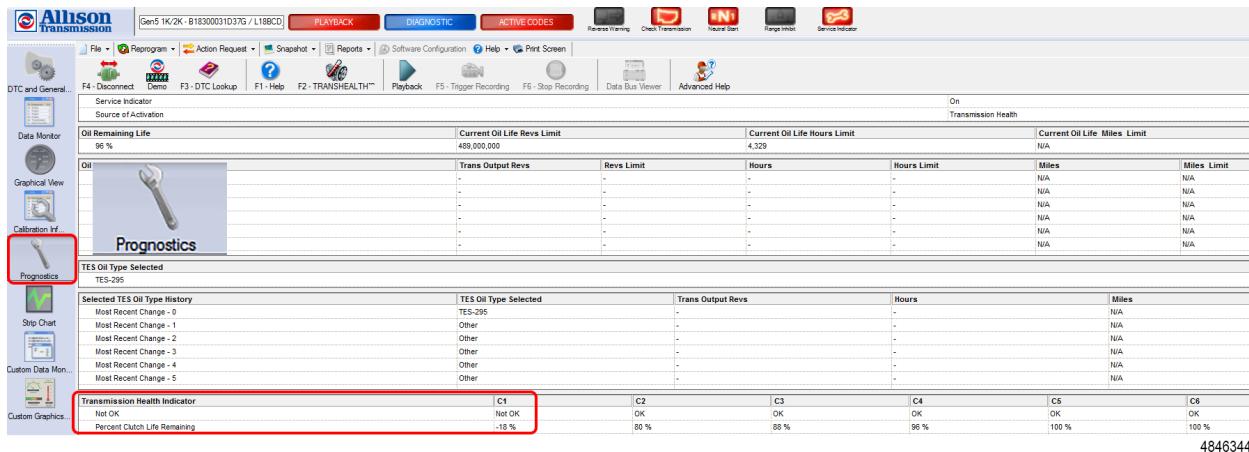
Figure 1. Trans Health Indicator Section

In some low mileage vehicles, the **Check Transmission** lamp may illuminate along with setting DTC P2789 Clutch Adaptive Learn at Limit. The C1 clutch may show as "Not OK" in the Trans Health Indicator section of the "Prognostics" tab in the Allison DOC® software, [Figure 1](#) and [Figure 2](#).

When the **Check Transmission** lamp illuminates due to DTC P2789, perform the diagnostic steps as outlined in the Troubleshooting Manual, TS7138.

If this issue is not resolved after following the diagnostic steps in TS7138, then reprogram the TCM by performing the following steps:
