Service Update

N192282970 ECM and Reductant Control Modules

Release Date: January 2020

Subject: N192282970 - Service Update
ECM and Reductant Control Modules

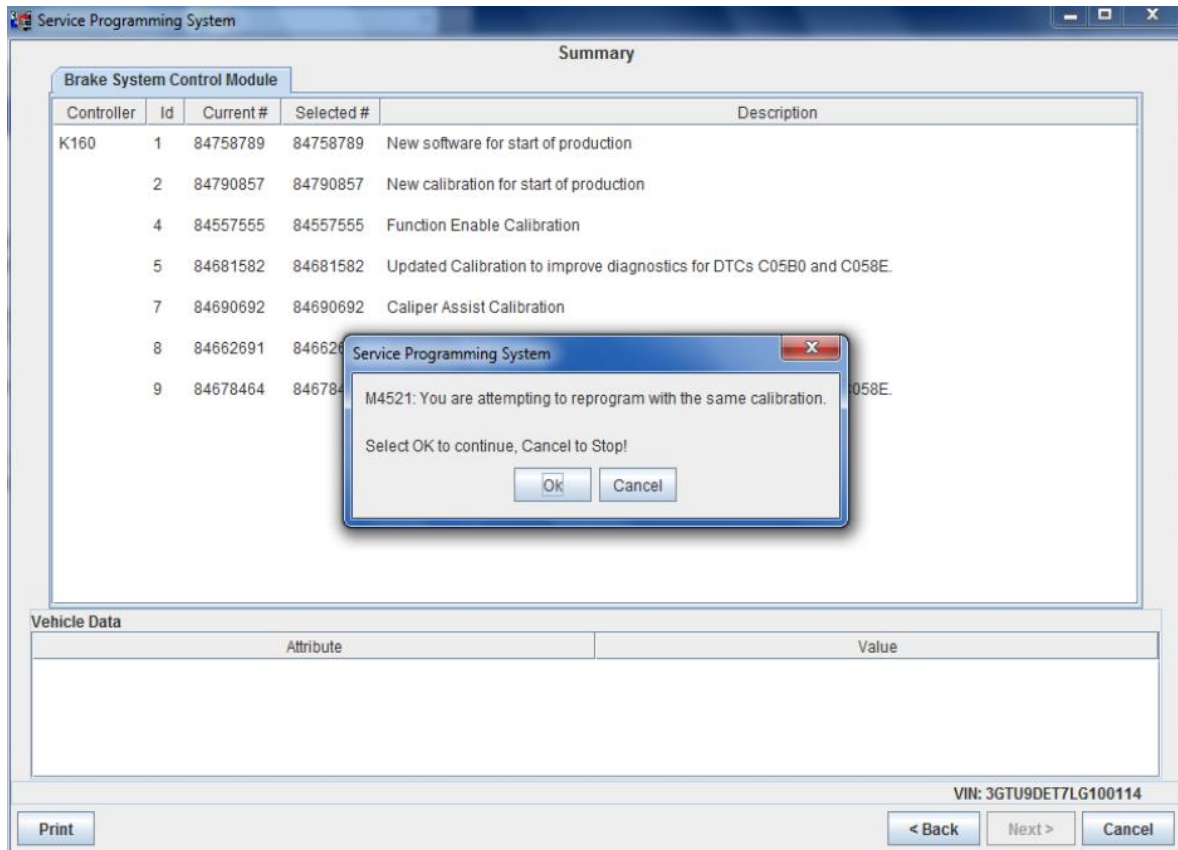
5431207

Important: If the Same Calibration/Software Warning is noted on the SPS screen, select OK and follow screen instructions. After a successful programming event, the WCC is located in the Service Programming System dialogue box of the SPS Summary screen. No further action is required. Refer to the Warranty section of the bulletin.

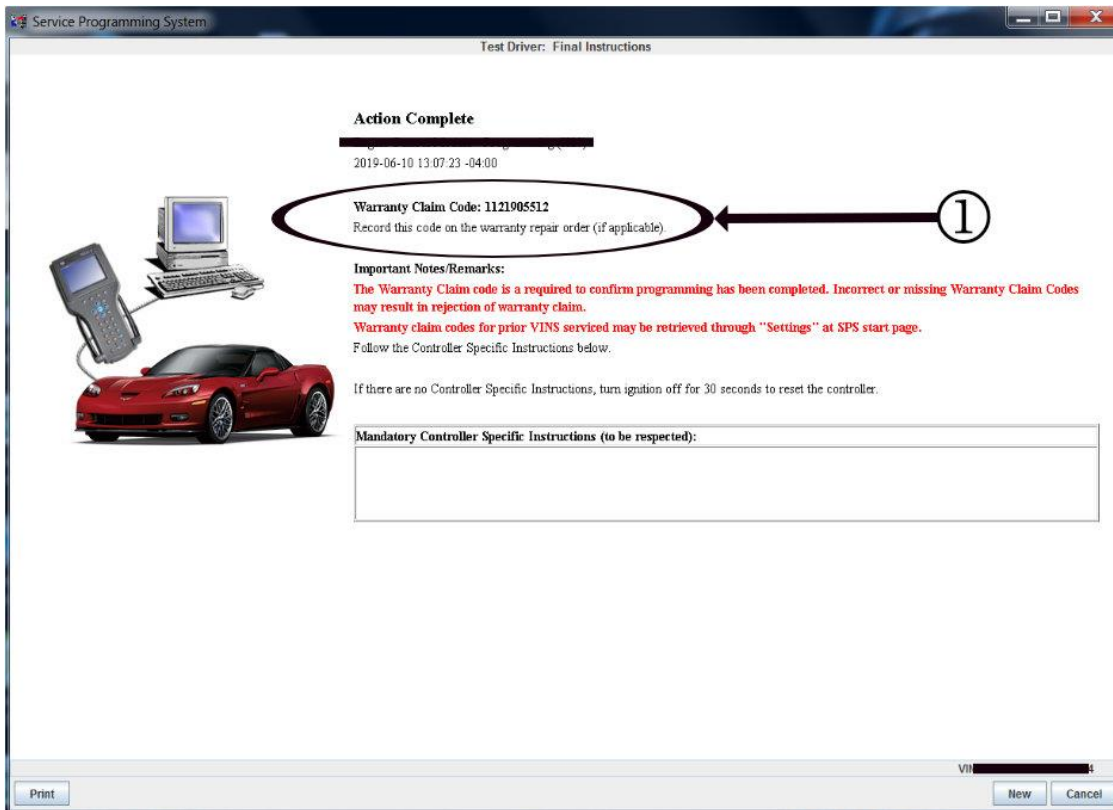
5431209

Important: To avoid warranty transaction rejections, you **MUST** record the warranty claim code provided on the SPS Warranty Claim Code (WCC) screen on the job card. Refer to callout 1 above for the location of the WCC on the SPS screen.

- Record SPS Warranty Claim Code on job card for warranty transaction submission.
