GLOBAL SAFETY FIELD INVESTIGATIONS  
DCS5273  
URGENT - DISTRIBUTE IMMEDIATELY

Subject: N192265660 - Customer Satisfaction Program  
Rear Window Defroster Thermal Events - US Only

Models: 2014-2018 Chevrolet Silverado 1500  
2014-2018 GMC Sierra 1500  
2019 Chevrolet Silverado LD  
2019 GMC Sierra 1500 Limited  
2015-2019 Chevrolet Silverado HD  
2015-2019 GMC Sierra HD  
All of the above equipped with Power Sliding Rear Window (RPO A48)

## N192265660 Rear Window Defroster Thermal Events - US Only

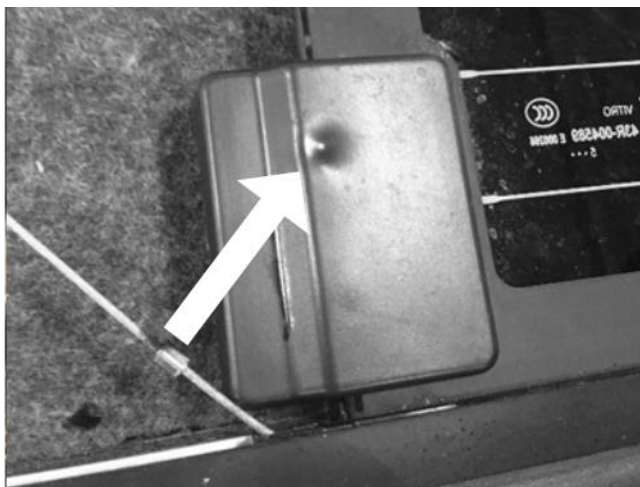
5423183

Cover showing heat damage

1. Inspect the heated rear window terminal cover for any indication of external heat related damage.
  - If **no heat damage** is indicated, proceed to step # 2.
  - If **heat damage** is indicated, replace the complete rear window assembly. Refer to *Rear Window Replacement* in SI.

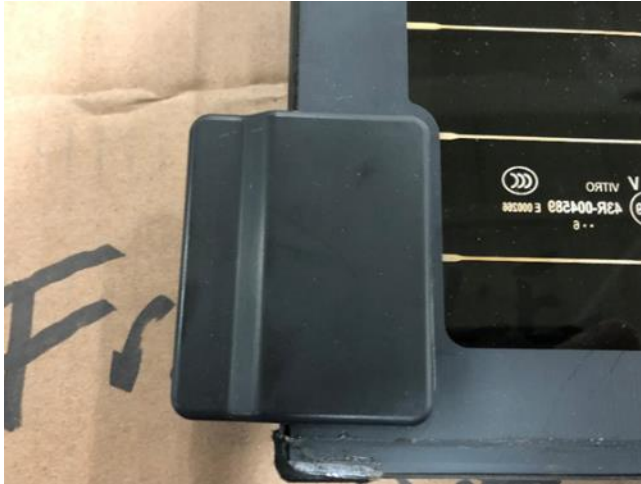
5423186

### Cover showing no heat damage

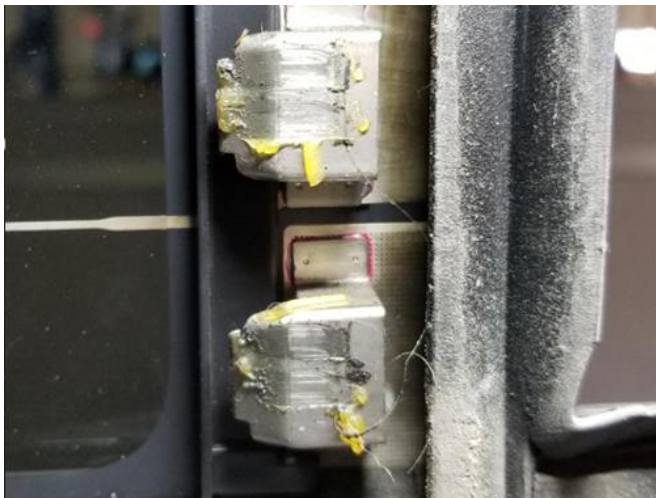
5423194

Pedestals showing no damage or distortion

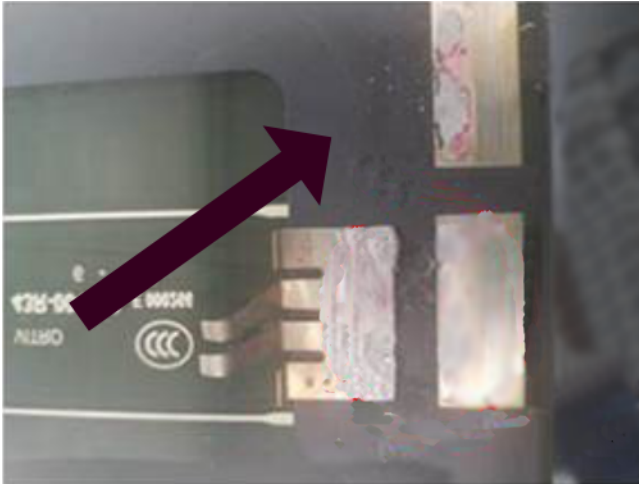
5423195

#### Finger damage, one set contact fingers missing

5. Inspect the contact fingers on the center glass section of the rear window for any indication of physical damage.
  - If **no damage** is indicated proceed to step #6.
  - If **damage** is indicated, replace the rear window center glass. Refer to *Rear Sliding Window Replacement (Center Glass)* in SI. Proceed to step #6.
