# Service Update

## N192226060 High Voltage Contactors Welded in Closed Position

Release Date: January 2020

Models: 2019 Chevrolet Volt

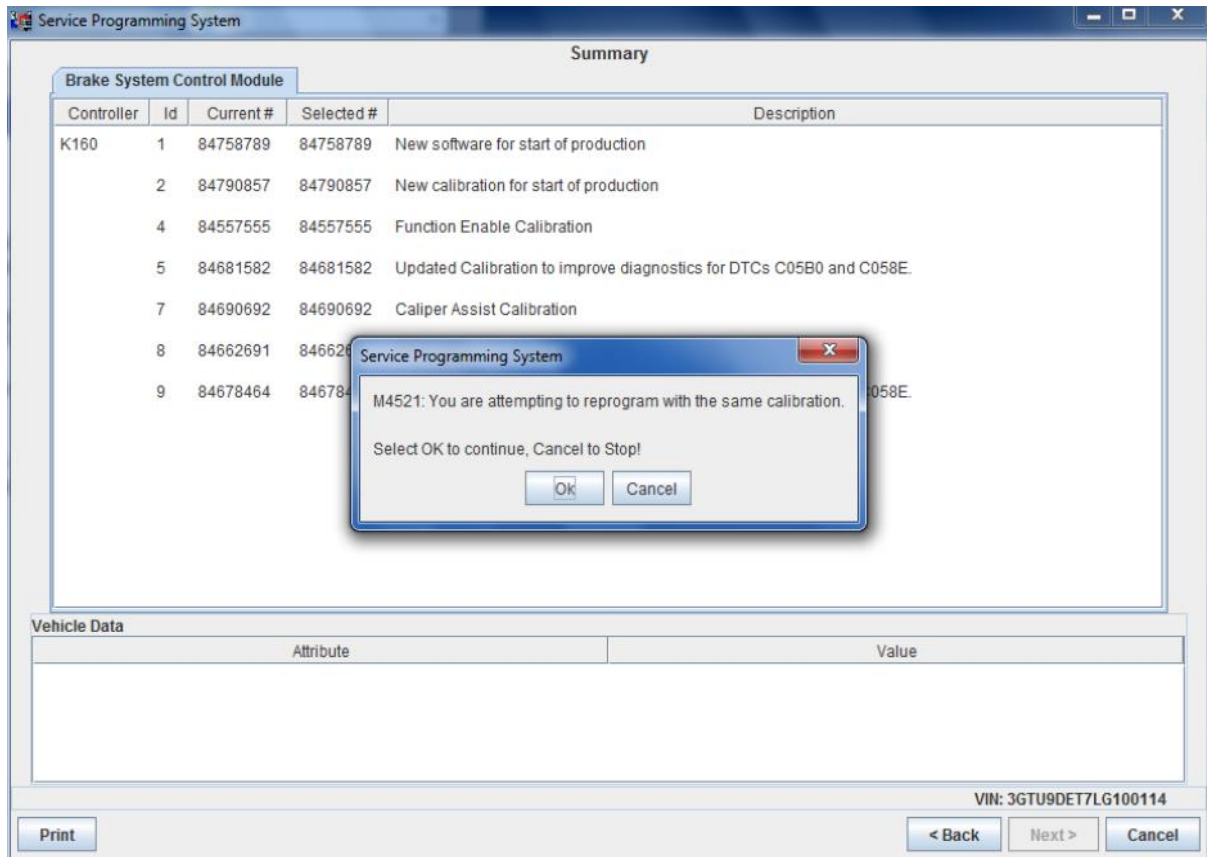
5431207

**Important:** If the Same Calibration/Software Warning is noted on the SPS screen, select OK and follow screen instructions. After a successful programming event, the WCC is located in the Service Programming System dialogue box of the SPS Summary screen. No further action is required. Refer to the Warranty section of the bulletin.

1. Reprogram the Hybrid Powertrain Control Module. Refer to *K114B Hybrid/EV Powertrain Control Module 2: Programming and Setup* in SI.

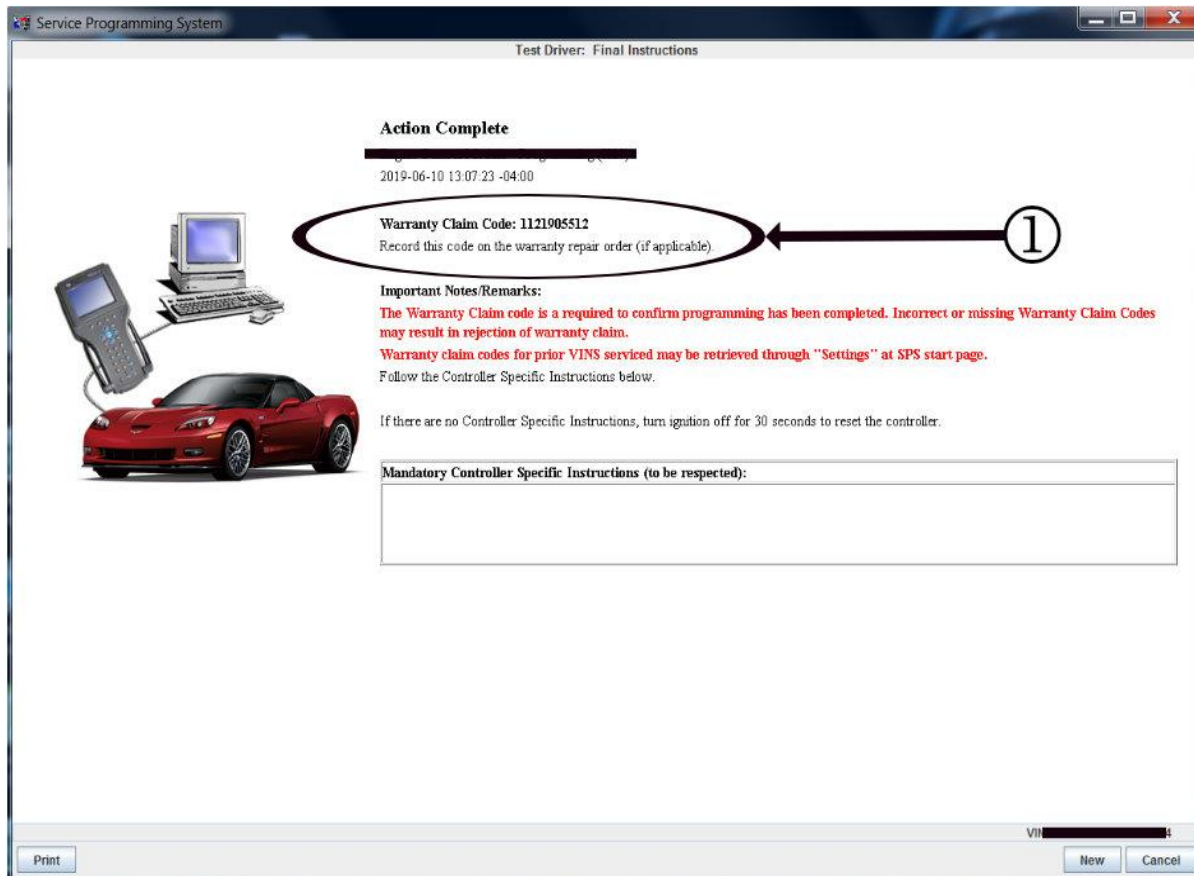
5431209

**Important:** To avoid warranty transaction rejections, you **MUST** record the warranty claim code provided on the SPS Warranty Claim Code (WCC) screen on the job card. Refer to callout 1 above for the location of the WCC on the SPS screen.

- Record SPS Warranty Claim Code on job card for warranty transaction submission.
