GLOBAL SAFETY FIELD INVESTIGATIONS
DCS5276
URGENT - DISTRIBUTE IMMEDIATELY

Subject: N192282480 - Customer Satisfaction Program
Body Control Module Wiring Damage – US Only

Models: 2019 Buick Encore, Enclave
2019 GMC Acadia, Canyon, Sierra 1500 (New Model),
Yukon and Yukon XL
2019-2020 GMC Terrain

N192282480 Body Control Module Wiring Damage – U.S. Only

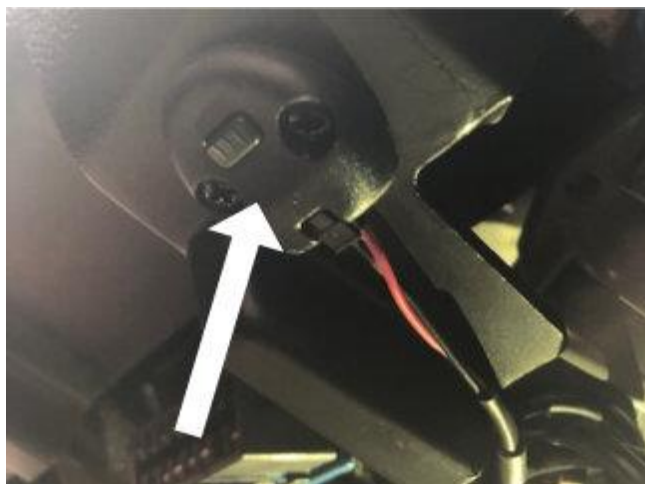
5480300

Inspect the knee bolster panel under the steering column for evidence of an aftermarket anti-theft module. This will show as:

- Screw holes, indicating that an anti-theft module was installed and has been removed. These vehicles require further repairs, refer to Repair Steps below.
- Anti-theft module installed, verify function of aftermarket system, no further action required.
- No evidence of any anti-theft device ever installed or removed, no further action required.

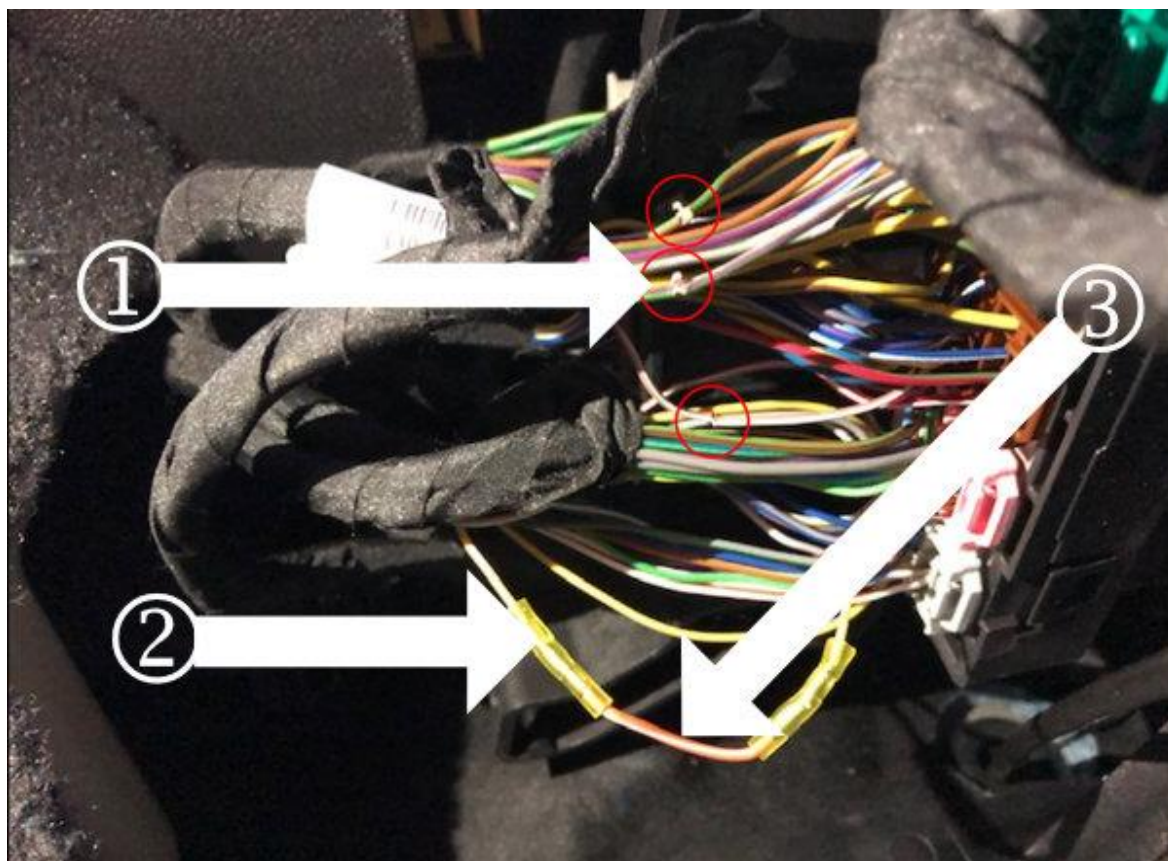
5480303

2. Inspect the wiring at the BCM electrical connector area for indications of repairs. These repairs may include wire insulation damage from wire-tap installation/removal (1), butt connector repairs that do not meet GM established materials and methods (2) or additional sections of wire spliced into the circuit (3).

NOTE: To ensure wire repair integrity, use DuraSeal Splice Sleeve # 19300089 (Pink in Color for AGW 20-18) or DuraSeal Splice Sleeve # 19168447 (Blue in Color for AGW 16-14).

- If the wire insulation is damaged from the removal of a wire-tap, use a DuraSeal splice sleeve to properly repair the damaged wire. Refer to *Wire to Wire Repair* in SI.
 - If the wire has an improper butt connector repair, use a DuraSeal splice sleeve to properly repair the damaged wire. Refer to *Wire to Wire Repair* in SI.
 - If the wire has insufficient length and a section of additional material has been spliced in, remove the added wire and install a terminated lead. Refer to *Repairing Connector Terminals (Terminated Lead Repair)* in SI.
3. Rewrap the wiring harness as required.
 4. If there are mounting holes drilled in the knee bolster panel, replace the knee bolster panel. Refer to *Instrument Panel Knee Bolster Replacement* in SI.
