Special Coverage Adjustment

N182201660 Driver Seat Belt Anchor Pretensioner Cable

Release Date: January 2020

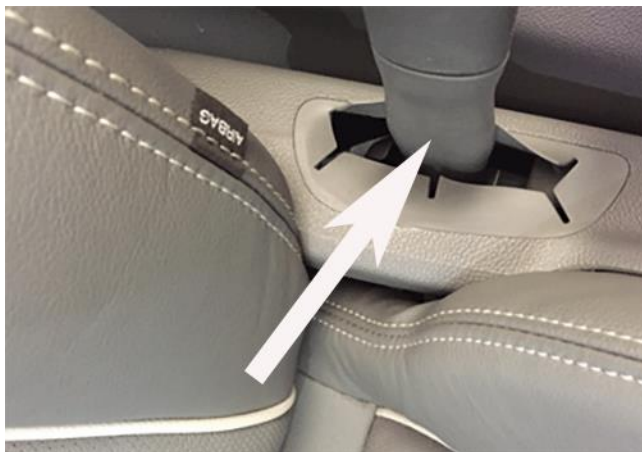
5483528

1. Move the driver seat to the full forward and full down position.
2. Inspect the seat belt pretensioner cable cover for damage. Inspect the complete cable cover from the base of the cable to the latch. Damage includes any splits, holes or cracks.

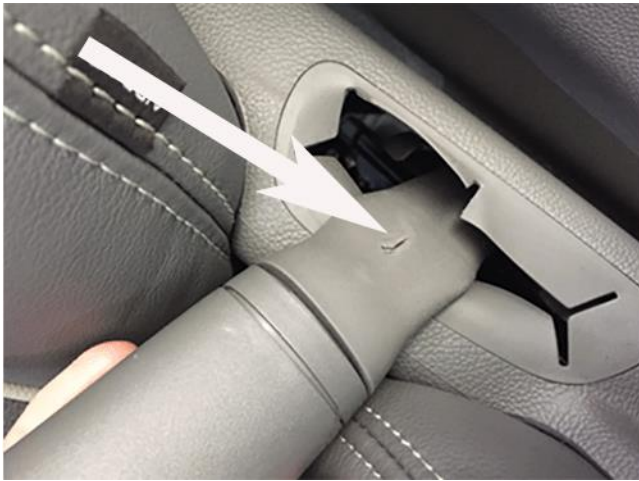
3. Flex the seat belt in an outboard direction and look on inboard side of driver seat seatbelt anchor cover for damage.

4. Flex the seat belt to the inboard side and look on outboard side of driver seat seatbelt anchor cover for damage.
 - If any damage is found, replace the driver side front seat belt anchor plate pretensioner and the front seat cushion outer finish cover, refer to step #5.
 - If no damage is found, no further action is required. Inform the customer that the special coverage condition is not present on their vehicle at this time and to keep monitoring as described in the customer letter.

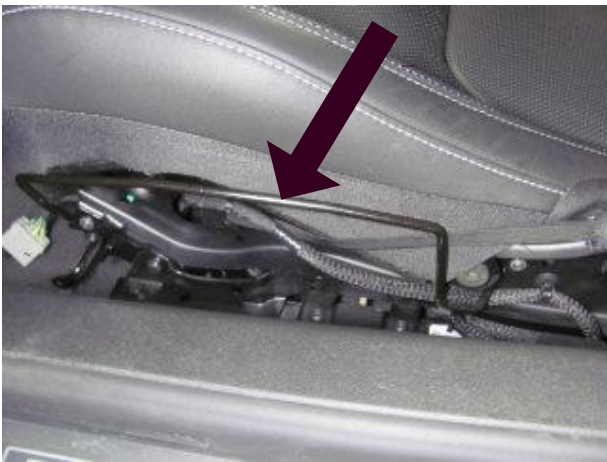
Revised Cover Retainer

NOTE: When replacing the front seat cushion outer finish cover, it is also necessary to replace the metal cover retainer and pivot bolt mounted bracket.

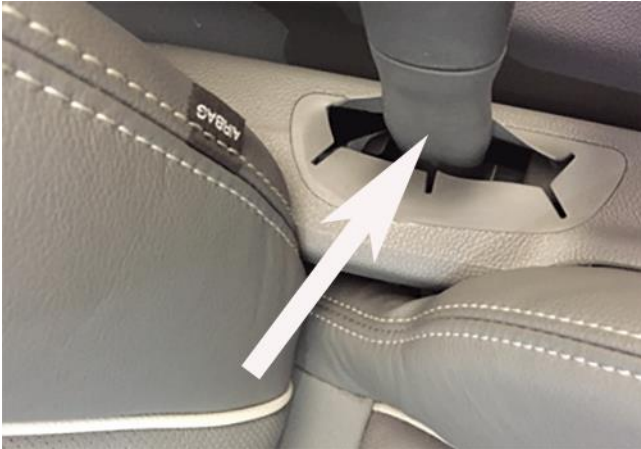
1. Move the driver seat to the full forward and full down position.
2. Inspect the seat belt pretensioner cable cover for damage. Inspect the complete cable cover from the base of the cable to the latch. Damage includes any splits, holes or cracks.

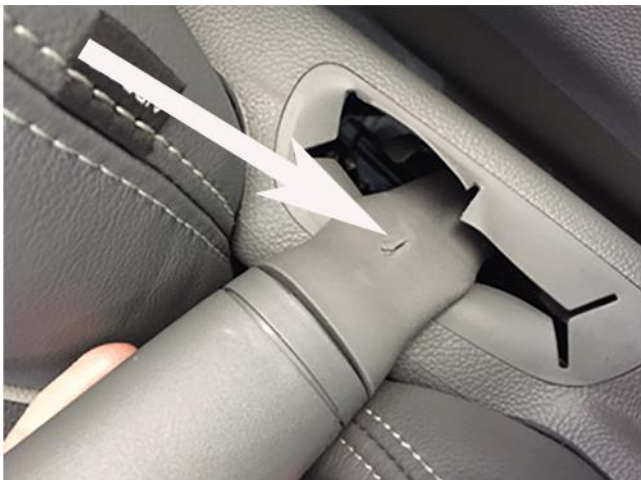
3. Flex the seat belt in an outboard direction and look on inboard side of driver seat seatbelt anchor cover for damage.

4. Flex the seat belt to the inboard side and look on outboard side of driver seat seatbelt anchor cover for damage.
 - If any damage is found, it will be necessary to take the car to your dealer for repairs.
 - If no damage is found, monitor the condition at regular 7,500 mile intervals as described in the owner manual.
