Special Coverage Adjustment

N192291100 Excessive Engine Oil Consumption – US Only

Release Date: January 2020

Revision: 01

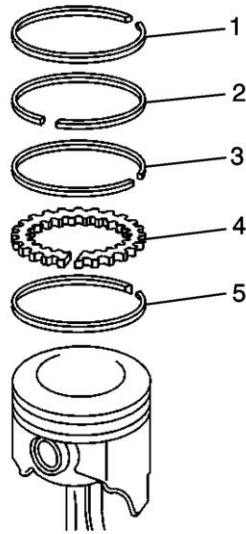
2146346

- Technical Service Bulletin 13-06-01-003 placing a special emphasis on the PCV orifice between the #2 and #3 intake runners.
- Piston and Connecting Rod Disassemble
- Piston and Connecting Rod Assemble
- Piston Connecting Rod, and Bearing Installation (LAF, LAT, LE5, LE9, LEA, or LUK)

Replace the pistons. Refer to *Piston, Connecting Rod, and Bearing Replacement* in SI.
