Subject: N192278640 - Service Update
Stop-Start Disabling Function Inoperative

Models: 2020 Chevrolet Silverado
2020 GMC Sierra

Service Update

N192278640 Stop-Start Disabling Function Inoperative

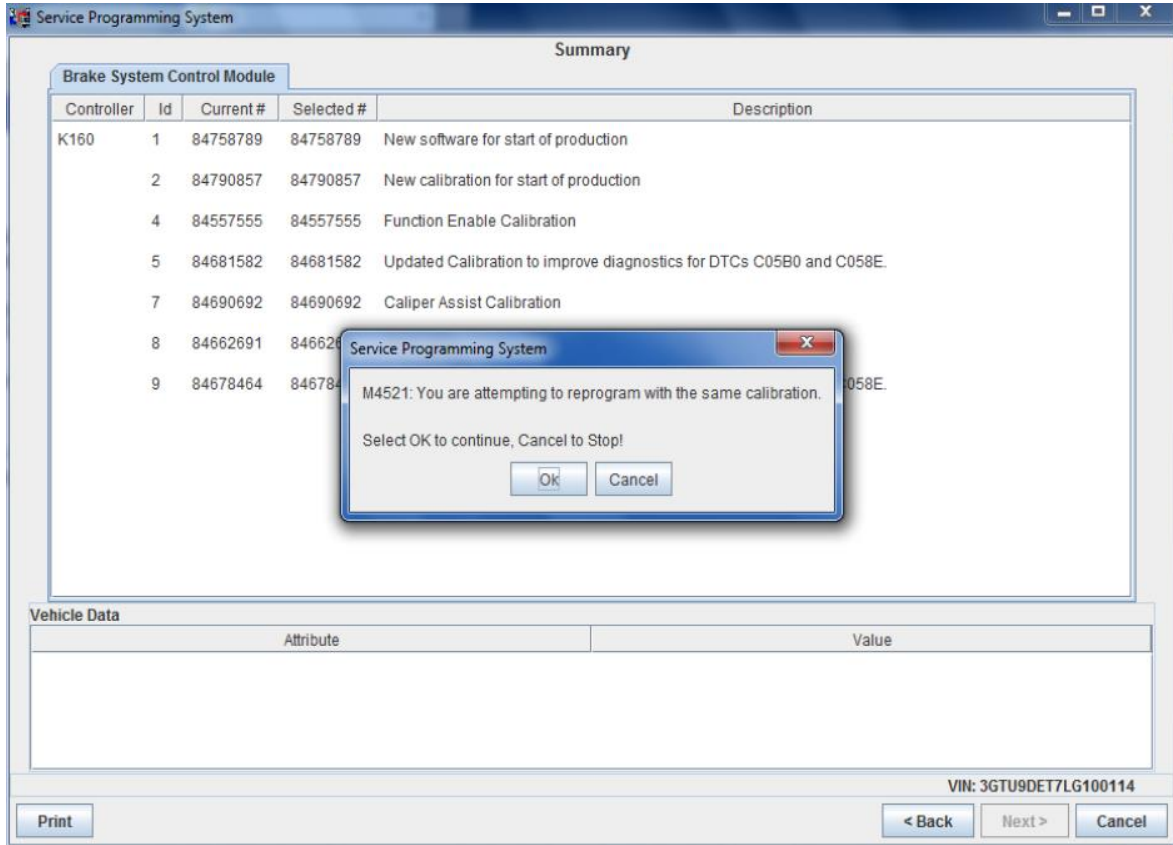
5431207

Important: If the Same Calibration/Software Warning is noted on the SPS screen, select OK and follow screen instructions. After a successful programming event, the WCC is located in the Service Programming System dialogue box of the SPS Summary screen. No further action is required. Refer to the Warranty section of the bulletin.

1. Reprogram the Engine Control Module. Refer to *K20 Engine Control Module: Programming and Setup* in SI.

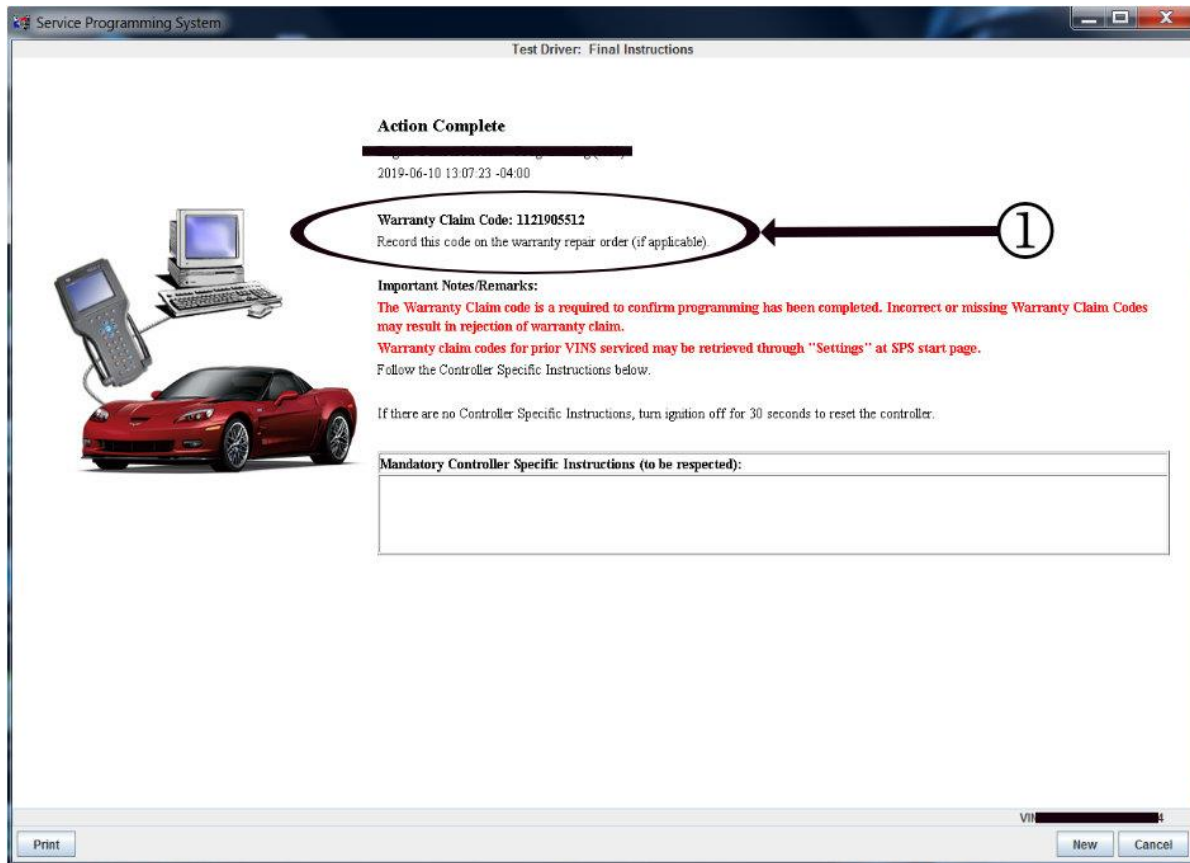
5431209

Important: To avoid warranty transaction rejections, you **MUST** record the warranty claim code provided on the SPS Warranty Claim Code (WCC) screen on the job card. Refer to callout 1 above for the location of the WCC on the SPS screen.

- Record SPS Warranty Claim Code on job card for warranty transaction submission.
