N192264210 Enable Diesel Engine Block Heater

Release Date: January 2020 Revision: 01

Condition	Certain 2017 - 2019 model year Chevrolet Silverado 2500/3500 and GMC Sierra 2500/3500 vehicles,
	equipped with the 6.6l Duramax diesel engine (RPO L5P) and optional engine-block heater cord, may
	have a condition in which the block heater cable function was disabled.
Correction	Dealers will replace the engine block heater and cord.

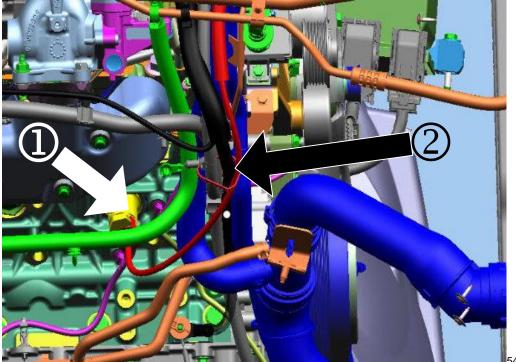
5495375

- 12. Route the new engine coolant heater power cord (red) to the upper motor compartment. Secure the power cord to the existing wiring harness with a wire tie as shown. Begin at the Element (1) and secure the wire tie (2) around the negative battery cable (black) and the engine chassis harness (grey).
- 13. Reinstall the right front wheel and tire. Refer to Tire and Wheel Removal and Installation (8-Lug Wheel) in SI.
- 14. Lower the vehicle.
