Extended Crank and/or MIL ON With DTC P0171, P0174, P0172, P0175, P1604 (Flex-Fuel)

Service Category Engine/Hybrid System

Some 2009 – 2018 model year Sequoia and 2009 – 2019 model year Tundra vehicles equipped with a 3UR-FBE engine may exhibit a hard start and/or MIL ON condition with one or more of the following Diagnostic Trouble Codes (DTCs):

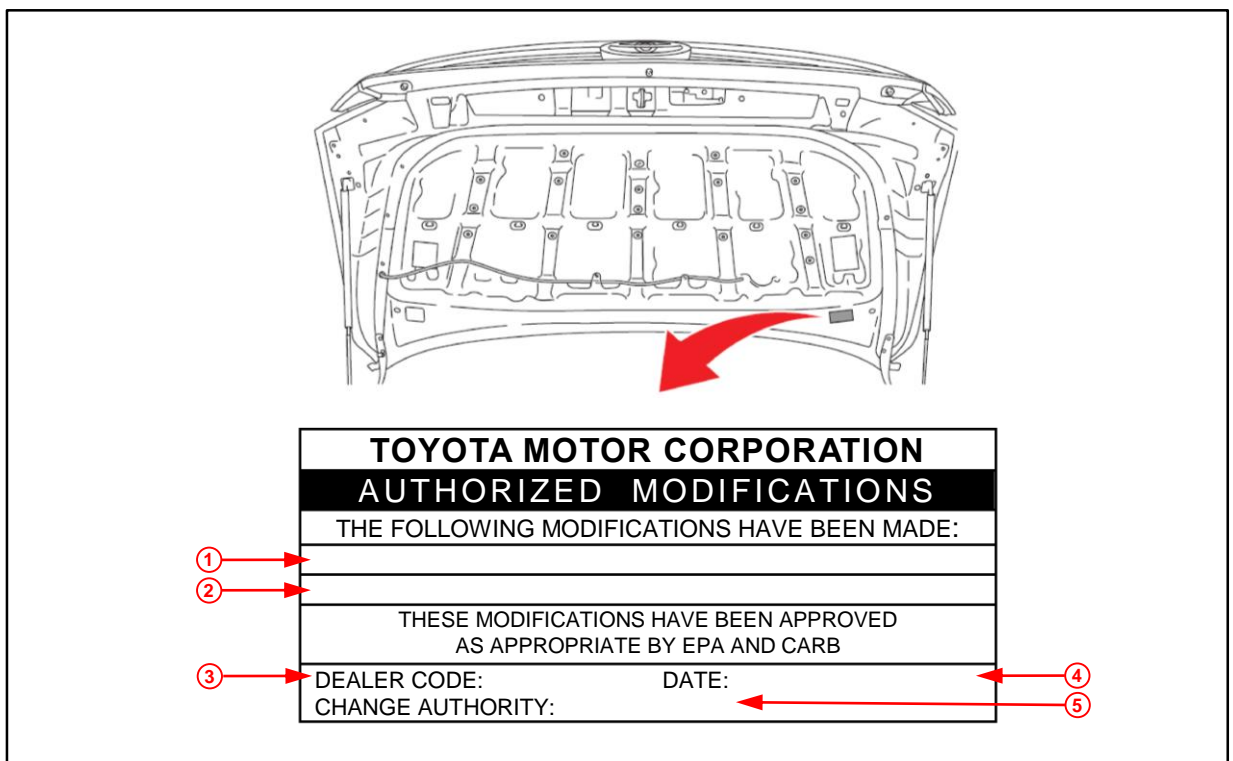
Figure 1. Location of Authorized Modifications Label on 2009 – 2018 Sequoia and 2009 – 2019 Tundra

- Use Techstream to confirm if the ECM (PCM) calibration has been updated and check for the Authorized Modifications Label affixed to the vehicle in the location shown below.

5. Prepare and install the Authorized Modifications Label.
 - A. Using a permanent marker, enter the following information on the label:
 - ECM (PCM) part number [*Refer to the **Parts Information** section for the **NEW PART NUMBER***]
 - Calibration ID(s) [*Refer to the **Calibration Information** section for the **NEW CALIBRATION ID***]
 - Dealer Code
 - Repair Date
 - Change Authority [***This bulletin number***]
 - B. Install the Authorized Modifications Label onto the vehicle at the location shown in Figure 1. The Authorized Modifications Label is available through the MDC, P/N 00451-00001-LBL.
