Subject <b>Air Conditioning System - Improved Component Inspection</b>		Market USA
Service Category Vehicle Interior	Section Heating/Air Conditioning	
Applicability Toyota

In certain cases of leaking air conditioning systems, the root cause of the leak is inadvertently overlooked, causing a repeat repair. To improve customer satisfaction and repair A/C system leaks in one dealer visit, Toyota has developed a set of guidelines for evaluating A/C system components.

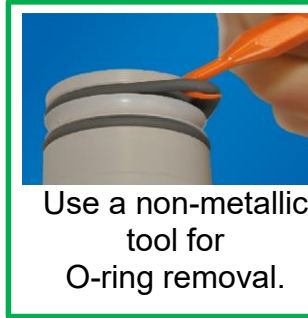
**OK Part\*** - Line at middle of O-ring is straight with no deformation. No tears, or crushed areas.  
 \*O-rings should be replaced anytime they are removed from a pipe/component to prevent leaks and foreign material.

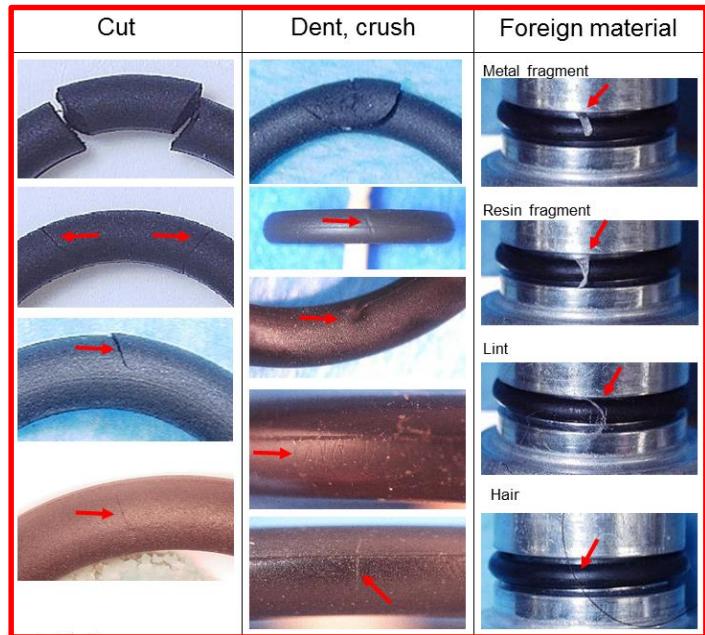
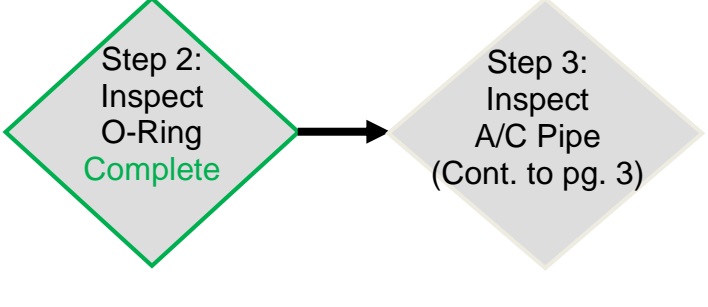
**Foreign Material– No Good Part**  
 O-ring contaminated by material outside A/C system. Replace O-ring, proceed with A/C Pipe inspection.

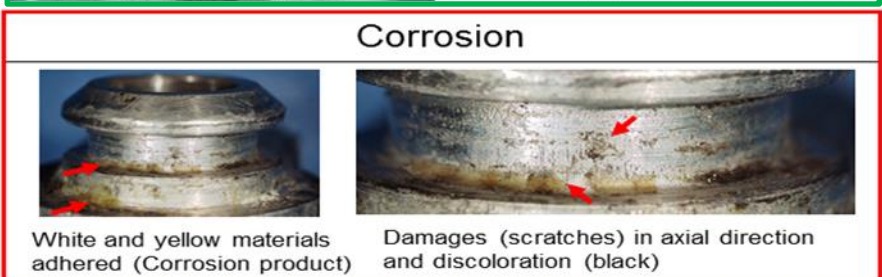
**Corrosion – No Good Part**  
Pipe is damaged due to corrosion of base material. Pipe replacement is recommended to prevent repeat repair.

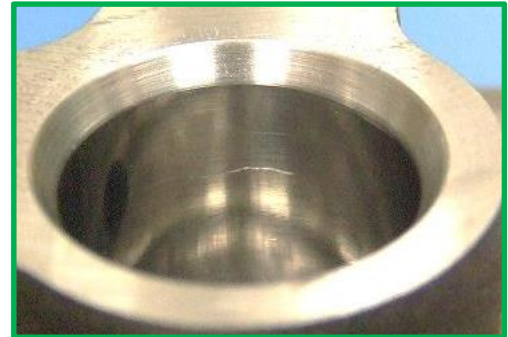
**OK Part** - Light scratching parallel with O-ring groove. This is caused by normal part processing. Compressor is ok to reuse.
