SIB 11 15 19

2020-01-07

## SERVICE ACTION: S58T ENGINE – CHECK ENGINE OIL DEFLECTOR SCREWS

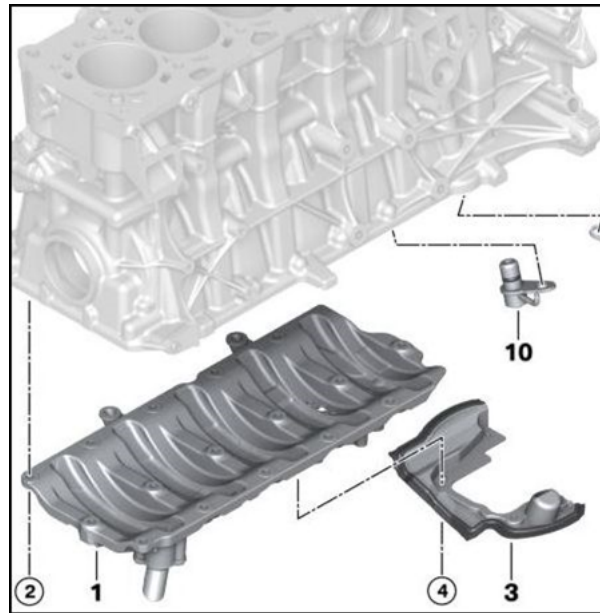
The engine oil deflector screws may have been tightened to the wrong torque.

1. Remove the engine oil pump as described in Repair Instruction “**11 41 000 Removing and installing/replacing the oil pump**”.
2. Retighten the 16 screws (**2, illustration below**) from the engine oil deflector (**1**) to **22 Nm**.
3. Reassemble the vehicle and refill the engine oil (**without an oil filter replacement and a CBS data reset**) as described in the Repair Instruction “**11 41 000 Removing and installing/replacing the oil pump**”.
