SIB 17 01 20

SERVICE ACTION: ADD SILICONE BOOSTER TO LOW TEMP COOLING SYSTEM

G05 (X5 Sports Activity Vehicle)	G06 (X6 Sports Activity Coupe)	G07 (X7 Sports Activity Vehicle)	All with the N63B or N63M engine
----------------------------------	--------------------------------	----------------------------------	----------------------------------

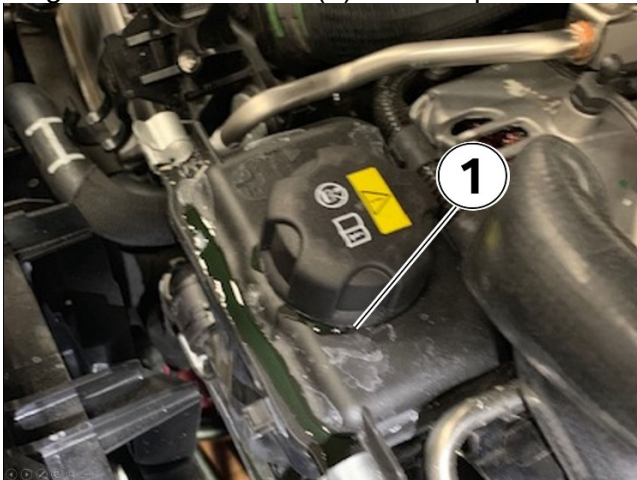
Step One: Check the cap on the low pressure cooling system for signs of overpressure (coolant leaking (1) or signs of dried coolant (2)- refer to photos below). If there are signs of coolant loss, proceed to Step Two. Coolant leaking (1).

Step Two: Do not add the silicon booster if there is any pressure released from the low temp cooling system. Follow [SI B17 06 17](#) to properly repair the vehicle.

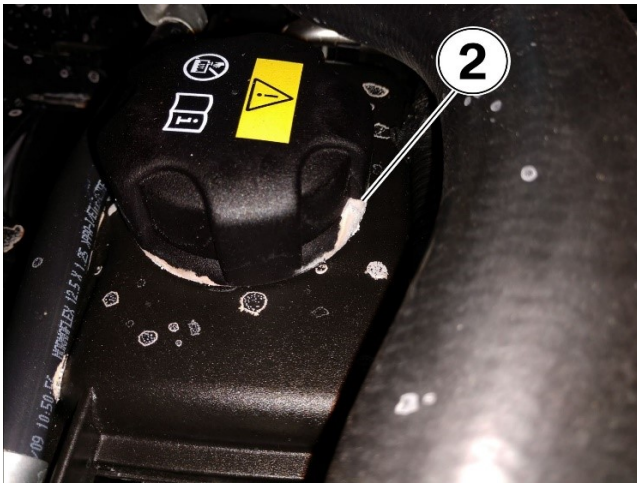
Signs of dried coolant (2).

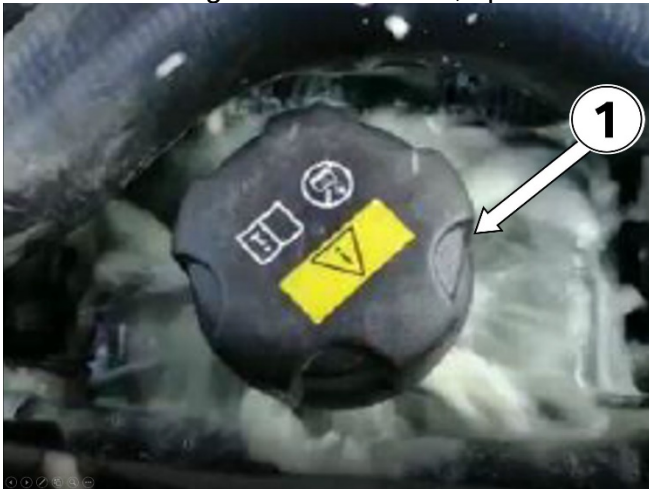
If there are no signs of coolant loss, open the reservoir cap for the low temperature cooling system. Was pressure released (1)?

- Yes: Continue to Step Two.
- No: Continue to Step Three.
