SIB 52 01 20

GROANING NOISE FROM TRIM APERTURE ON THE FRONT SEAT

2020-01-30

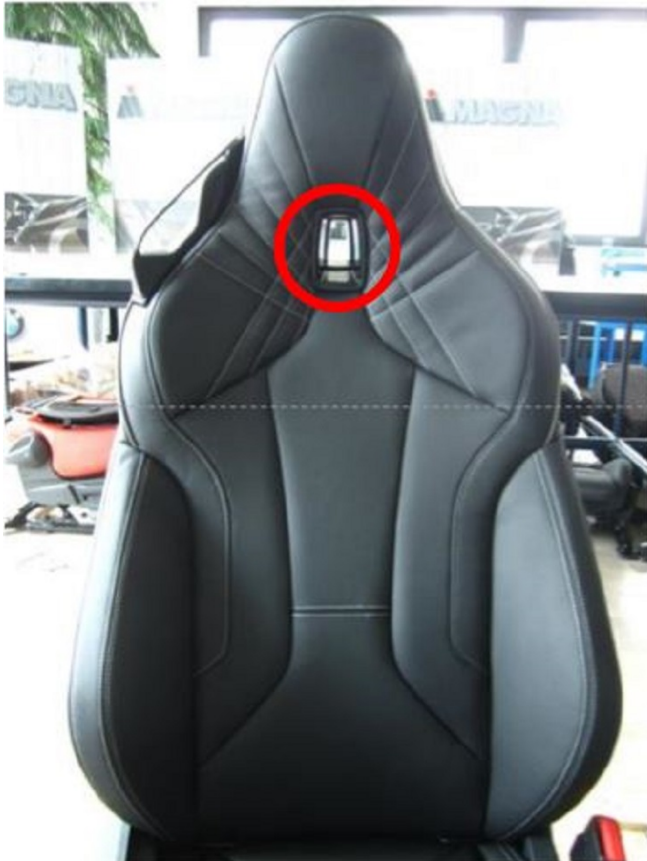
When getting in or out of the vehicle, a groaning noise can be heard from the opening (aperture) in the seat backrest. The noise may be heard from one or both of the front seats.

The trim aperture in the front seat is insufficiently lubricated. The front and rear halves of the trim can contact each other, causing friction noise.

Lubricate the trim aperture (circled).
