SIB 61 21 19

SERVICE ACTION: INSPECT AND REWORK ENGINE COMPARTMENT WIRING HARNESS

E-Series	Model Description	Production Date
G20	3 Series Sedan	October 24 th , 2018 – March 19 th , 2019

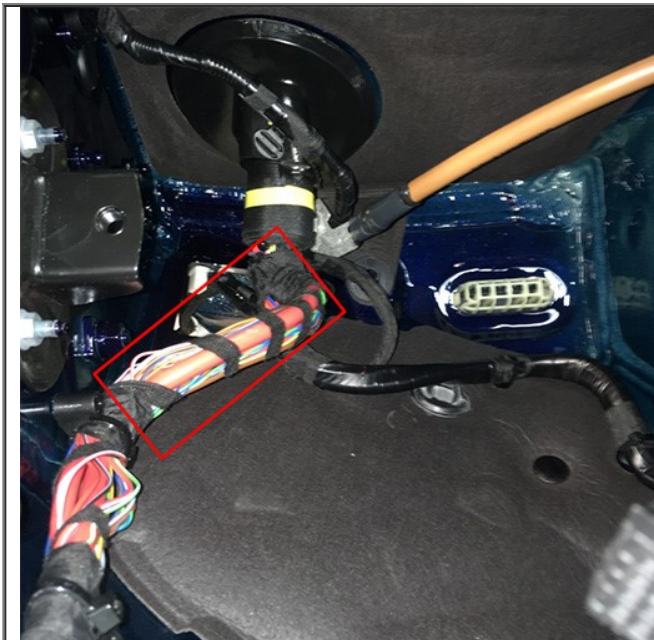
Check the wiring harness in the marked area for damage and repair as described below.

1. Remove the Dual Storage Battery Holder by following the instructions on the Attachment “**Removal of the Dual Storage Battery Holder**”

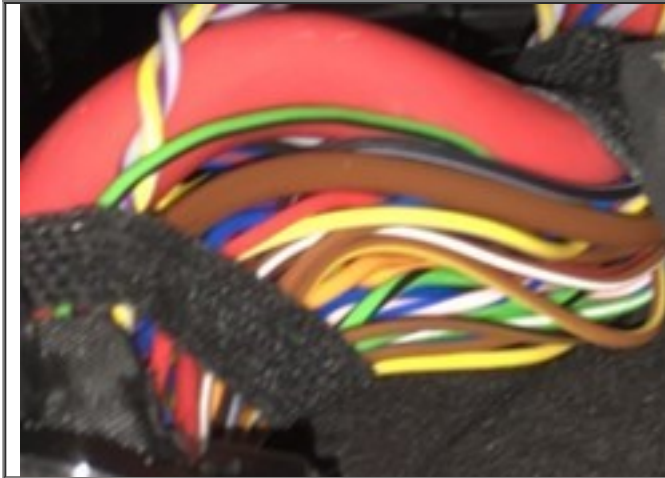
2. If no damage is found, as shown on the picture, proceed to **Step 3**.

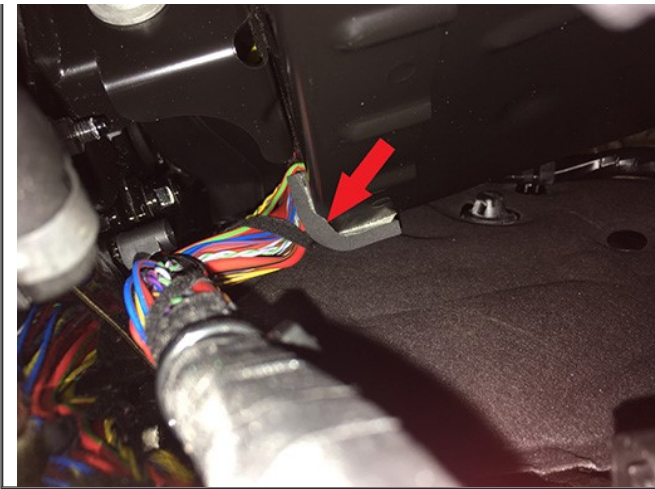
- Foam shown properly installed on the vehicle, by looking down the front left side of the battery holder, next to the wiring harness.

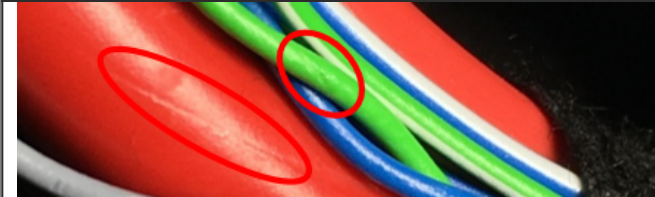
4. If wiring harness insulation shows damaged/ chafe marks visible on insulation, but no copper strands are visible.

- Wrap the damaged single strand with insulating tape, and perform **Step 3**.

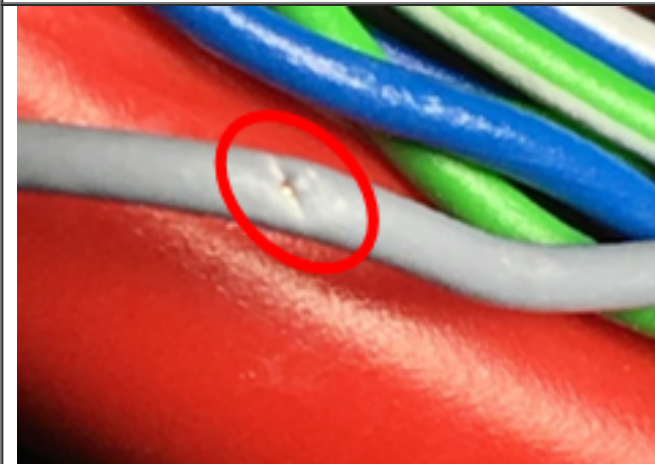
5. If the copper strands are already visible or the insulation shows severe damage.

- Repair the single strand with butt connectors (Refer to REP 6111 "Wiring harness repair"), and perform **Step 3**.

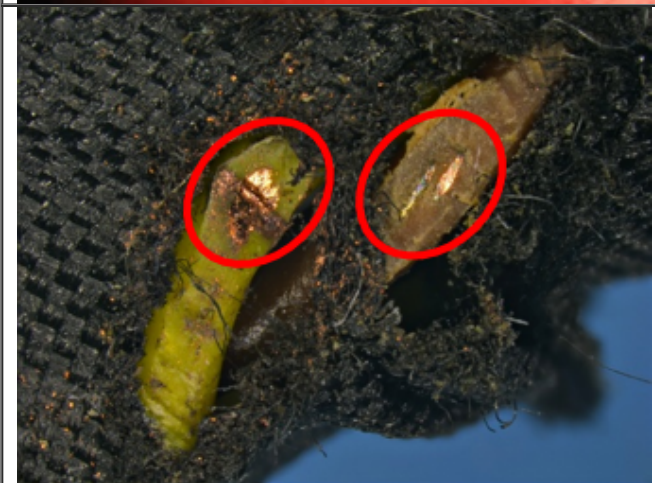
(Example of severe insulation and wiring damage)
