SIB 66 35 19

## DELIVERY STOP: PROGRAM CONTROL UNITS – DRIVING ASSISTANT PACKAGE

E-Series	Model Description	Production Date	Affected Option Code
G20	3 Series Sedan	August 1 – October 4, 2019	SA5AR – Extended Traffic Jam Assistant

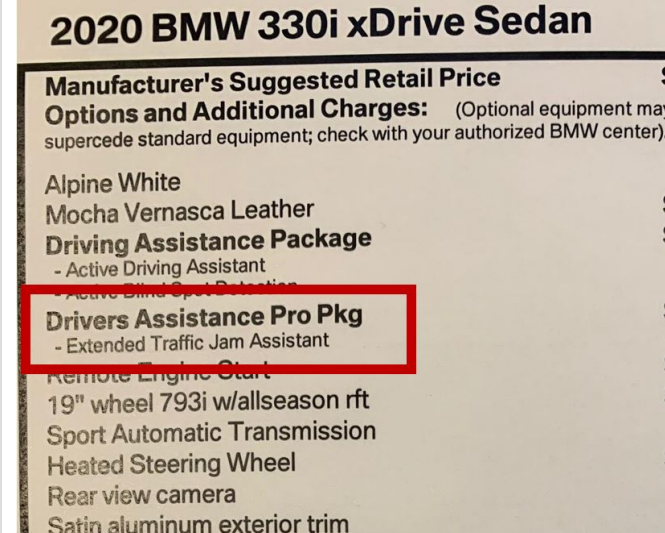
Vehicle Order and the Monroney label are incorrect.

<p>This image shows an incorrect Monroney label with the extra option listed.</p>
--	---

1. Change the VO (delete 5AR) and program the vehicle with ISTA 4.19.20 or higher (available September, 2019).
  - Target Integration Level: S18A-19-07-553 or higher.
2. Replace the Monroney label if the vehicle was received at your center prior to January 8, 2020.
