SIB 84 04 16 SOS MALFUNCTION DISPLAYED

2020-01-06

This Service Information Bulletin (Revision 1) replaces SI B84 04 16 **dated September 2016**.

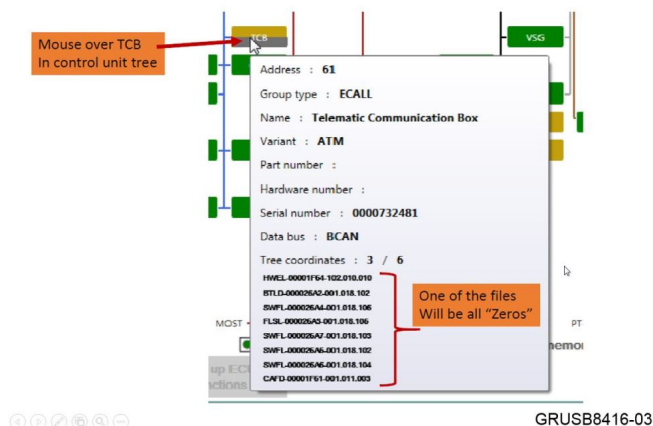
Screen shot taken from ISTA Diagnosis Control Unit Tree

- Using the mouse, hover cursor over the ATM/TCB2 in the control unit tree.
- Look at the list of software files

Does one of the filenames display as all “Zeros”?

YES- Replace the ATM/TCB2 control unit. Follow the corresponding repair instructions to Remove the control unit. Go to step 4 when complete.

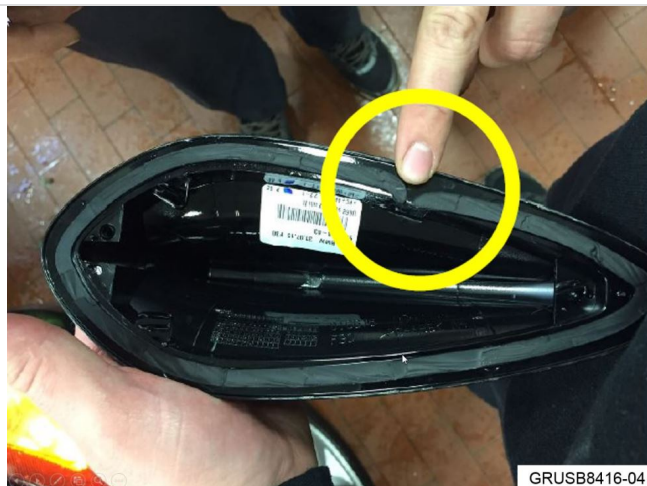
- Software file missing from the ATM/TCB2 control module
- Water leak at the “shark fin” roof antenna (aka roof aerial), leading to corrosion in the ATM/TCB2 control module

- Picture shows a space/gap in the seal of the shark fin that would cause leakage.

- Remove and reinstall the shark fin per REP 65 20 030.

Note: The repair instructions contain the procedure on cleaning and resealing the shark fin.

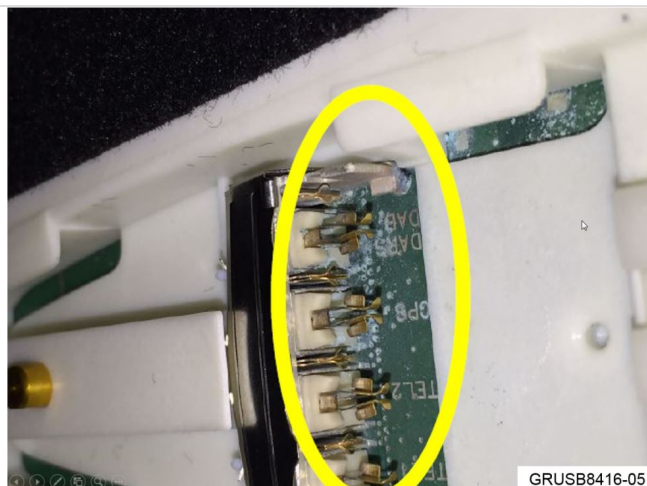
- Remove and replace the ATM/TCB2 as per REP 65 20 037
- This picture shows corrosion on the contact of the ATM/TCB2 control unit.
