SIM 11 01 17

2020-01-06

## FAULT 118002 - MIXTURE TOO RICH - SETS DURING WINTER WITH COLD AMBIENT TEMPS

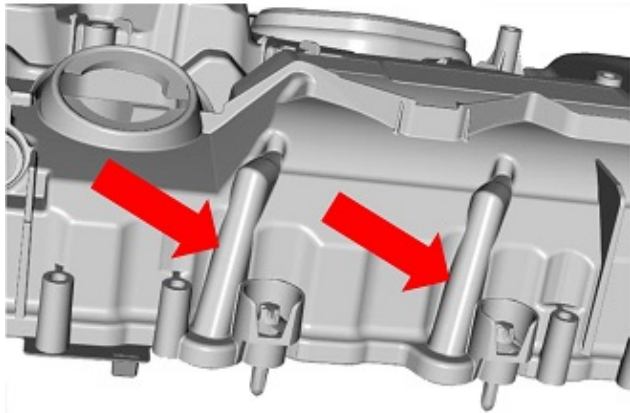
GRUSB1118-31

Older version shown.

Replace the cylinder head cover and profile gasket if the older version is equipped.

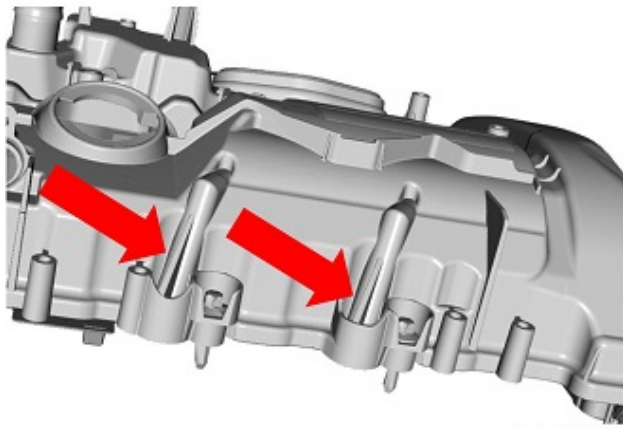
GRUSB1118-32

Newer version shown.

Note: This updated version can be identified by the additional supports on crankcase ventilation ports (arrows).
