# Blind Spot Monitor DTC C1AC1 or C1AC2

## Applicability

| YEAR(S) | MODEL(S) | ADDITIONAL INFORMATION |
|---|---|---|
| 2019 | Tacoma | |

Some 2019 model year Tacoma vehicles may exhibit a Blind Spot Monitor System warning message with any of the following Diagnostic Trouble Codes (DTCs) present.

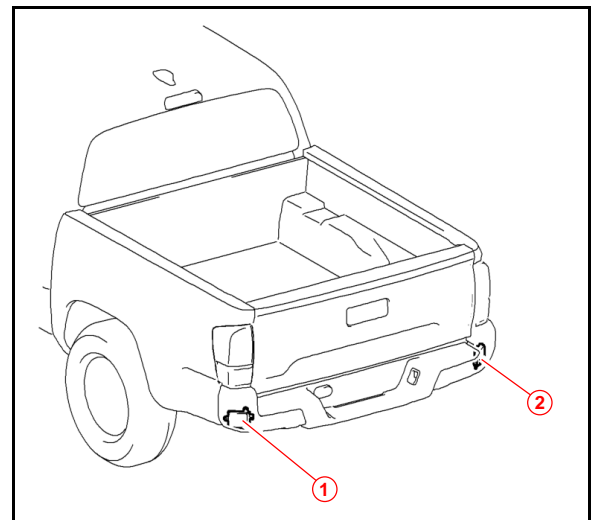
**Figure 1.**

| 1 | Blind Spot Monitor Sensor LH (Master) |
| 2 | Blind Spot Monitor Sensor RH (Slave) |

- B. Install the NEW Blind Spot Monitor sensors with the three nuts.

Torque nuts to 9.0 N\*m  
(92 kgf\*cm, 80 in\*lb)
