**Solution K73241583**

| Title | Mack Chassis - <b>Anthem (AN) Models</b> - Headlight Diagnostics And Replacement;<br>Instructions For Non-Functioning Headlight Or Turn Signal In Headlight Housing |

| <b>Mack Model</b> | AN - Anthem |

| Cause | Diagnostics and replacement instructions for Mack Anthem headlights and headlamp housing turn signals. |

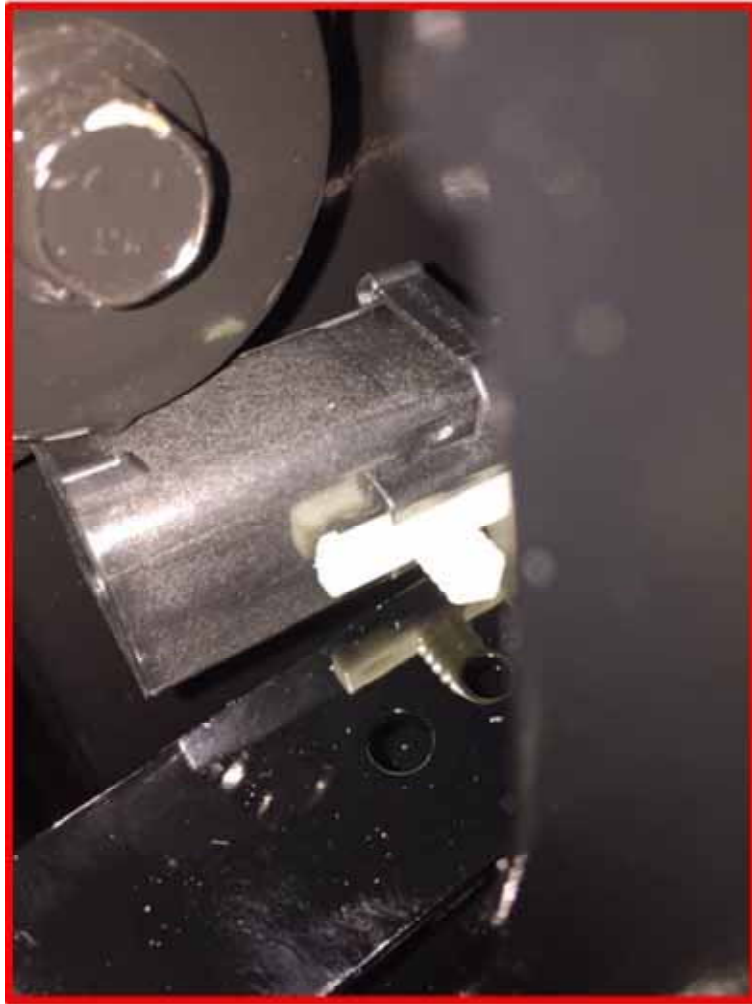
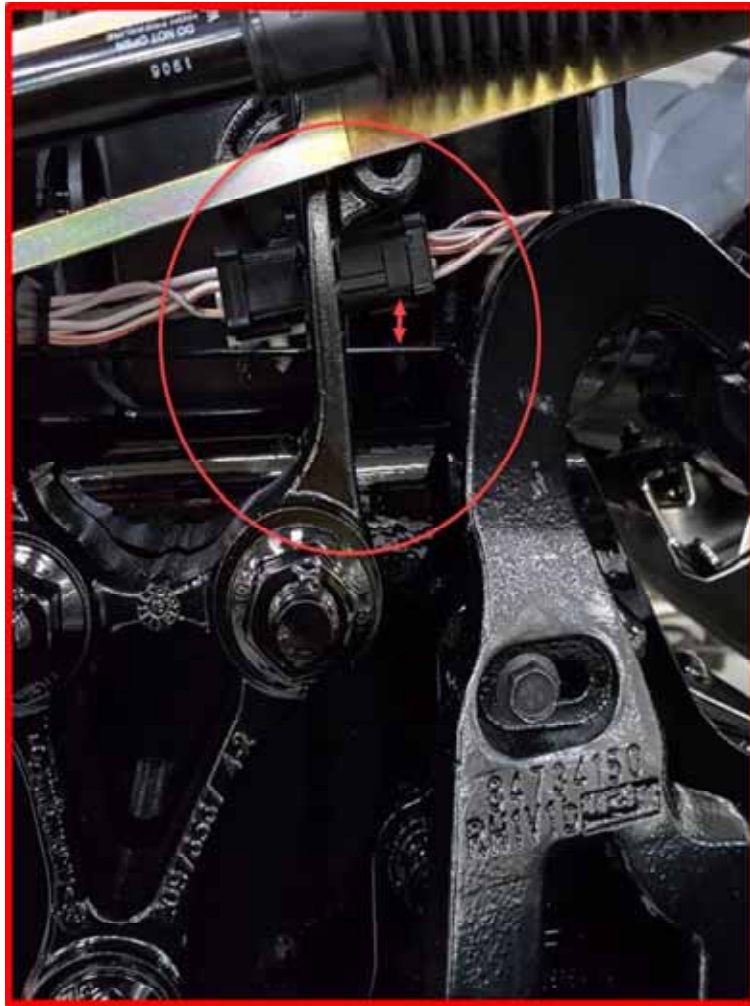
**Check if the connectors shown below are aligned correctly and securely pushed into the bracket.** Wiring fatigue may result in a headlight, marker light, or fog light not working due to an open or short circuit.

1. Clip the harness securely to the hood bracket and the chassis bracket to pull harness away from the charge air cooler (CAC).
2. Use cable ties to secure the harness in the positions shown below.

**If the wiring harness is found to be damaged:** Repair the harness using pigtail(s) part number [23662347](#) (chassis side) and/or part number [23662349](#) (hood side).

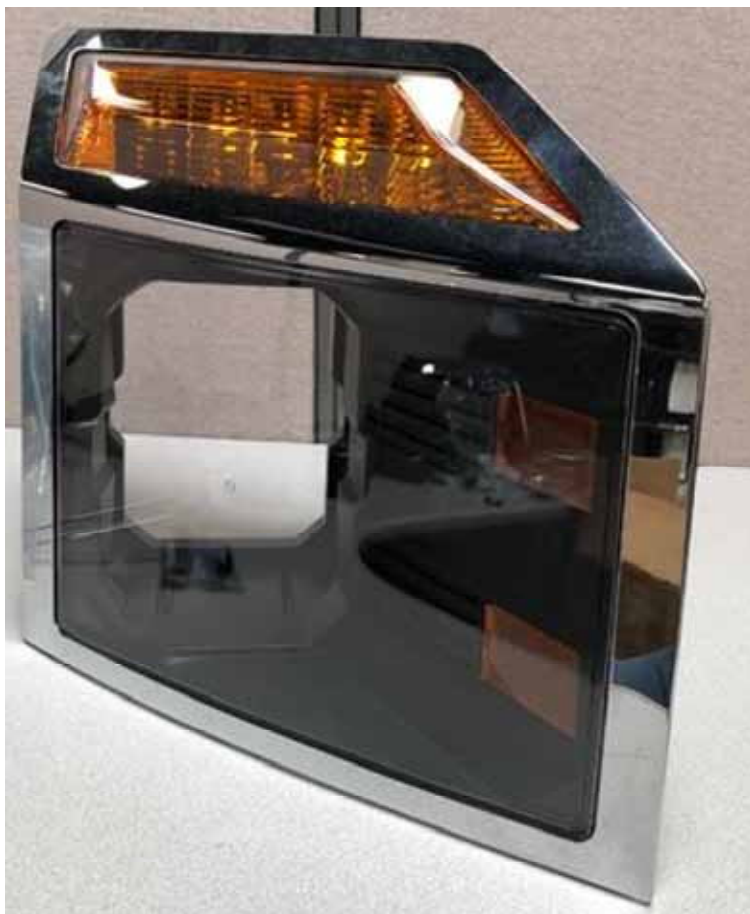
If the amber/turn signal is not working the complete headlight assembly will need to be replaced. The failure has been found to be the headlight housing itself. Due to the housing/lens geometry, the turn signal can not be sold as a replacement part ( unable to install after lens is

glued to housing ).

**NOTE:** The headlight module should NOT be replaced if the turn signal is not working.

Refer to [Impact](#) for the current headlight assembly part number.

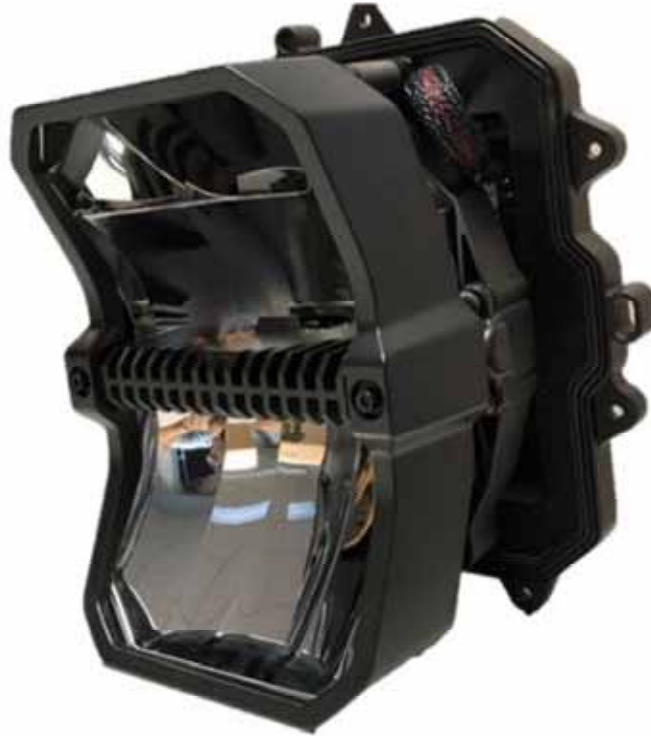
If the headlight is not working, only the headlight module will need to be replaced. The headlight module is the only serviceable part for the Mack Anthem headlamp.

- Right and Left- [84735466](#)

For removal and installation instructions refer to [3521-03-02-01 Headlamp Assembly, Replacement](#) located in [Impact](#).
