| Title | Mack Chassis - <b>Model MRU</b> - Inner and Outer Door Panel Repair Procedure; Outer Door Surface Separating From The Inner Door Surface |

| <b>Mack Model</b> | MRU - TerraPro |

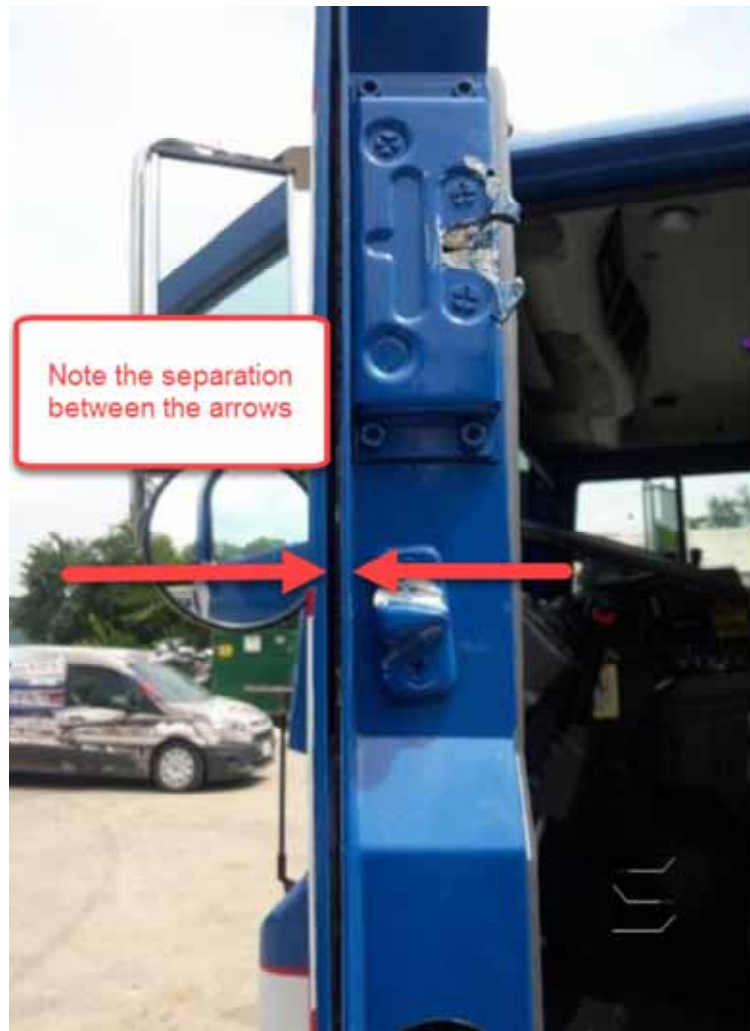
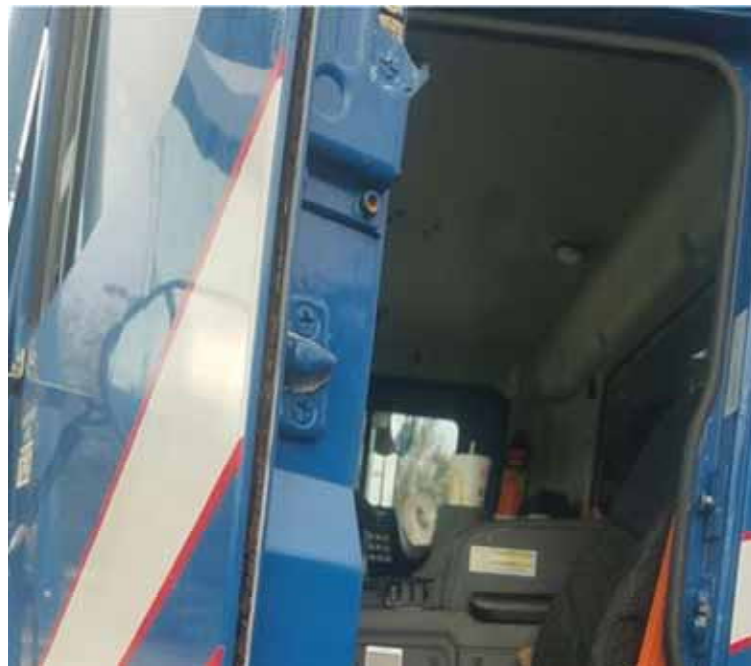
Solution

| Cause | Inner and outer door panel portions of MRU chassis may begin to come apart. |

**Refer to the steps below for the inner and outer door panel repair procedure.**
