| RE: <b>Service Campaign Launch Notification</b><br><b>Check Left and Right Front Fender Gap Covers</b><br><b>MY20 167 (GLE-Class)</b> | DATE: January 10, 2020 |

Campaign No. 2019110017, January 2020

SUBJECT: **Model GLE-Class (167 platform)**  
**Model Year 2020**

## **Check Left and Right Front Fender Gap Covers**

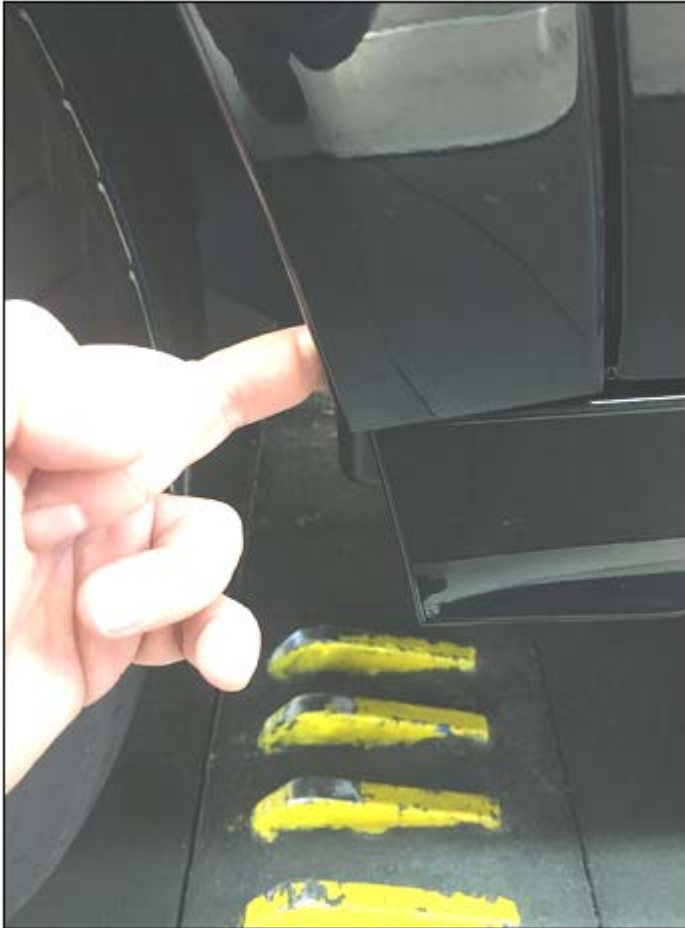
**Figure 1**

1. Check whether the left and right front fender gap covers are seated correctly.
  - i** The check of the fender gap cover must be performed in the area of the door sill in each case.
  - i** The fender gap cover must be checked while applying slight pressure away from the vehicle (**Figure 1**).
  - i** The fender gap cover must not be released from the clip in the fender.

- a. Fender gap cover comes **loose**:  
Continue performing **check/test procedure**.
- b. Fender gap cover does **not** come **loose**:  
**End measure.**

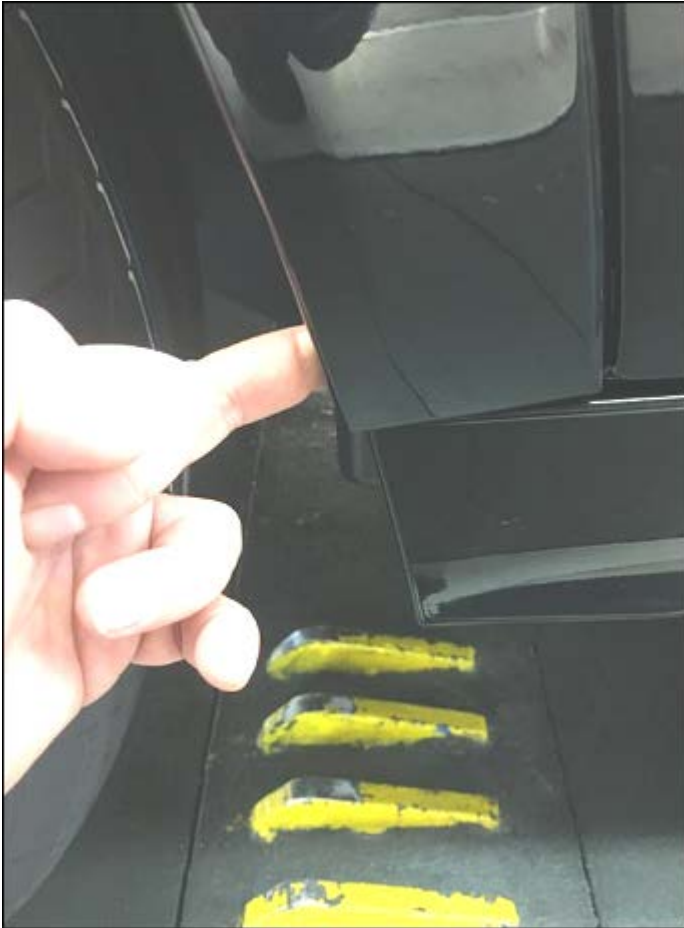
**Figure 3**

**i** The fender gap cover must be checked while applying slight pressure away from the vehicle (**Figure 3**).

- a. Fender gap cover comes **loose**:  
Carry out **work procedure**.
- b. Fender gap cover does **not** come **loose**:  
**End measure**.
