Title Mack Chassis - **Equipped With A Cummins Engine** - Engine Preheat Icon Does Not Illuminate In The Instrument Cluster (IC) During Engine Pre-heat (Intake Air Heater) Operation - **Vehicles With 2018 Instrument Cluster Update, Model Year 2018 And Newer**

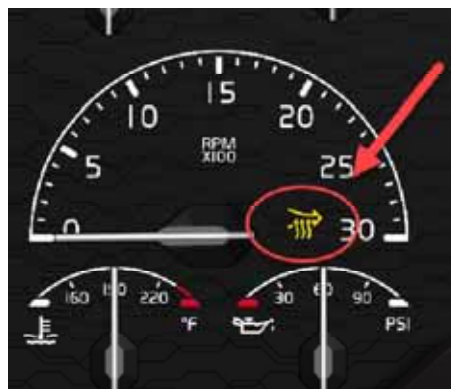
**Cause** In Cummins-powered vehicles with the new instrument cluster design, the Preheat Icon may not illuminate during engine preheat operation, providing no indication to the driver that the function is active.

The icon may not illuminate due to a parameter missing from the Instrument Cluster (IC) module.

**Solution** If the Preheat Icon does not illuminate while Engine Preheat is active as shown below:

**A. Update Instrument Cluster Software (SW) to enable the parameter.**

1. In Premium Tech Tool (PTT), run Operation [1700-22-03-06 Accessory Kit](#). The operation can be found under the Program tab.
2. When prompted, enter Accessory Kit Number [85153771](#).

3. Press the Program button in the lower right-hand corner of the screen.
4. Allow the programming operation to complete.

## B. Set Vehicle (System) Date And Time.

1. Run PTT Operation [1700-22-03-02 System Date and Time](#). The operation can be found under the Program tab.
2. More information can be found in CBR Solution [K11533602](#).
