Audio switches on steering wheel, no function

REF NO: TJ 32033.5.0	ISSUING DEPARTMENT: Technical Service	CAR MARKET: United States and Canada		
3 US 7	PARTNER: 7510 Volvo Car USA	ISSUE DATE: 2020-01-08	STATUS DATE: 2020-01-14	
FUNC GROUP: 6414	FUNC DESC: Steering wheel, control buttons	Page	1 of 3

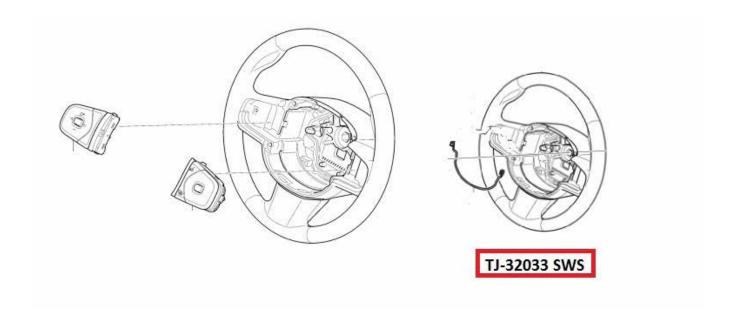
File Name	File Size
TJ 32033 SWSM.JPG	0.0437 MB

If the audio switches on steering wheel have no or intermittent function, see advice under Service.

New improved steering wheel switches were introduced week 46, 2019 and come as a complete assembly including both switches and wire harness, see attached picture <u>TJ 32033 SWSM.JPG</u> The new steering wheel switch assembly supersedes the old steering wheel switches.

Replace the steering wheel switches according to VIDA instructions.

PN **32266342** Charcoal (Variant code: RU05)

PN 32266343 Crystal Look (Variant code: RU02 or RU06 or RU08 or RU09)
