TECHNICAL INSTRUCTIONS

SPECIAL SERVICE CAMPAIGN 19TC06

ENGINE ECU REPROGRAM

CERTAIN
2020 CAMRY
2020 AVALON

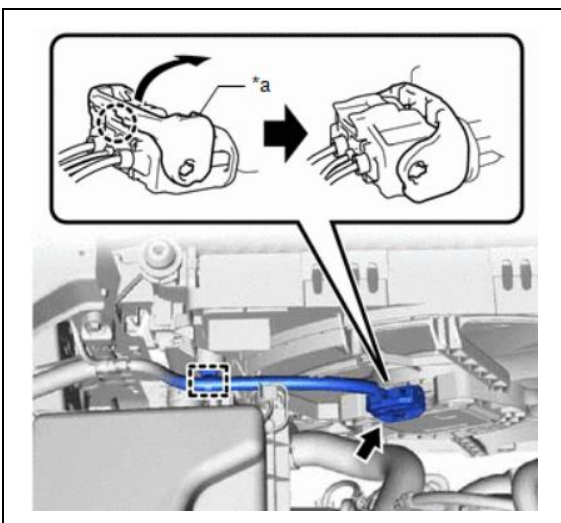
4. DISCONNECT COOLING FAN

- a. Disconnect the electrical connector from the cooling fan ECU on the radiator fan shroud.

If the cooling fans run during the Calibration update procedure, the battery voltage will be inconsistent and could cause damage to the control module(s).

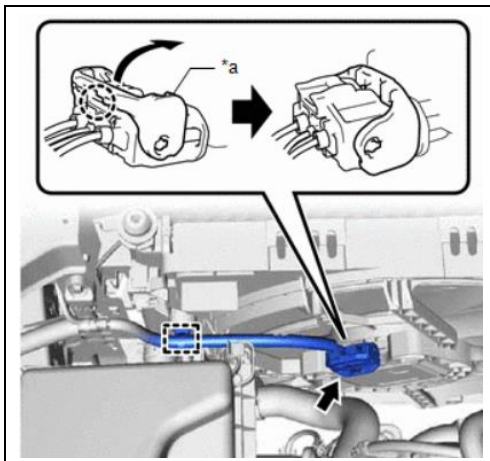
1. CONNECT COOLING FAN

- a. Connect the electrical connector to the cooling fan ECU on the radiator fan shroud.

Camry shown. Avalon is similar.

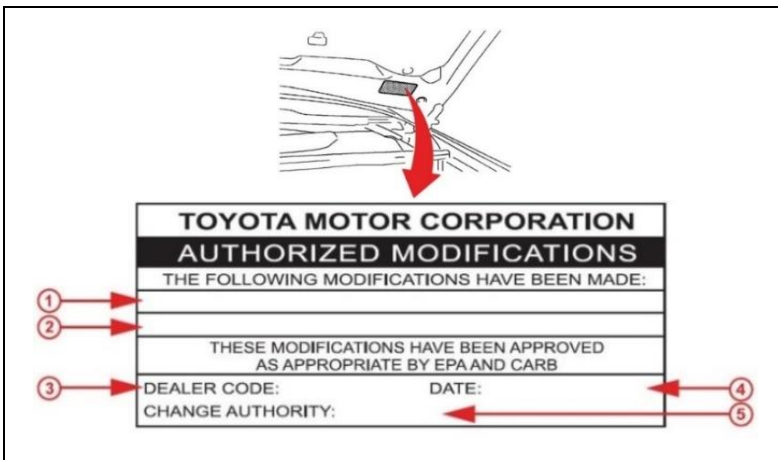
5. ATTACH THE AUTHORIZED VEHICLE MODIFICATION LABEL

- a. Fill out the label.
- b. Affix the label to the under-side of the hood.

1	Engine & Trans
2	Calibration Update
3	(Dealer Code)
4	(Date Completed)
5	19TC06
