Never Plug into the Audio Unit's/Audio-Navigation Unit's Empty 12-Pin Connector Cavity!

Year	Model	Trim
2016- 20	Civic	ALL with Display Audio

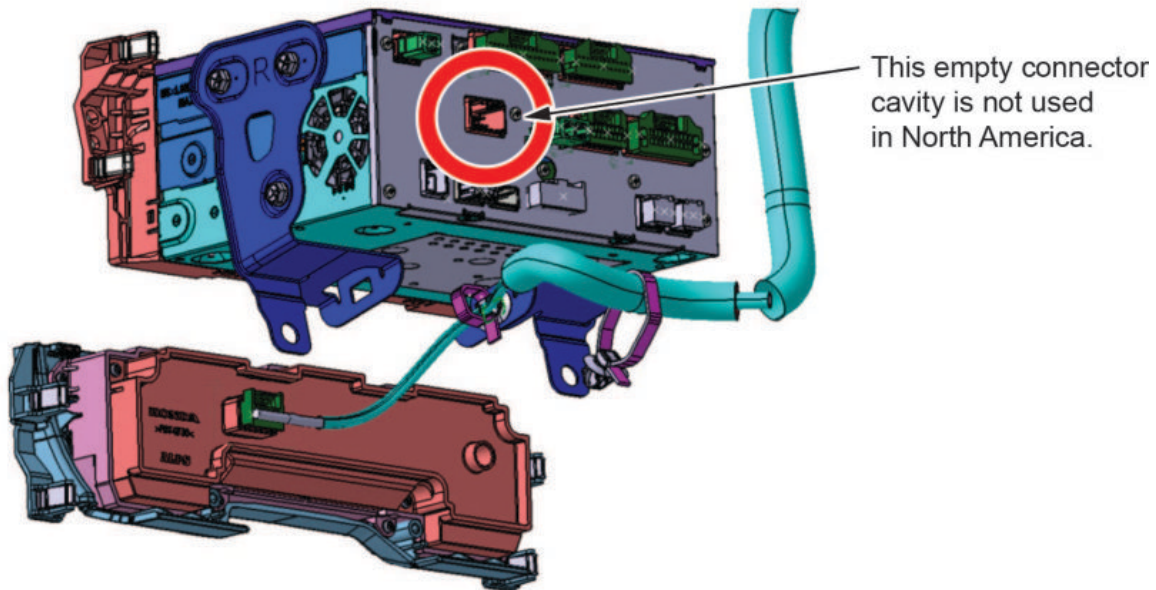
The 12-pin connector cavity in the back of the audio unit/audio-navigation unit is intentionally empty. It's used as a service port for other markets, so **never** try plugging into it.

Although the 12-pin connector for the panel and the kit's ambient light harness fit right into that empty cavity, plugging them in will damage the dimming circuit in the gauge control module, causing a loss of the shift indicators and other switch backlighting. Furthermore, these symptoms may not appear until **after** the vehicle is returned to your customer, so you could end up with a comeback.

The only way to fix this issue is to replace the gauge control module.
