Service Action

Code: 19N8

Subject	After-Run Coolant Pump
Release Date	February 18, 2020
REVISION SUMMARY	Updated claiming and work instructions: A single part number per criteria will now be used.
Affected Vehicles	U.S.A.: Certain 2012-2017 MY Audi vehicles with a 2.0L TFSI gasoline engine CANADA: Certain 2013-2017 MY Audi vehicles with a 2.0L TFSI gasoline engine <i>Check Campaigns/Actions screen in Elsa on the day of repair to verify that a VIN qualifies for repair under this action. Elsa is the <u>only</u> valid campaign inquiry & verification source.</i> <ul style="list-style-type: none">✓ Campaign status must show “open.”✓ If Elsa shows other open action(s), inform your customer so that the work can also be completed at the same time the vehicle is in the workshop for this campaign.
Problem Description	Power to the electric (after-run) coolant pump was disconnected under Safety Recall 19N4.
Corrective Action	Install a new electric (after-run) coolant pump and update ECM software.

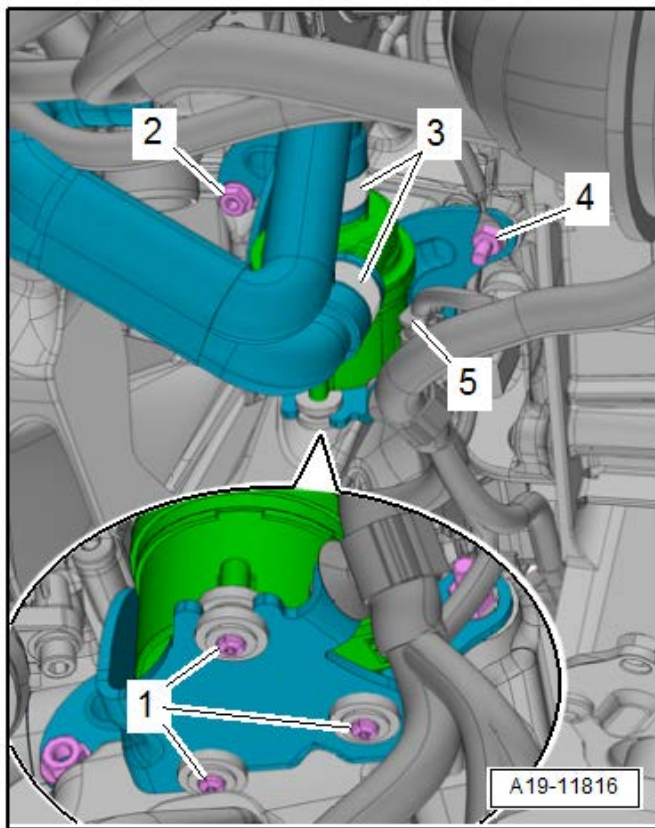
Before plugging in the connector for the after-run coolant pump, make sure there is no coolant inside the connector housing of the after-run coolant pump.

- Install new after-run coolant pump/bracket assembly.
- Install nut <2> and torque to 9 Nm.
- Install double bolt at location <4> and torque to 9 Nm.
- Install ground wire.
- Install nut at location <4> and torque to 9 Nm.
- Install hoses and secure hose clamps <3>.

- Connect connector <5>.
