# Technical Service Bulletin

## 19 Coolant level warning light on with coolant marks on the coolant pump - 4.0 TFSI

19 20 01 2048936/2 February 13, 2020. Supersedes Technical Service Bulletin Group 19 number 17-91 dated September 20, 2017 for reasons listed below.

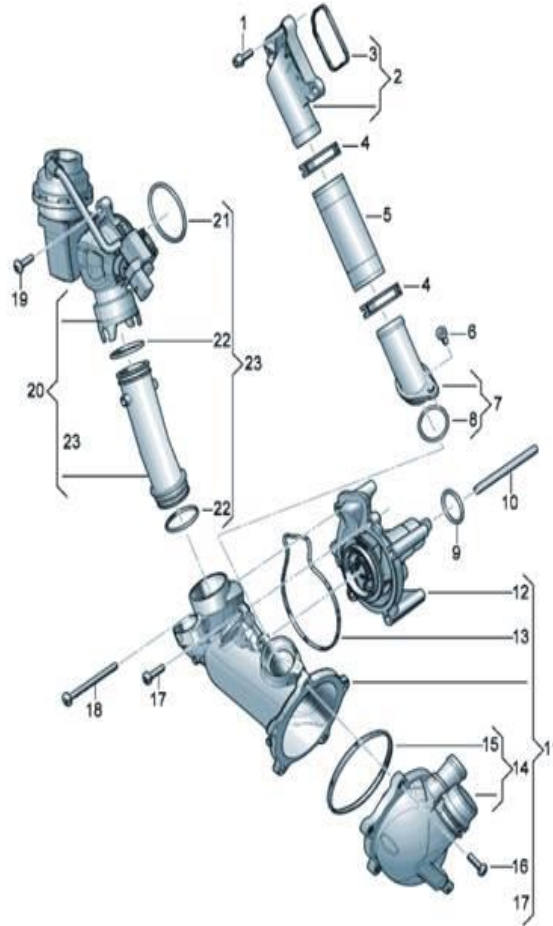
There are coolant marks in the area of the coolant pump housing (Figure 1, position 12), the coolant connector union (Figure 1, position 7) or the thermostat housing (Figure 1, position 14). After cleaning the coolant marks and performing another leakage test there are **fresh** coolant marks on the coolant pump drive (Figure 2 through Figure 6).

**Figure 1.** View position complete water pump assembly (rear view).

1. Fully complete the attached worksheet and attach it to the repair order.
2. Remove the coolant marks and bleed the cooling system according to the repair manual. Then check the cooling system for leaks according to the repair manual:
  - If there is no new leak visible on the coolant pump, **do not** perform any further repairs.
3. If a new coolant leak is detected and can be assigned to a component, take a photo of the **renewed** leak and attach it to the repair order.
4. If there is a coolant leak in the area of the coolant connector union a replacement of the O- ring only (Figure 1, position 8) is sufficient.

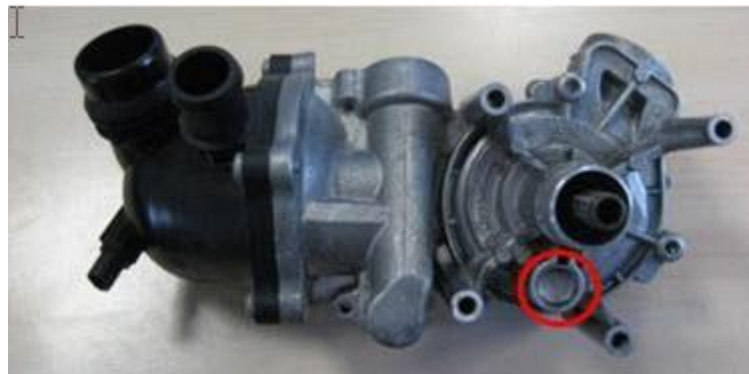
**Figure 2.** Coolant marks in the plug of the coolant pump housing.

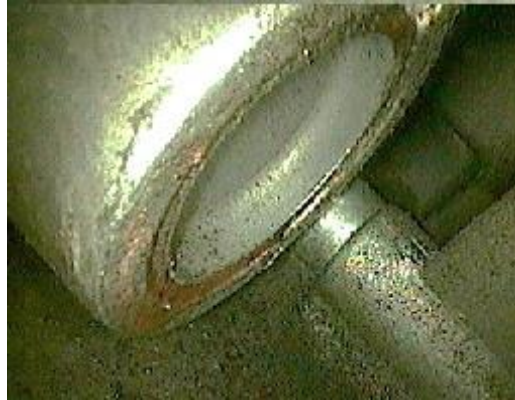
**Figure 3.** Coolant marks on the flange of the coolant pump housing.

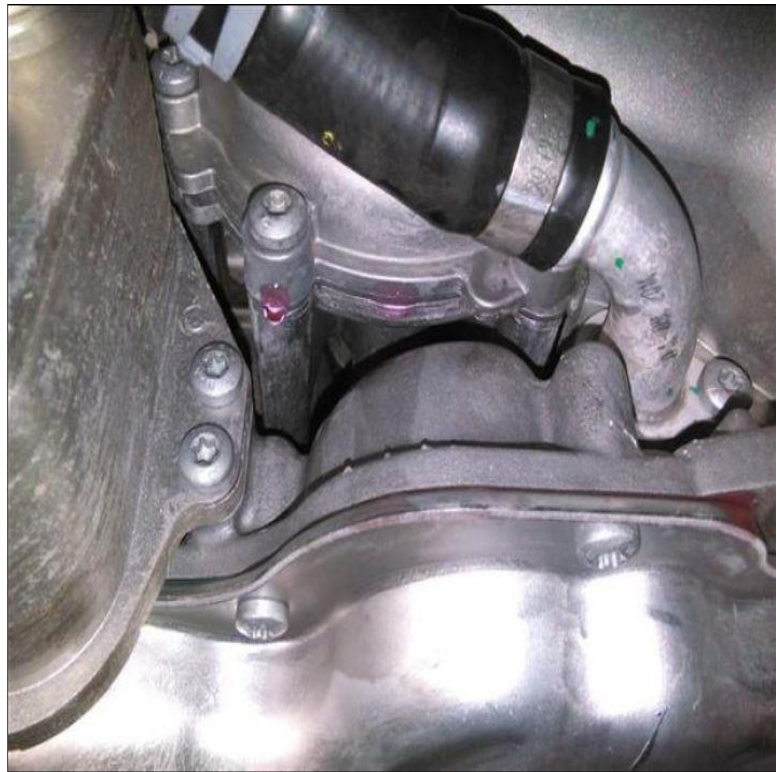
**Figure 4.** Coolant marks on the flange of the thermostat housing.

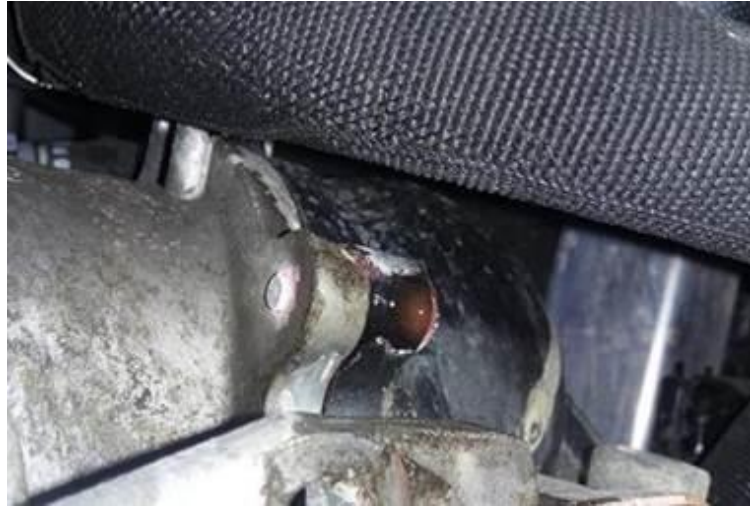
**Figure 5.** Coolant marks on coolant connector union.

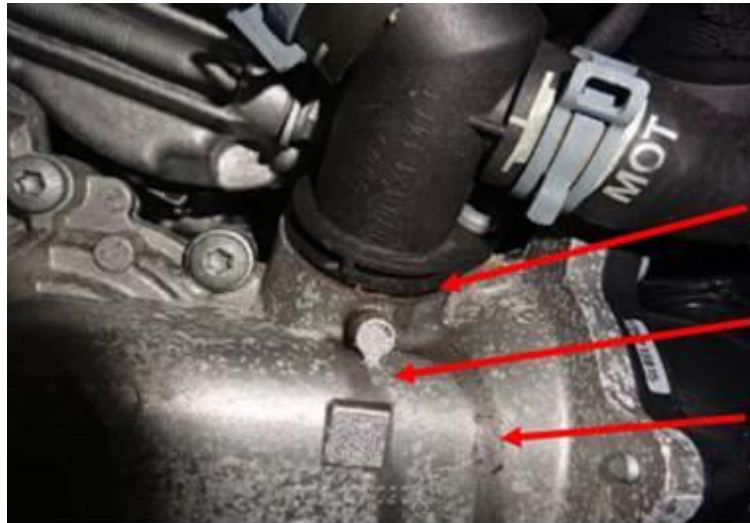
**Figure 6.** Areas where coolant marks can be found.

The coolant pump housing is sealed off with a slip ring seal to the input shaft. To prevent the seal from drying up, a minor coolant leak is necessary to lubricate the seal.
