Service Alert

Subject: MAZDA CONNECT REBOOT OR BLANK SCREEN	Service Alert No.: SA-011/20
	Last Issued: 02/18/2020

2014-2018 Mazda3
2016-2020 Mazda6
2016-2020 CX-3
2016-2020 CX-5
2016-2020 CX-9
2016-2020 MX-5

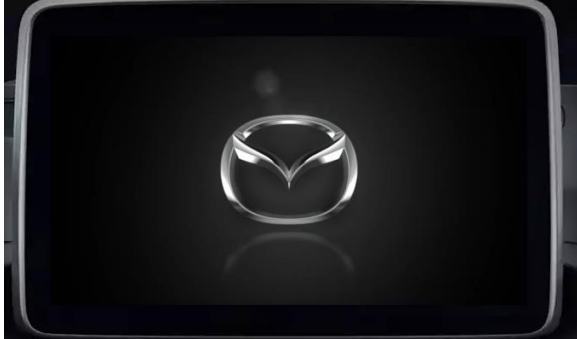
1. Start your stopwatch (or phone stopwatch app) the instant the Mazda logo appears. It may disappear for a second and reappear, do not stop your stopwatch yet.

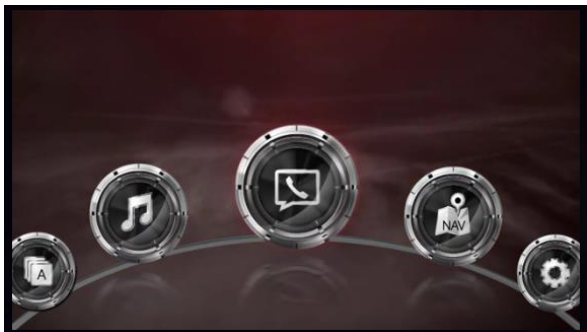
2. The HOME screen will appear, do not stop your stopwatch yet.
