Service Alert

Subject: VALVE TAPPING OR KNOCKING NOISE HEARD FROM CYLINDER HEAD	Service Alert No.: SA-025/20
	Last Issued: 02/11/2020

2018-2019 CX-5 vehicles (2.5L with cylinder deactivation)
2018-2019 Mazda6 vehicles (2.5L with cylinder deactivation)

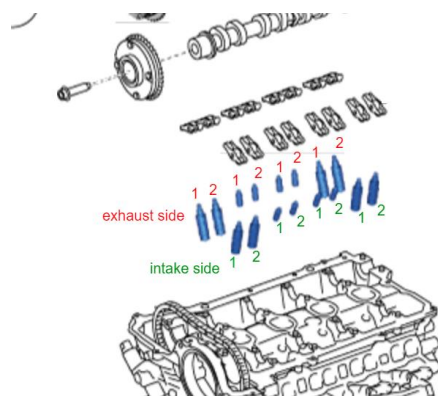
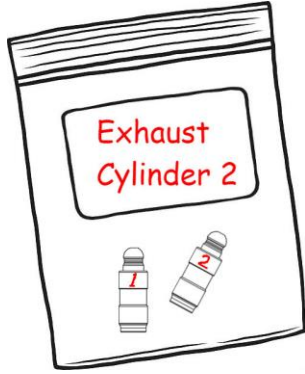
A valve tapping or knocking noise may be heard from the top end after the engine cools down (the vehicle is parked overnight) or after it has been idling for an extended time. The tapping noise will decrease as the vehicle is being driven or if the rpm is held above 2500 -3000 RPM. This may be caused by the valve Hydraulic Lifters (HLA) bleeding down as the engine cools or when the engine has been idling for an extended period of time, creating excessive valve lash clearance.

- If the tapping can be isolated, replace the appropriate HLA's (HYDRAULIC LASH ADJUSTER (HLA) REMOVAL INSTALLATION [SKYACTIV-G 2.5 (WITH CYLINDER DEACTIVATION))). Package each set (2) of HLA in a plastic bag and identify on the bag the location it was removed from. Example: #2 exhaust.
- If the tapping can not be isolated, replace all the HLA's (HYDRAULIC LASH ADJUSTER (HLA) REMOVALINSTALLATION [SKYACTIV-G 2.5 (WITH CYLINDER DEACTIVATION))). Package each set (2) of HLA's in a plastic bag and identify on the bag the location it was removed from. Example: #2 exhaust.
