Service Alert

Subject: "IN-VEHICLE NETWORK MALFUNCTION" INSTRUMENT CLUSTER WARNING MESSAGE	Service Alert No.: SA-029/20
	Last Issued: 02/25/2020

2019-2020 Mazda3
2020 CX-30

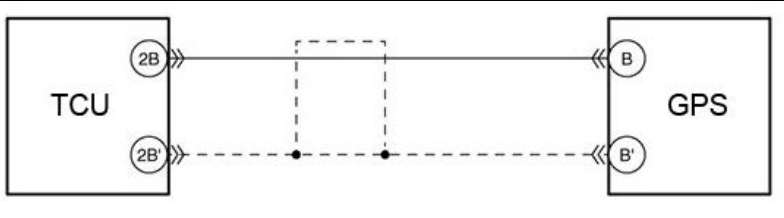
DTC	Action
B119F:01	<p>1. Check GPS antenna connection.</p> <ol style="list-style-type: none"> 1. GPS connection is good - No further repairs needed. TSB repair is coming soon. 2. GPS connection is bad - Repair GPS antenna connection.

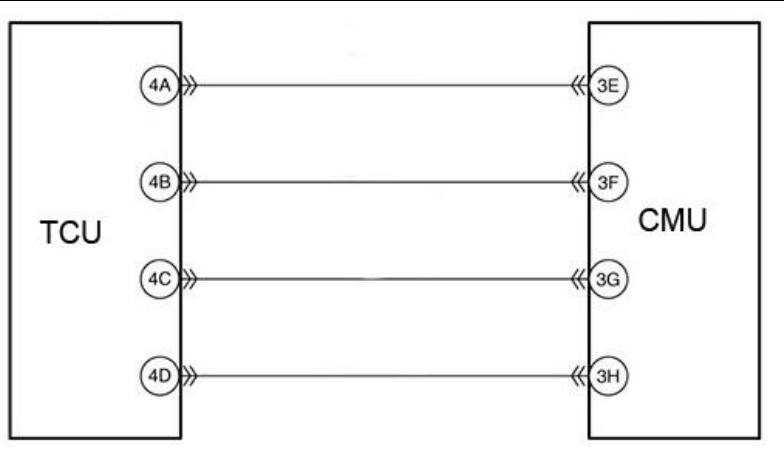
B1252:87	<p>1. Check USB cable connections between TCU and CMU.</p>
