Technical Service Bulletin

91 MIB2 High: Navigation data read error/reboots, DTC B126CF0 and/or B126CF1 stored in the information module

91 20 37 2057052/2 February 20, 2020. Supersedes Technical Service Bulletin Group 91 number 19-08 dated October 31, 2019 for reasons listed below.

Model(s)	Year	VIN Range	Vehicle-Specific Equipment
A5, Q5	2018 - 2019	All	MIB2 High
A3, A6, A7, and TT	2016 - 2019	All	MIB2 High
A4, Q7, and R8	2017 - 2019	All	MIB2 High

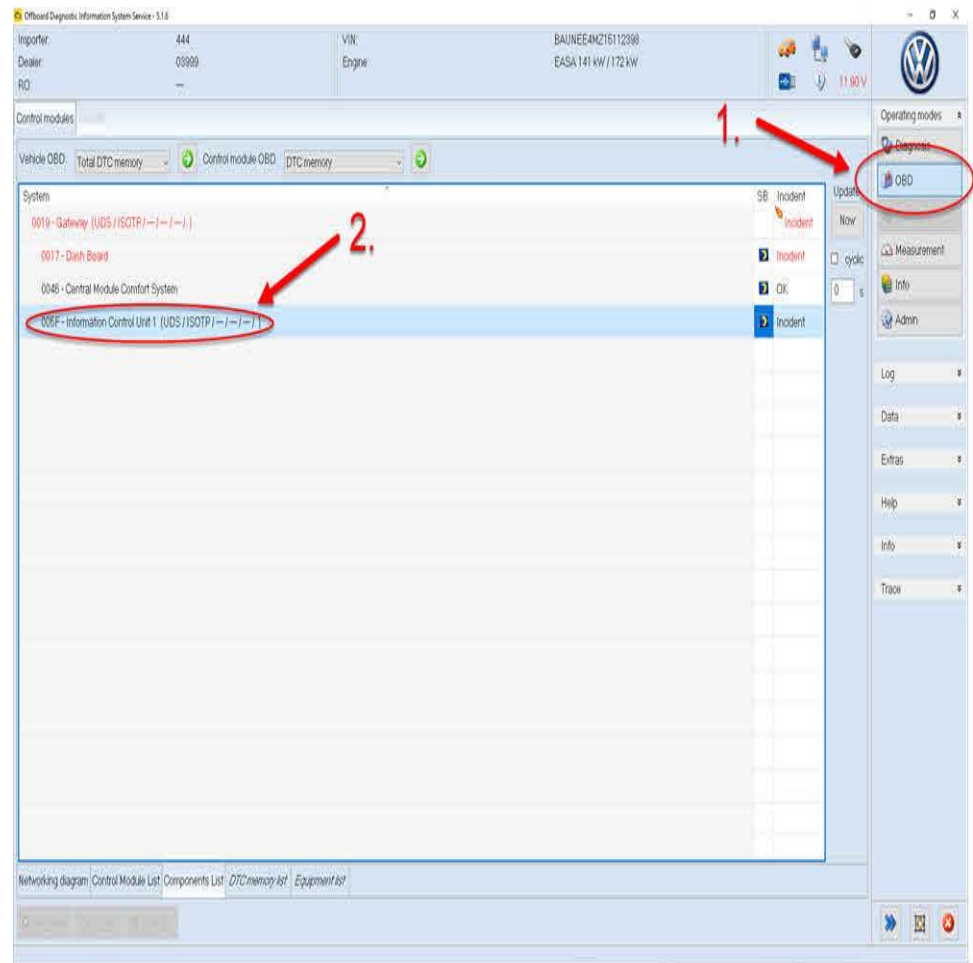
Figure 2. Select the 005F module.

1. In ODIS, please select “OBD” (1). Then select the 005F – Information Control Unit 1 (2) (Figure 2).

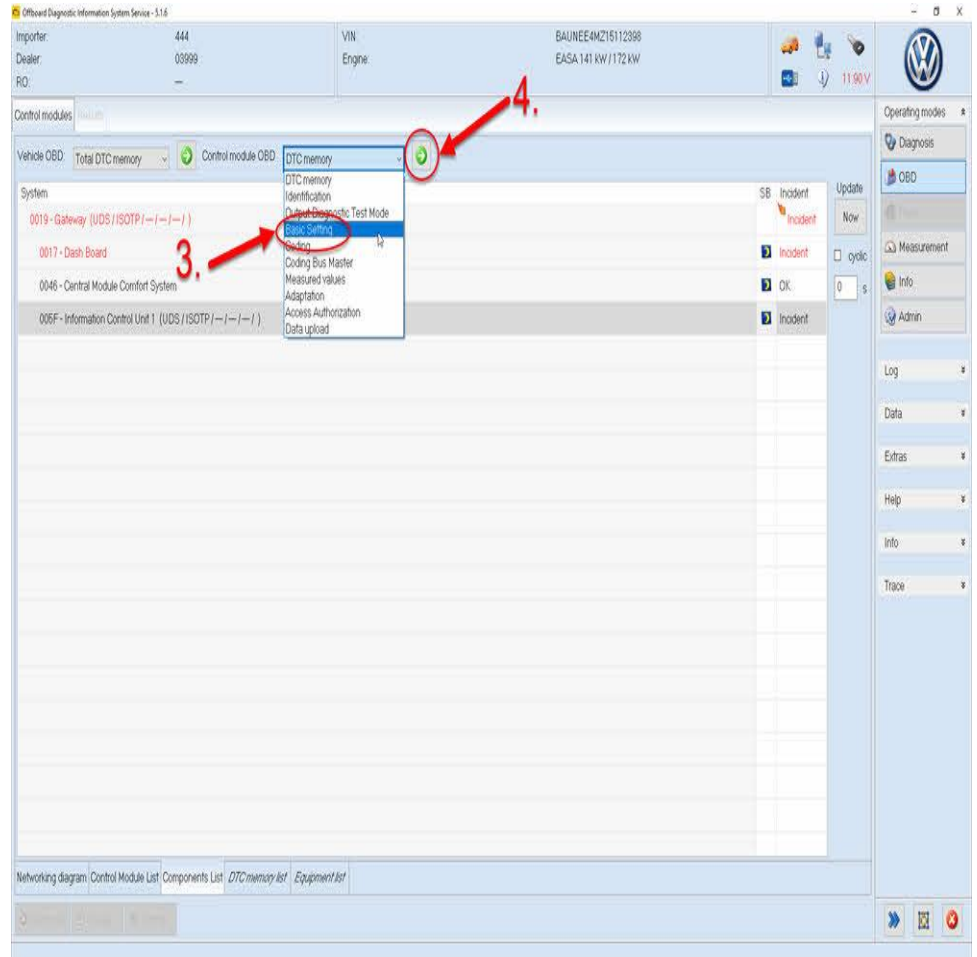
Figure 3. Select the basic settings.

- 2, In the drop-down menu “Control module OBD”, select “Basic Settings” (3), then click on the arrow to the right (4) (Figure 3).

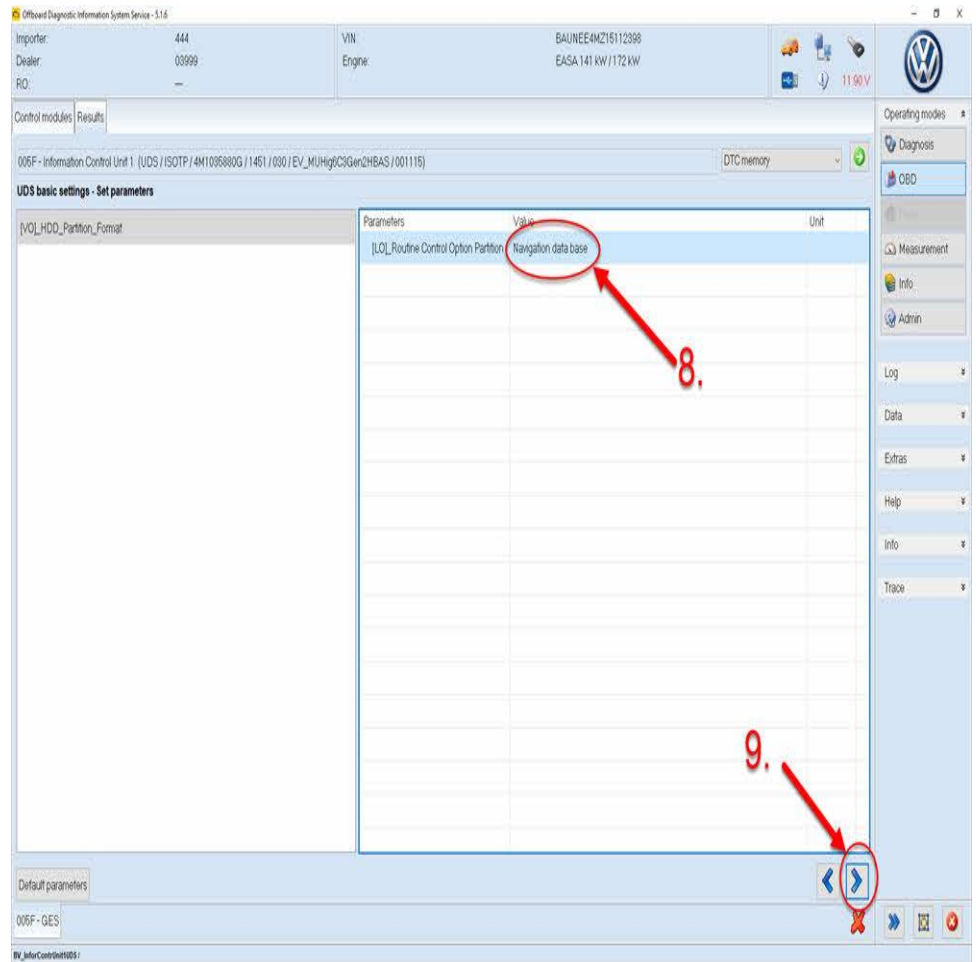
Figure 6. Navigation data base partition.

5. Make sure that the value for the parameter “[LO]_Routine Control Option Partition” says “Navigation data base” (8), then click “Next” (9) (Figure 6).

Tip: Make sure that the “Navigation data base” is selected. An incorrect selection in this step might render the control module/unit nonviable.

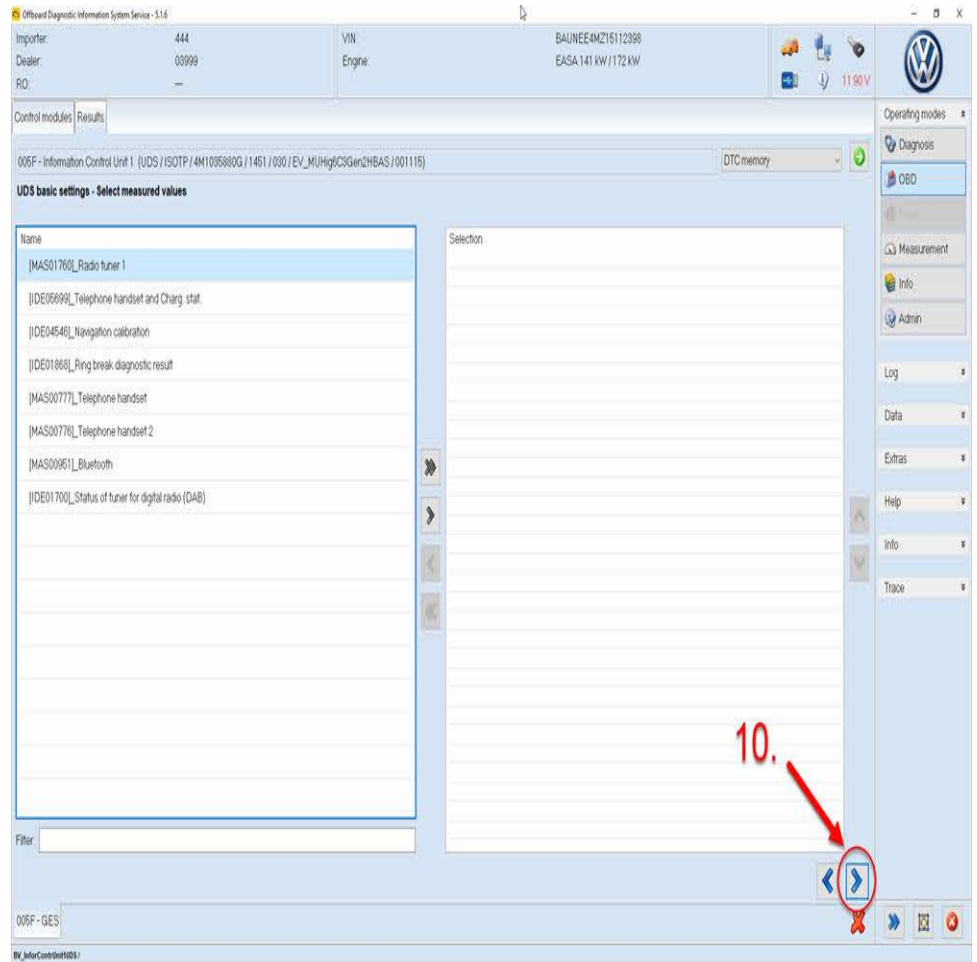
Figure 7. Select next.

6. Click “Next” one more time (10) (Figure 7).

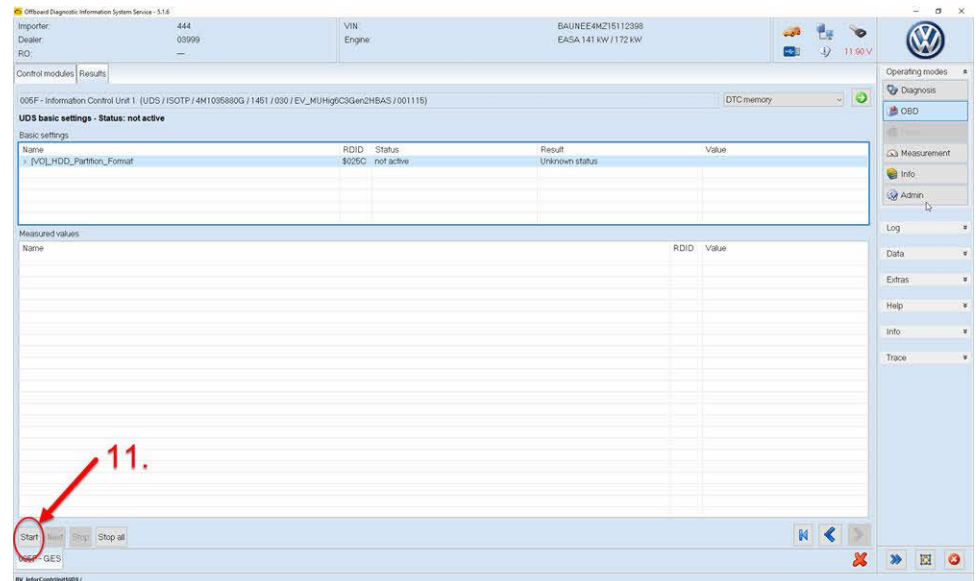
Figure 8. Execute the basic setting.

7. Select “Start” (11). The basic setting should complete within a few seconds (Figure 8).
