WARRANTY BULLETIN

Campaign no.: 2020-0005

Subject: **Spyder® RT - Abnormal Gaps Around the Rear Cargo Module Access Covers**

No. **2020-3**

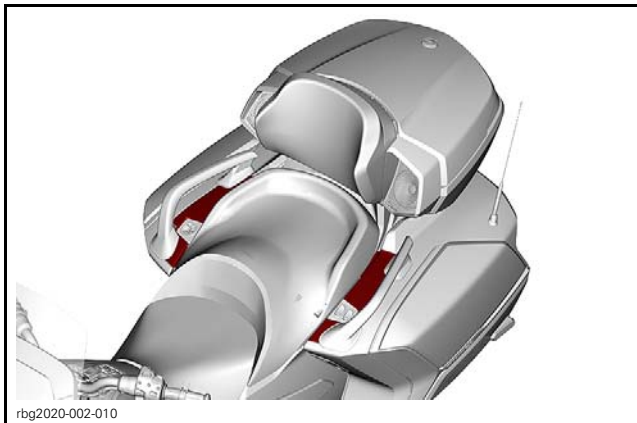
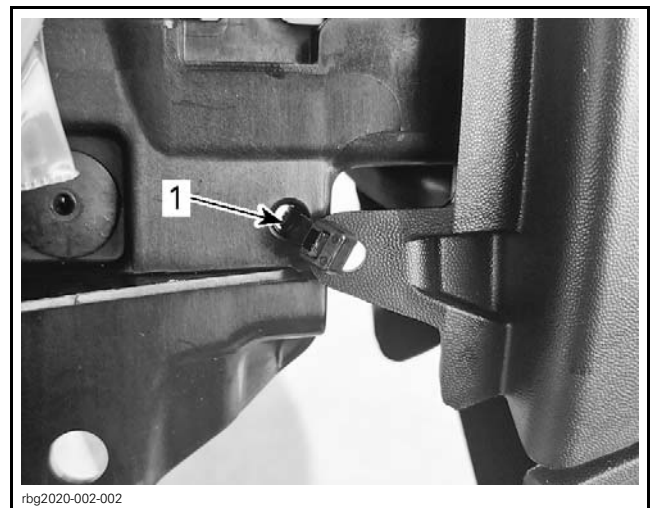
Abnormal gaps are present between both rear cargo module access covers and adjacent body parts.

To minimize the gaps, only the access cover rear screw was installed from factory.

The front was intentionally secured with a locking tie instead of a screw.

1. Locking tie

Replace both access covers and install screws instead of the locking ties.

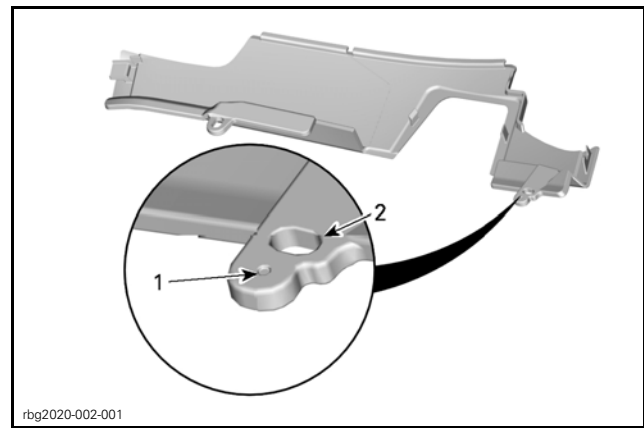
rbg2020-002-001

1. Molded dot where drill
2. Front slotted hole

1. Remove the passenger seat.
2. Cut the locking tie securing the front of the access cover.
3. Remove and keep the rear screw.
4. Remove and discard the access cover.
5. Turn the new access cover upside down.
6. Using a 5mm drill bit, drill a hole on the front tab, under the front slotted hole.

7. Position the access cover and loosely install the previously removed screw and a new K50 x 16 Torx screw.
8. Move the access cover to have an equal gap in back and in front.
9. Hold the access cover in this position and tighten screws.
