Technical Service Bulletin

Subject: CHECK ENGINE LIGHT ON WITH DTCs P24C6:00, P24AE:00, P24B1:00 AND/OR P24AF:00	Bulletin No.: 01-003/20
	Last Issued: 02/13/2020

APPLICABLE MODEL(S)/VINS
2018-2019 CX-5 SKYACTIV-D 2.2

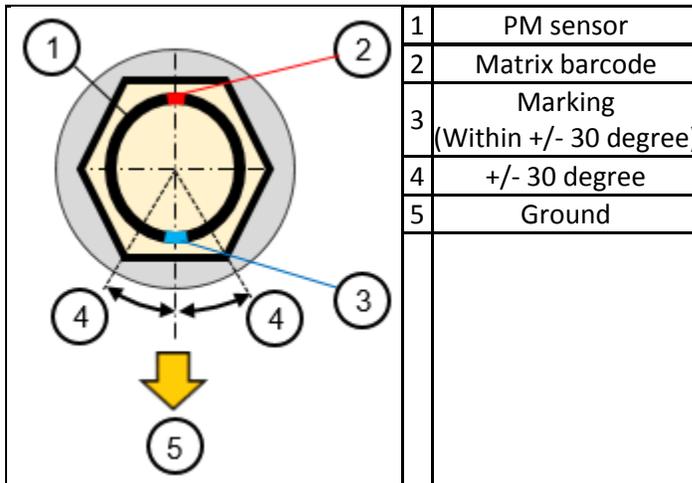
NOTE: To reduce water accumulation in the PM sensor, follow the steps below when installing the sensor so the sensor element faces upward.

1. Find the matrix barcode (2) on the PM sensor (1) that faces the same direction as the sensor element (See "Location of matrix barcode" below).
2. Mark (3) the sensor body 180 degrees opposite of the matrix barcode and harness side of the free nut.
3. Install the PM sensor so that the marking faces downward to the ground (5) +/- 30 degrees (4).

NOTE: When tightening the free nut, the sensor housing may turn together. For the best result, temporarily tighten the nut holding the sensor housing at 15 degrees before the target angle, then tighten to the specified torque.

- **Tightening torque: 30-44 ft·lbf {40-60 N·m, 4.1-6.1 kgf·m}**

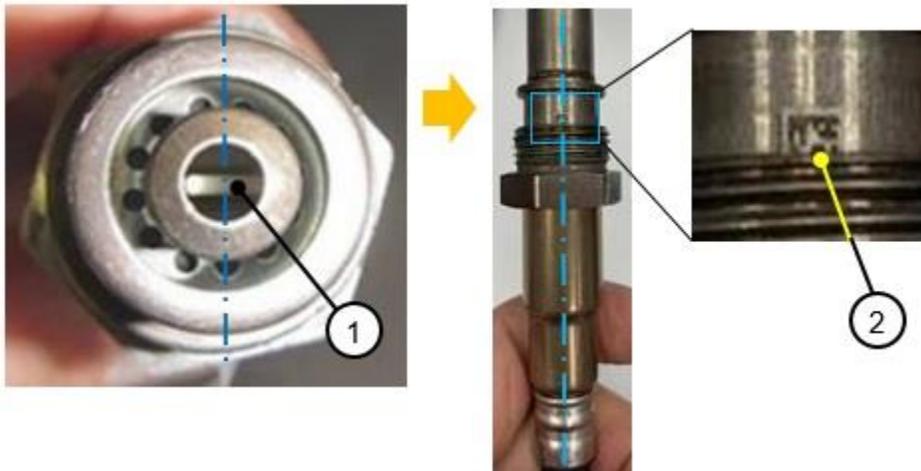
Location of the matrix barcode:

Locate the sensor element plate (1) and imagine the dashed line as shown below. The matrix barcode (2) is printed at the crossing of the line and either side of the sensor housing.

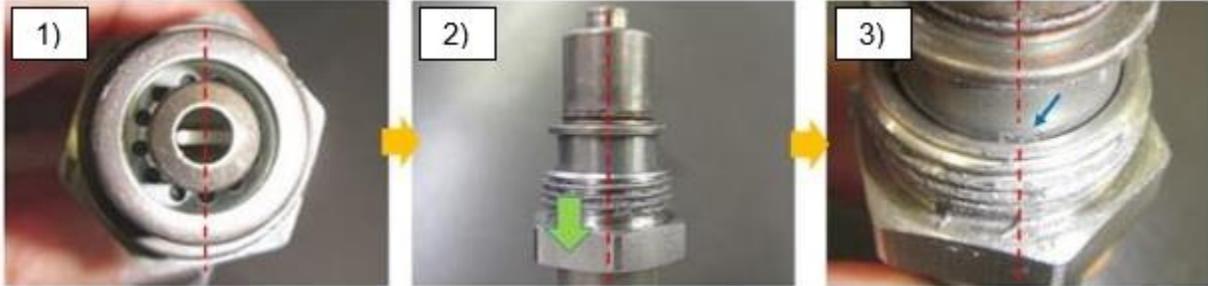
Procedure (A) Looking from the sensor element side:

- 1) Locate the sensor element plate.
- 2) Push the free nut downward.
- 3) Hold the nut to create clearance, then inspect the area shown below by the arrow.

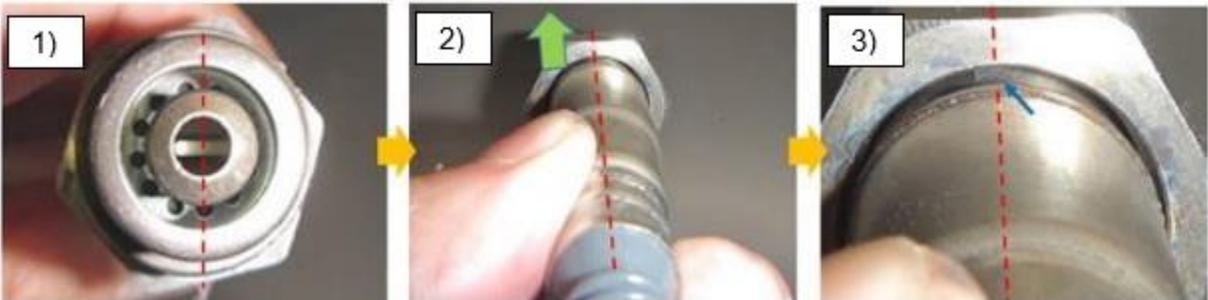
**Procedure (B)** Looking from the harness side:

- 1) Locate the sensor element plate.
- 2) Push the free nut upward.
- 3) Hold the nut to create clearance, then inspect the area shown below by the arrow.

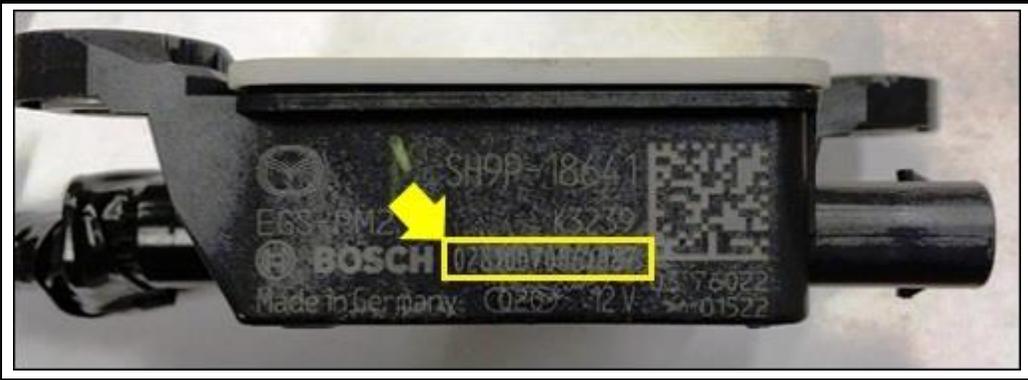
1. Inspect the ID Number (shown below) on the PM sensor from kit SH9P-18-641A.
 2. Is the ID Number **0281007918/919** or greater?
- If No, the kit cannot be used in this repair.
 - If Yes, the kit can be used in this repair.
